Technical Journal Title <b>Squeak noise from second row outer seats over bumps</b>		Ref. No. <b>TJ 36865.1.1</b>	
Issuer (Dept.) <b>Technical Service</b>		Issue Date <b>2/19/24</b>	Status Date <b>3/14/24</b>
Car Market <b>United States and Canada</b>	Partner <b>3 US 7510 Volvo Car USA</b>	Function Group <b>8530</b>	
Function Description <b>Rear seat, passenger seat, bench</b>		Page <b>Page 1 of 3</b>

## Points of application

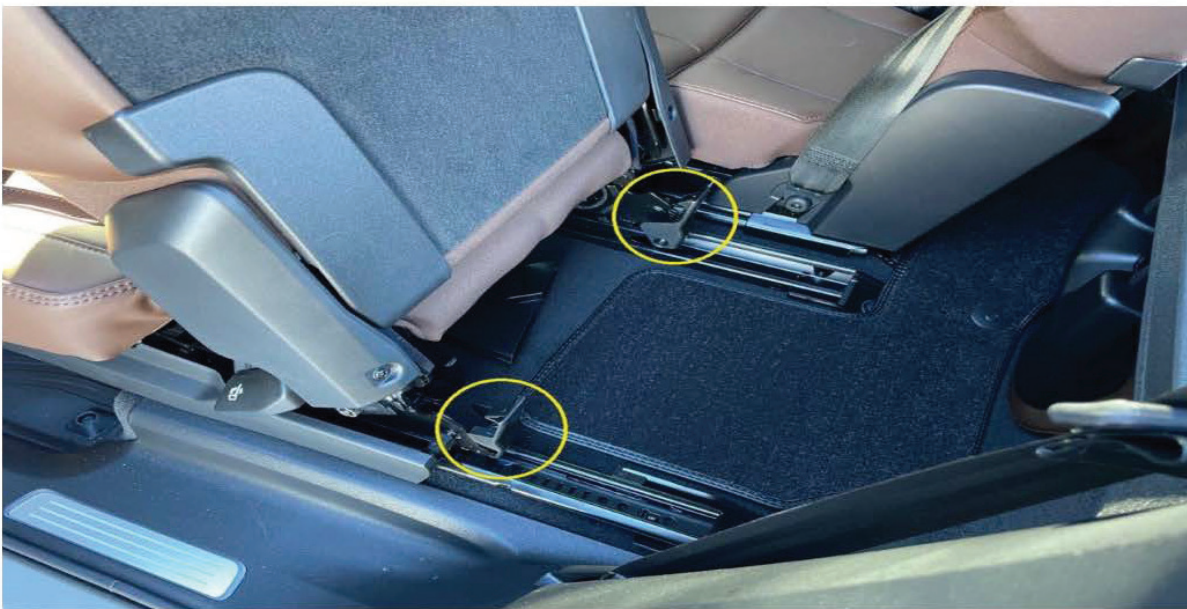
**1** Apply Anti squeak spray on both sides

Please refer to picture for points of application.

Use PFPE Anti squeak spray, p/n 30749880 spray. **Note:** Only .10 will be reimbursed.

Apply this on both side on both left and right seats.

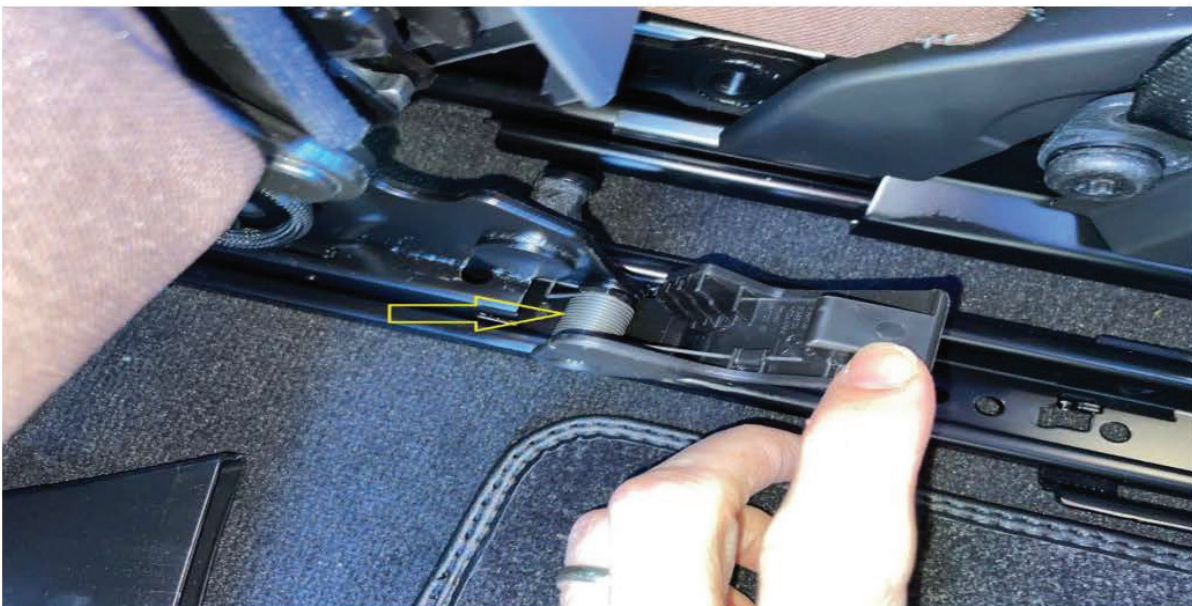
**2** Closer look at point of application (both sides)
