# Technical Service Bulletin

GROUP	NUMBER
<b>CAMPAIGN</b>	<b>24-01-030G</b>
DATE	MODEL(S)
<b>APRIL 2024</b>	<b>GV80 (JX1)</b>

SUBJECT:	ALL WHEEL DRIVE (AWD) ELECTRONIC CONTROL UNIT (ECU) CHECK & REPLACEMENT (SERVICE CAMPAIGN T45G)
----------	---

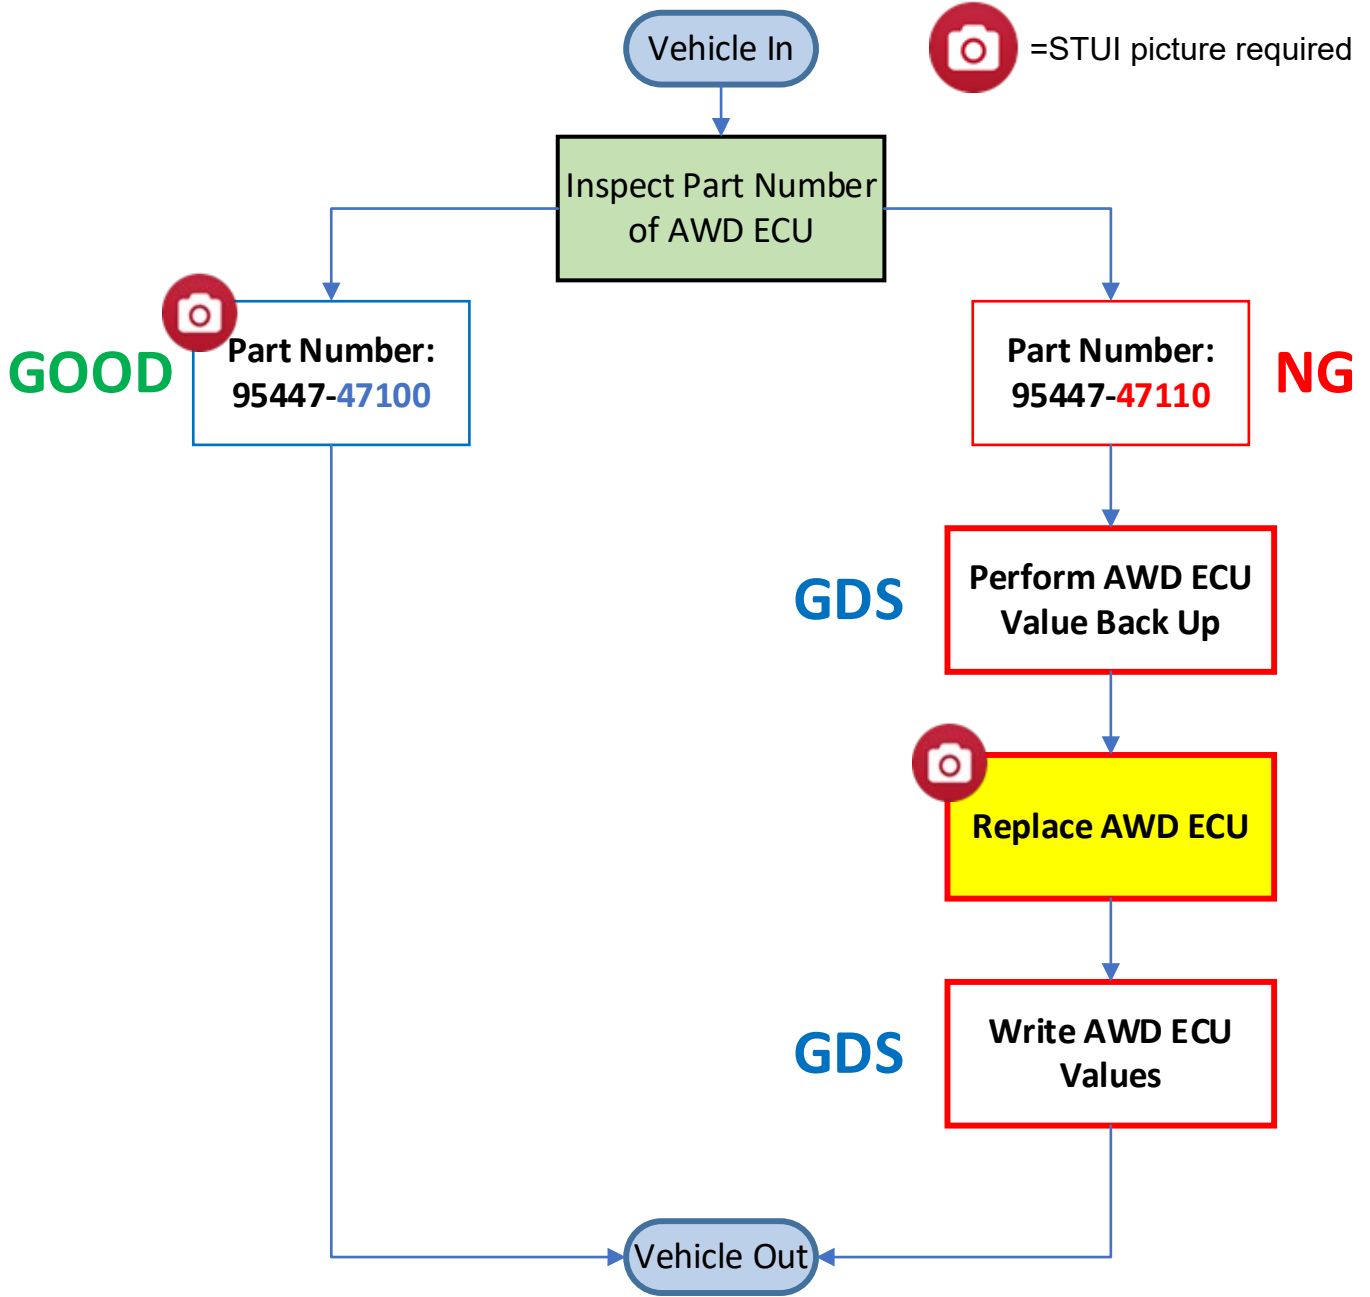
Refer to the flowchart below for overall procedure.

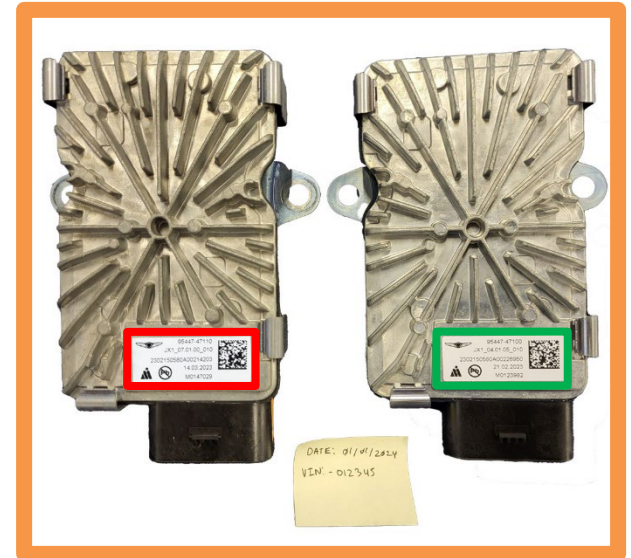
Using STUI, take a picture of the new AWD ECU next to the old AWD ECU. Include a piece of paper with the last six digits of the VIN and date of repair in the photo. Ensure the picture is in focus and the part labels are clearly visible. Upload the photo to STUI.

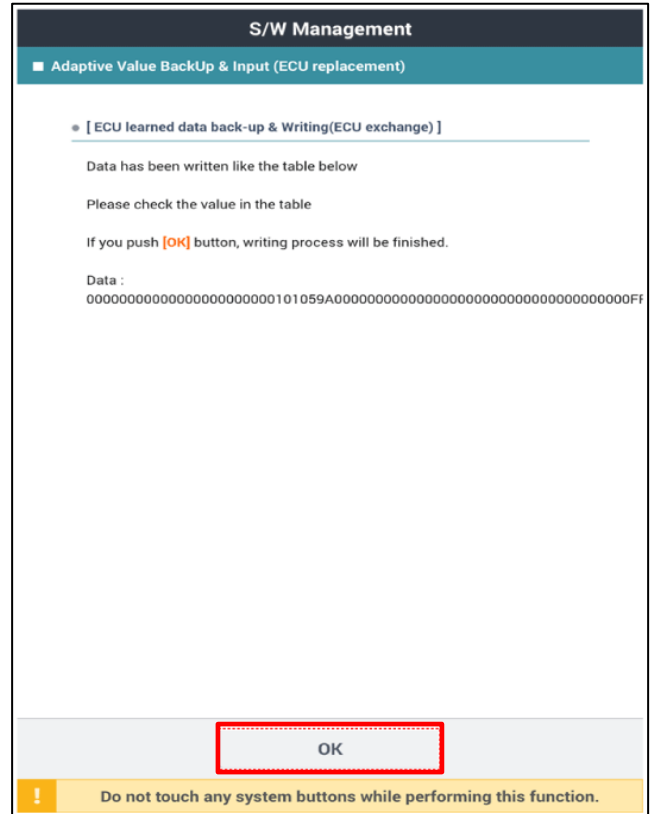
5. Select the "OK" button to write the backed-up values to the new ECU.
6. Check if any Diagnostic Trouble Codes (DTCs) were created during the ECU replacement, and clear all related DTCs.
7. Service procedure is now complete.
