MAS004040 RU 24-07

RAPID UPDATE

Rapid Update 705 MC20 Cielo – Gearbox Oil Leak Check

DATE: MARCH 7, 2024

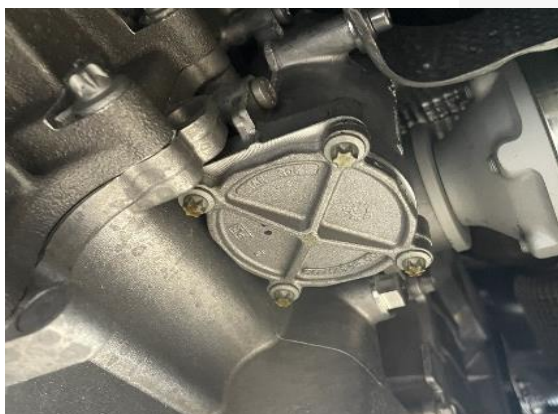
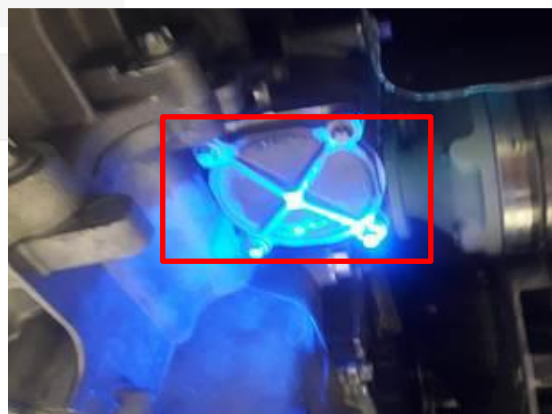
1. Due to a potential oil leak around the oil filter cover, it is necessary to replace it following the Instructions outlined in the workshop manual.

Example of oil leak around the oil filter cover

SECTION 03.10 – 1 (Procedure N. 3.10.157 GEARBOX OIL FILTER CARTRIDGE Removal-Refitting or Replacement)

2. Perform the **DTCM purge cycle procedure** as instructed on **page 4** of this bulletin to ensure that there are no residual leaks

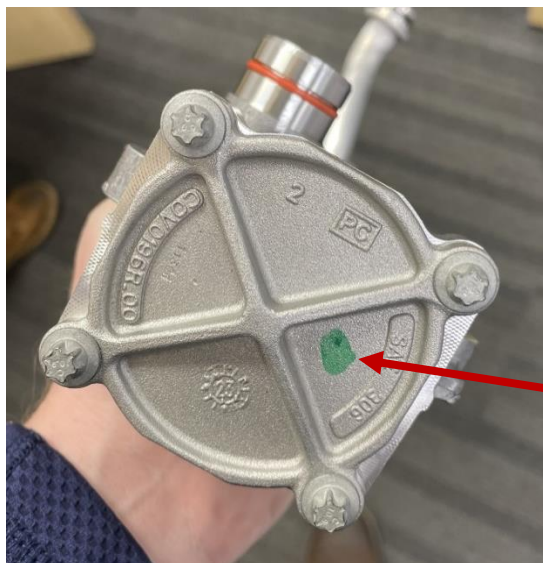
IMPORTANT: For this action it is necessary to use only new components that have a recognition mark as shown in the following image. The use of unmarked components does not guarantee the success of the operation.

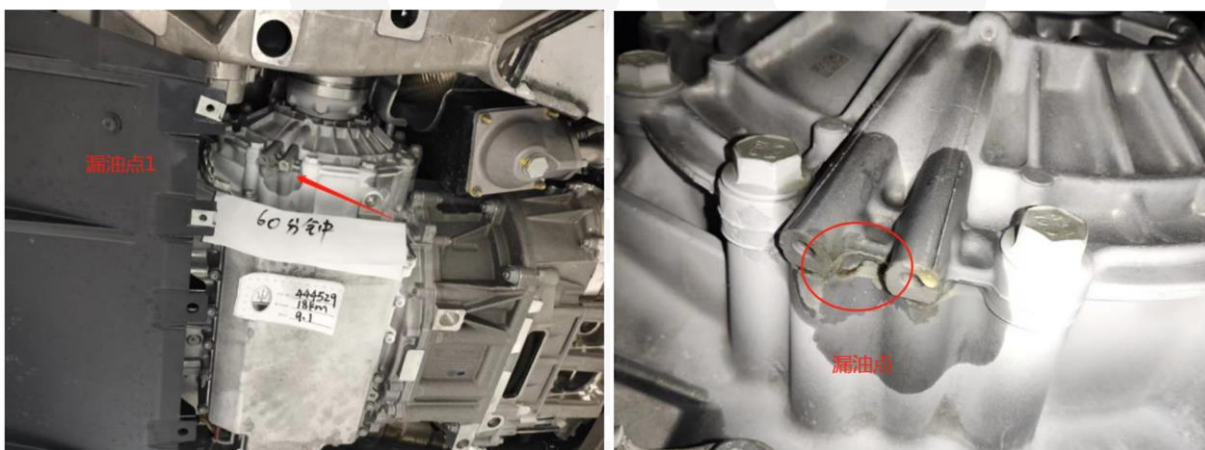
1. Due to a potential oil leak around the differential area of the gearbox, it is necessary to replace the entire gearbox assembly following the instructions outlined in the workshop manual.

Example of oil leak around the differential area

IMPORTANT! READ THE WORKSHOP MANUAL COMPLETELY BEFORE PROCEEDING WITH THE REPLACEMENT.
SECTION 03.10 – 1 (Procedure N. 03.10.060 15 COMPLETE AUTOMATIC GEARBOX – Replacement)

2. Perform the **DTCM purge cycle procedure** as instructed on **page 4** of this bulletin to ensure that there are no residual leaks

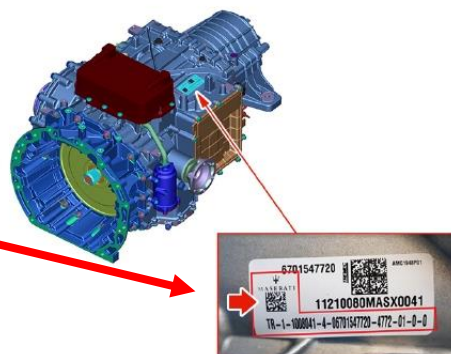
TECH TIP: Before installing the new Gearbox into the vehicle, take a clear picture of the QR code tag located on top of the gearbox as it may not be accessible/visible once installed after finishing the replacement. The QR code is needed to “Register” the new Gearbox to the vehicle using the EVO. (See the workshop manual for details)

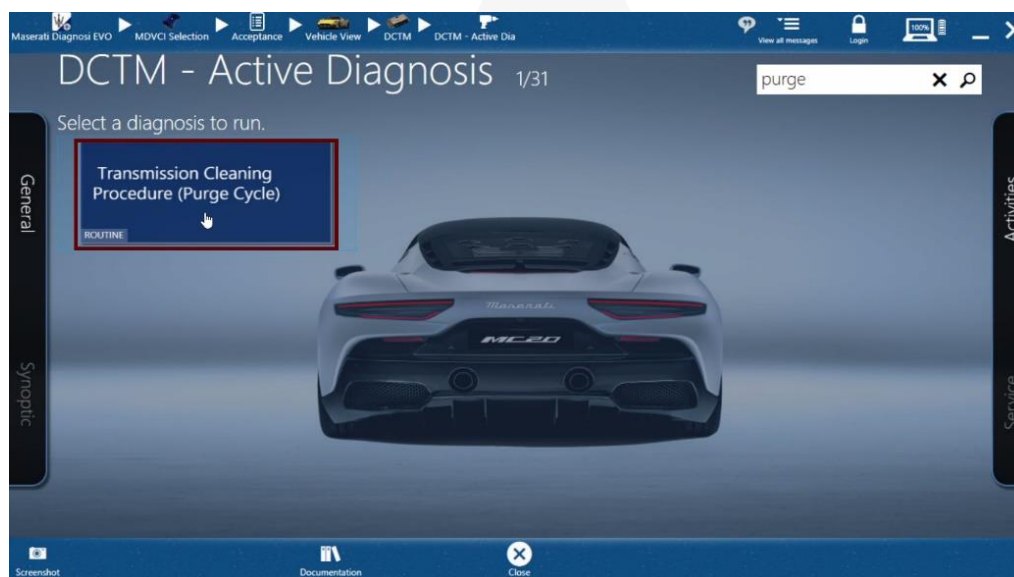
1. **Before proceeding, ensure that the following preconditions are met:**
 - a. Engine running.
 - b. Brake pedal fully depressed.
Warning: if the brake pedal is released, the procedure will stop immediately.
 - c. Change to N.
 - d. Parking brake ON.
2. Select: DCTM ► Active Diagnosis ► Transmission Cleaning Procedure (Purge Cycle).

Note: The engine will increase to 3000 rpm for approximately 15 minutes.

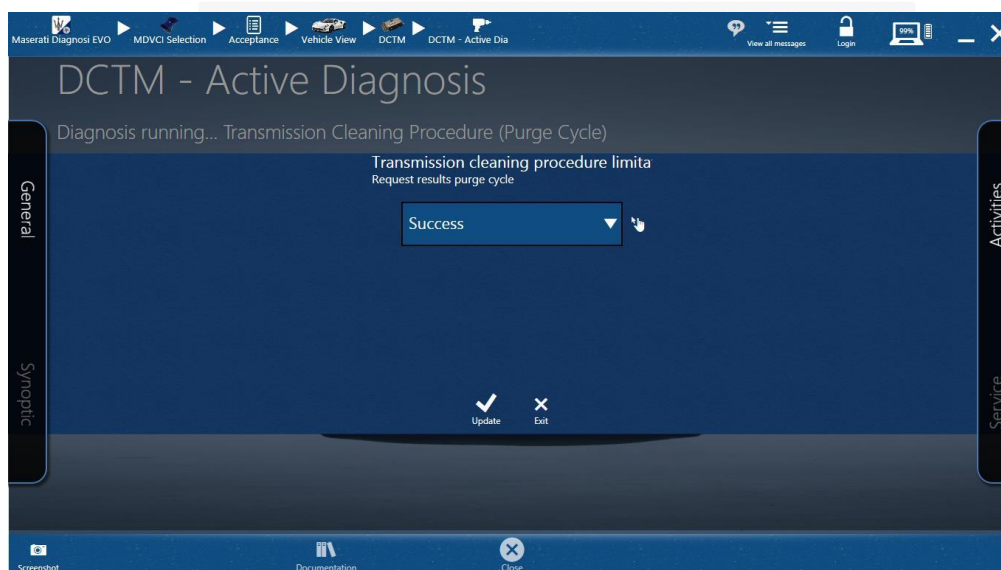
3. The cycle can be considered completed when the engine returns to idle.

Note: No message will appear automatically. When the engine returns to idle, press "Update" to see if the "Success" message appears.

Note 2: Release the brake pedal ONLY if the "Success" message appears.

4. Repeat the procedure **3 (three) more times**.
5. Procedure complete.
