Technical Journal

Outer rear view mirror jamming

REF NO: TJ 36763.2.0	ISSUING DEPARTMENT: Technical Service	CAR MARKET: United States and Canada	
PARTNER: 3 US 7515 Polestar		ISSUE DATE: 2024-02-20	STATUS DATE: 2024-04-24
FUNC GROUP: 8460	FUNC DESC: Outside mirrors	Page 1 of 3

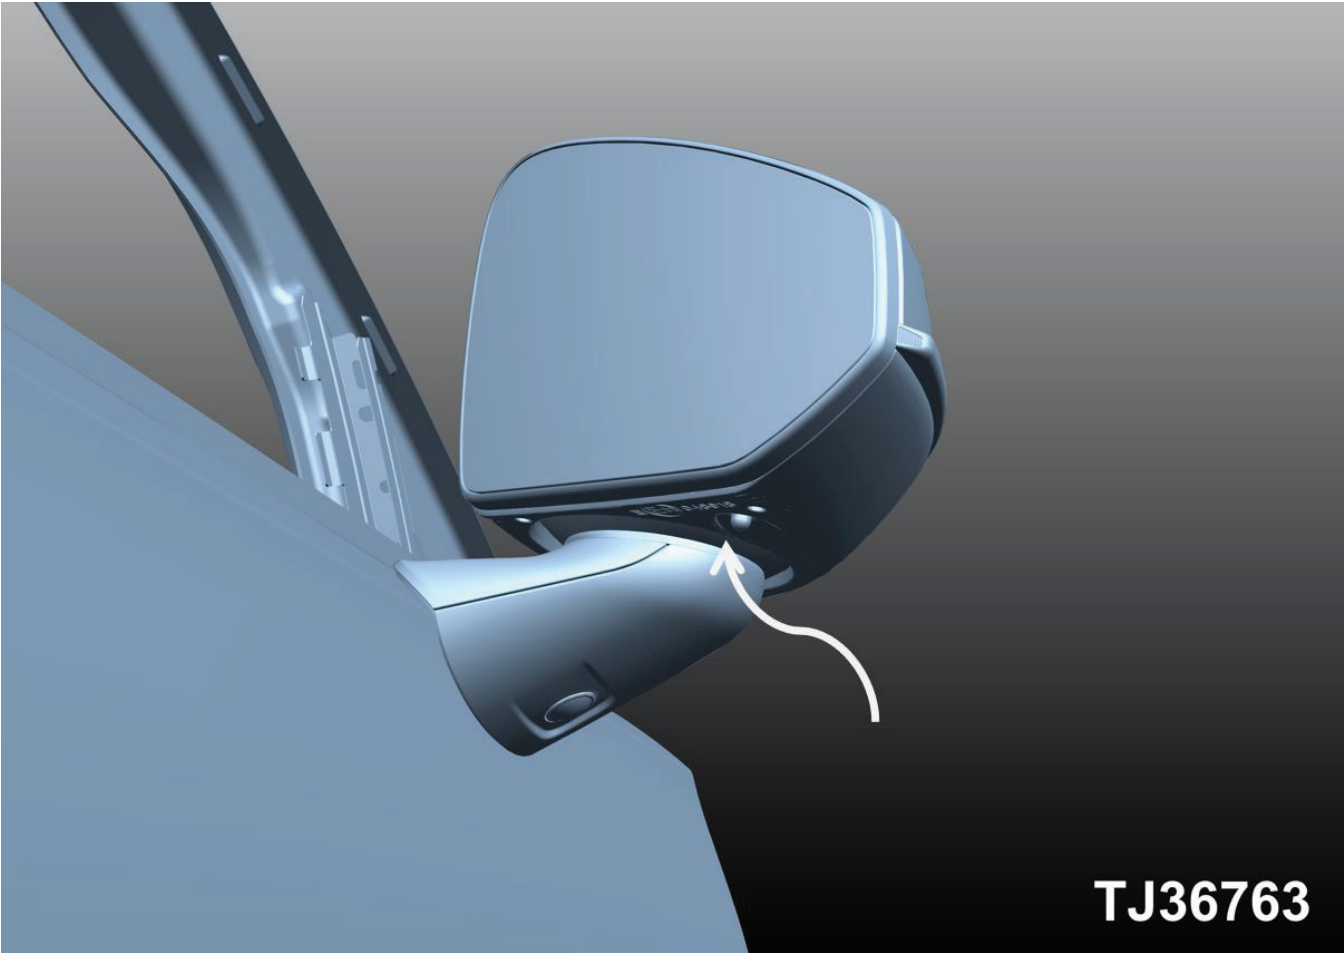
File Name	File Size
TJ 36763_1.JPG	0.0576 MB

1. Assemble the cable correctly and then lock/unlock the car. If the symptom remains, see step 2.
2. Use Würth Dry Lubricant Spray (PTFE) with part number 0893550 and spray underneath the mirror at the base. See attachment.
