10001607  
**HYUNDAI Technical Service Bulletin**

Group	BODY ELECTRICAL
Number	03-90-009
Date	APRIL, 2003
Model	2001-2003 ELANTRA

Subject  
**2001-03 ELANTRA CORROSION IN THE FRONT DOOR WIRING CONNECTOR**

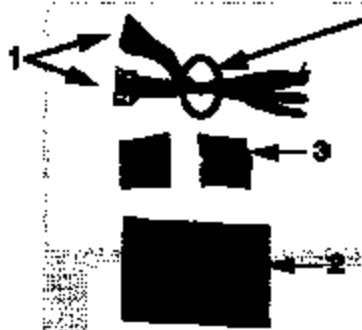
1. Wiring Assy.
2. Vinyl Sheet
3. Heat Shrink Tube

**ID TAPE COLOR**  
**A: BLACK**  
**B: BLUE**  
**C: YELLOW**  
**D: RED**

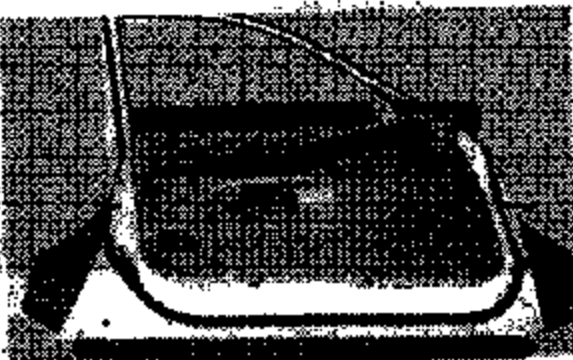
7. Remove the front door assembly. Set it on a clean soft cloth where it will not be scratched or damaged.

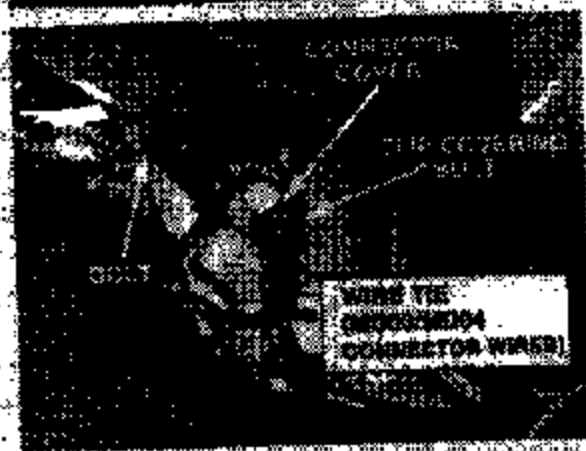
1. Open the passenger's side door.
2. Remove the door sill trim.
3. Remove the right cowi side trim.
4. Unclip the main wire harness from the connector cover. Cut the wire tie holding the MD03/MD04 connector wires to the connector cover. Remove the wiring connector cover mounting bolts (2EA) and then remove the cover.
5. Follow the MD03/MD04 connector wires up to the connectors, disconnect the connectors. The release for the top connector is on top, the release for the bottom connector is on bottom.
6. Release the 4 door wiring harness connector locking clips by pressing them one at a time, working around the connector. Push the connector out of the body hole.

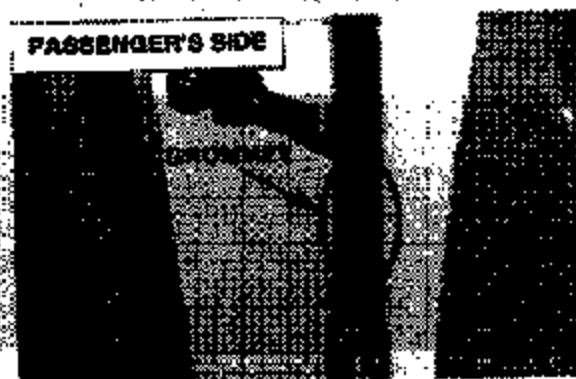
11. Carefully install the door wire connector back into the mounting hole. Be careful to keep the grommet in position.

**NOTE:** If the grommet separates from the connector, remove the connector, refit the grommet in position, reapply a small amount of sealant to the grommet, and reinstall the connector.

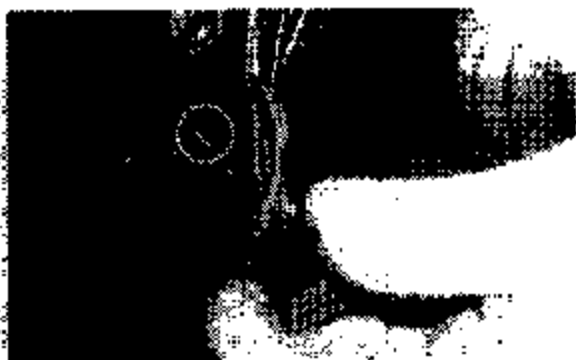
3. Strip the corresponding wire from the replacement connector (0.25inch, 7mm). Be sure to verify the wire position in the new connector matches the position the wire was cut from in the original connector.

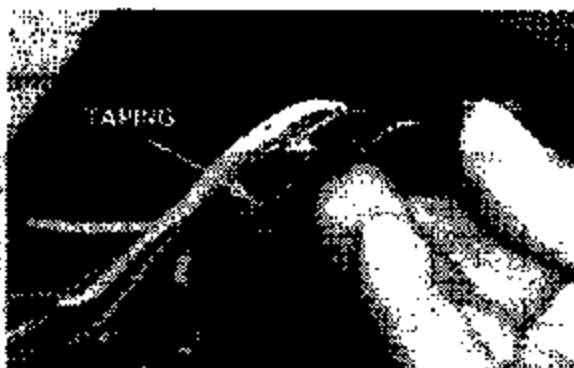
7. Some wires on the new door connector kit may not be used (different options). In this case, cut the unused wires 1 inch (25 mm) from the connector and tape the cut ends.

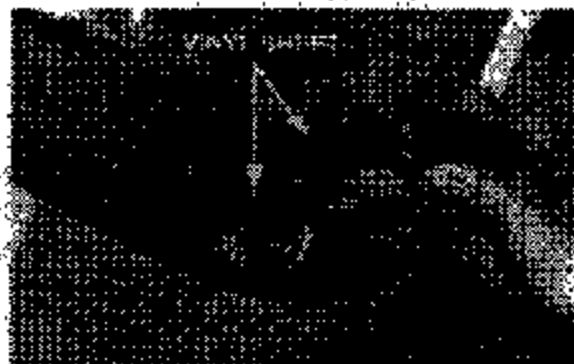
8. Wrap the spliced wire harnesses with the supplied vinyl sheet.

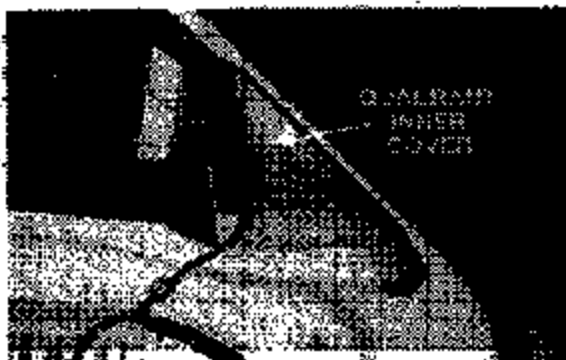
9. Remove the front door quadrant inner cover from inside the mirror mounting area.

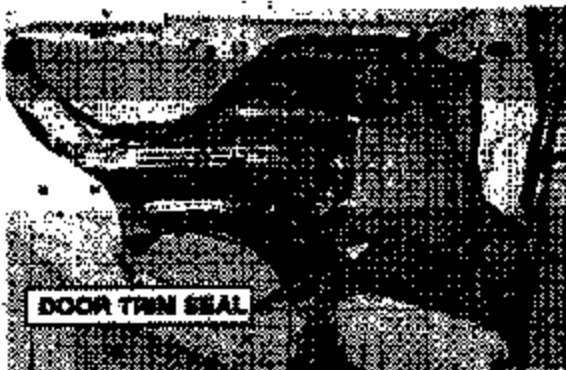
11. Remove the door trim seal.

**NOTE:** The door trim seal must be replaced if it is torn or damaged. Any leaks may cause door trim panel damage, or water leakage into the vehicle interior.

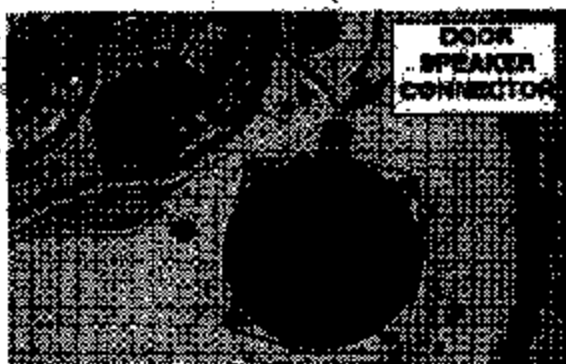
12. Disconnect the door speaker connector and then remove the door speaker.

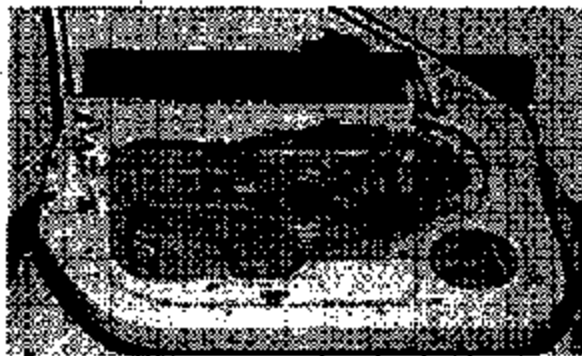
13. Remove the front door wiring.

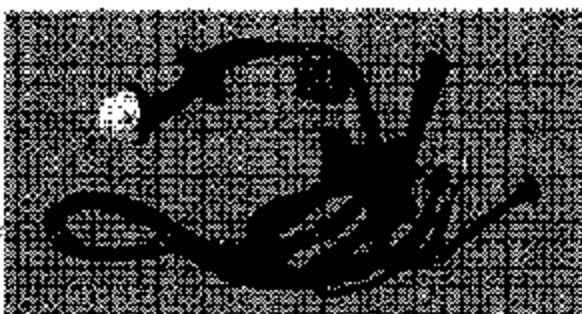
14. Replace the door wiring with a new part.

**IMPORTANT:** Verify you have the correct new door wiring assembly part number. Refer to page 19 of this TSB.

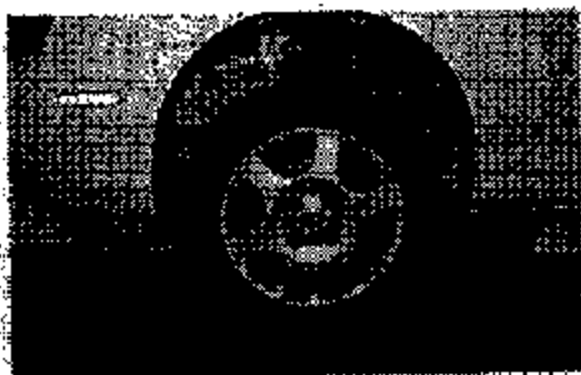
1. Lift up the vehicle.
2. Remove the front wheel and tire.
3. Remove the plastic front wheel guard (splash trim).

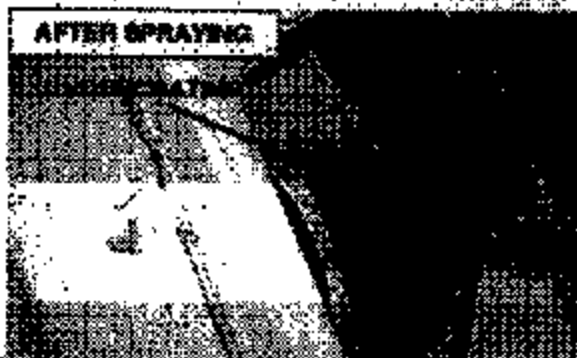
Spray all panel seams with undercoating.
