Service Bulletin

SB-10033024-1907

SUBJECT: Special Coverage Adjustment – Fuel Odor or Spotting on Ground – Replace Fuel Pump Module

MODELS: 2006 Chevrolet Cobalt
2006 Pontiac G4
2006 Saturn ION
Originally Sold or Currently Registered in Alabama, Arkansas, California, Florida, Georgia, Hawaii, Louisiana, Mississippi, North Carolina, New Mexico, Oklahoma, South Carolina, Tennessee, Texas
2007 Chevrolet Cobalt
2007 Pontiac G5
2007 Saturn ION
Originally Sold or Currently Registered in Alabama, Arkansas, Georgia, Hawaii, Louisiana, Mississippi, North Carolina, New Mexico, Oklahoma, South Carolina, Tennessee

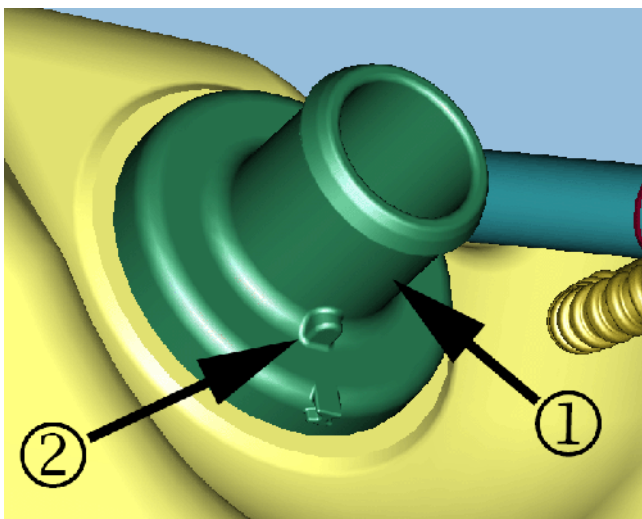
4093630

Identifying the 20870462 or 25947828 fuel tank.

The fuel tank hose connection (1) will have an index feature (2) at the bottom 6 O'clock position where the hose joins the tank. Older style tanks have this feature on top at the 12 O'clock location. The fuel tank may also have an identifying tag displaying the part number.

- If the part number *is* 20870462 or 25947828, and has the bottom index, proceed to Step 5.
 - If the part number *is not* 20870462 or 25947828, and has the top index, proceed to Steps 3 and 4.
3. Replace the fuel tank with p/n 20870462 or 25947828, as applicable. Refer to *Fuel Tank Replacement* in SI.
 4. For Cobalt, G4, G5: Replace the fuel tank filler pipe. Refer to *Fuel Tank Filler Pipe Replacement* in SI.

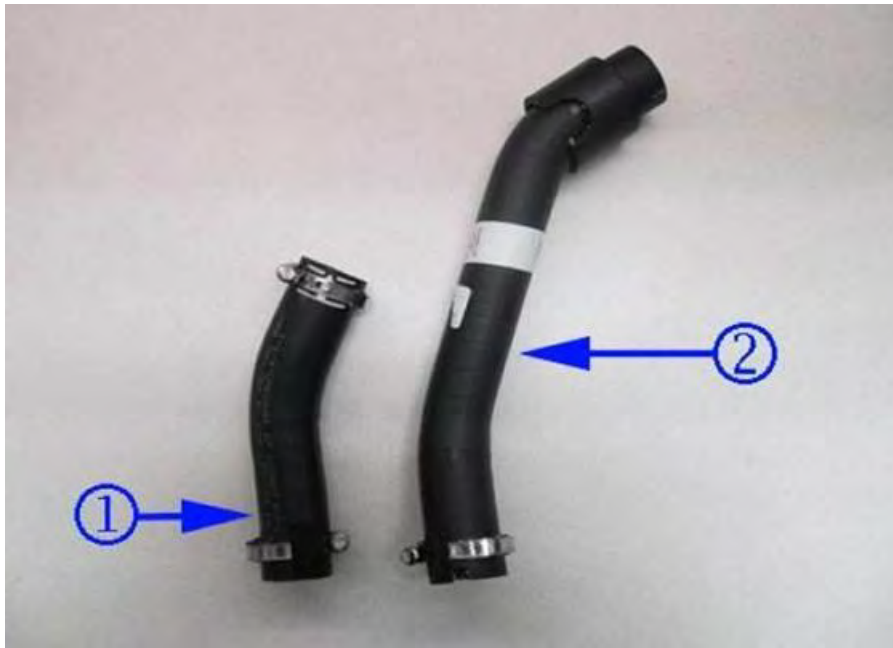
4109439

4.1 Remove fuel tank filler hose from vehicle mounted fill pipe.

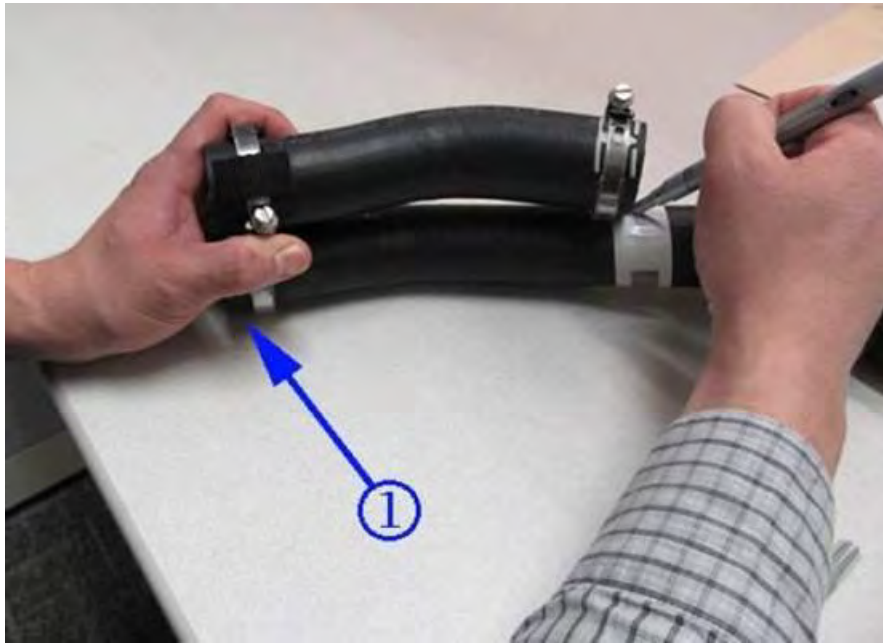
4109445

4.2 Match the new hose (2) to the original (1), aligning side by side.

4.3 Using a paint pen or equivalent, mark the new hose to the original, starting with the notched fuel tank ends of the hoses so that both hoses are the same length.

Note: When cutting the hose, be sure the cut is as straight as possible. Use a hose clamp or tape as a guide. Failure to cut the hose straight could result in leaks.

4.4 Cut the hose **from the fill end** opposite of the side with the notch (1) to match the length.
