## Vehicle drops at rear axle, display message: "AIRmatic - Service Required"

Topic number	LI32.22-P-048597
Version	2
Design group	32.22 Air suspension
Date	10-28-2010
Validity	Model 212.0## with air suspension (SA code 489) Model 212.2##
Reason for change	Part numbers of air springs added.
Reason for block

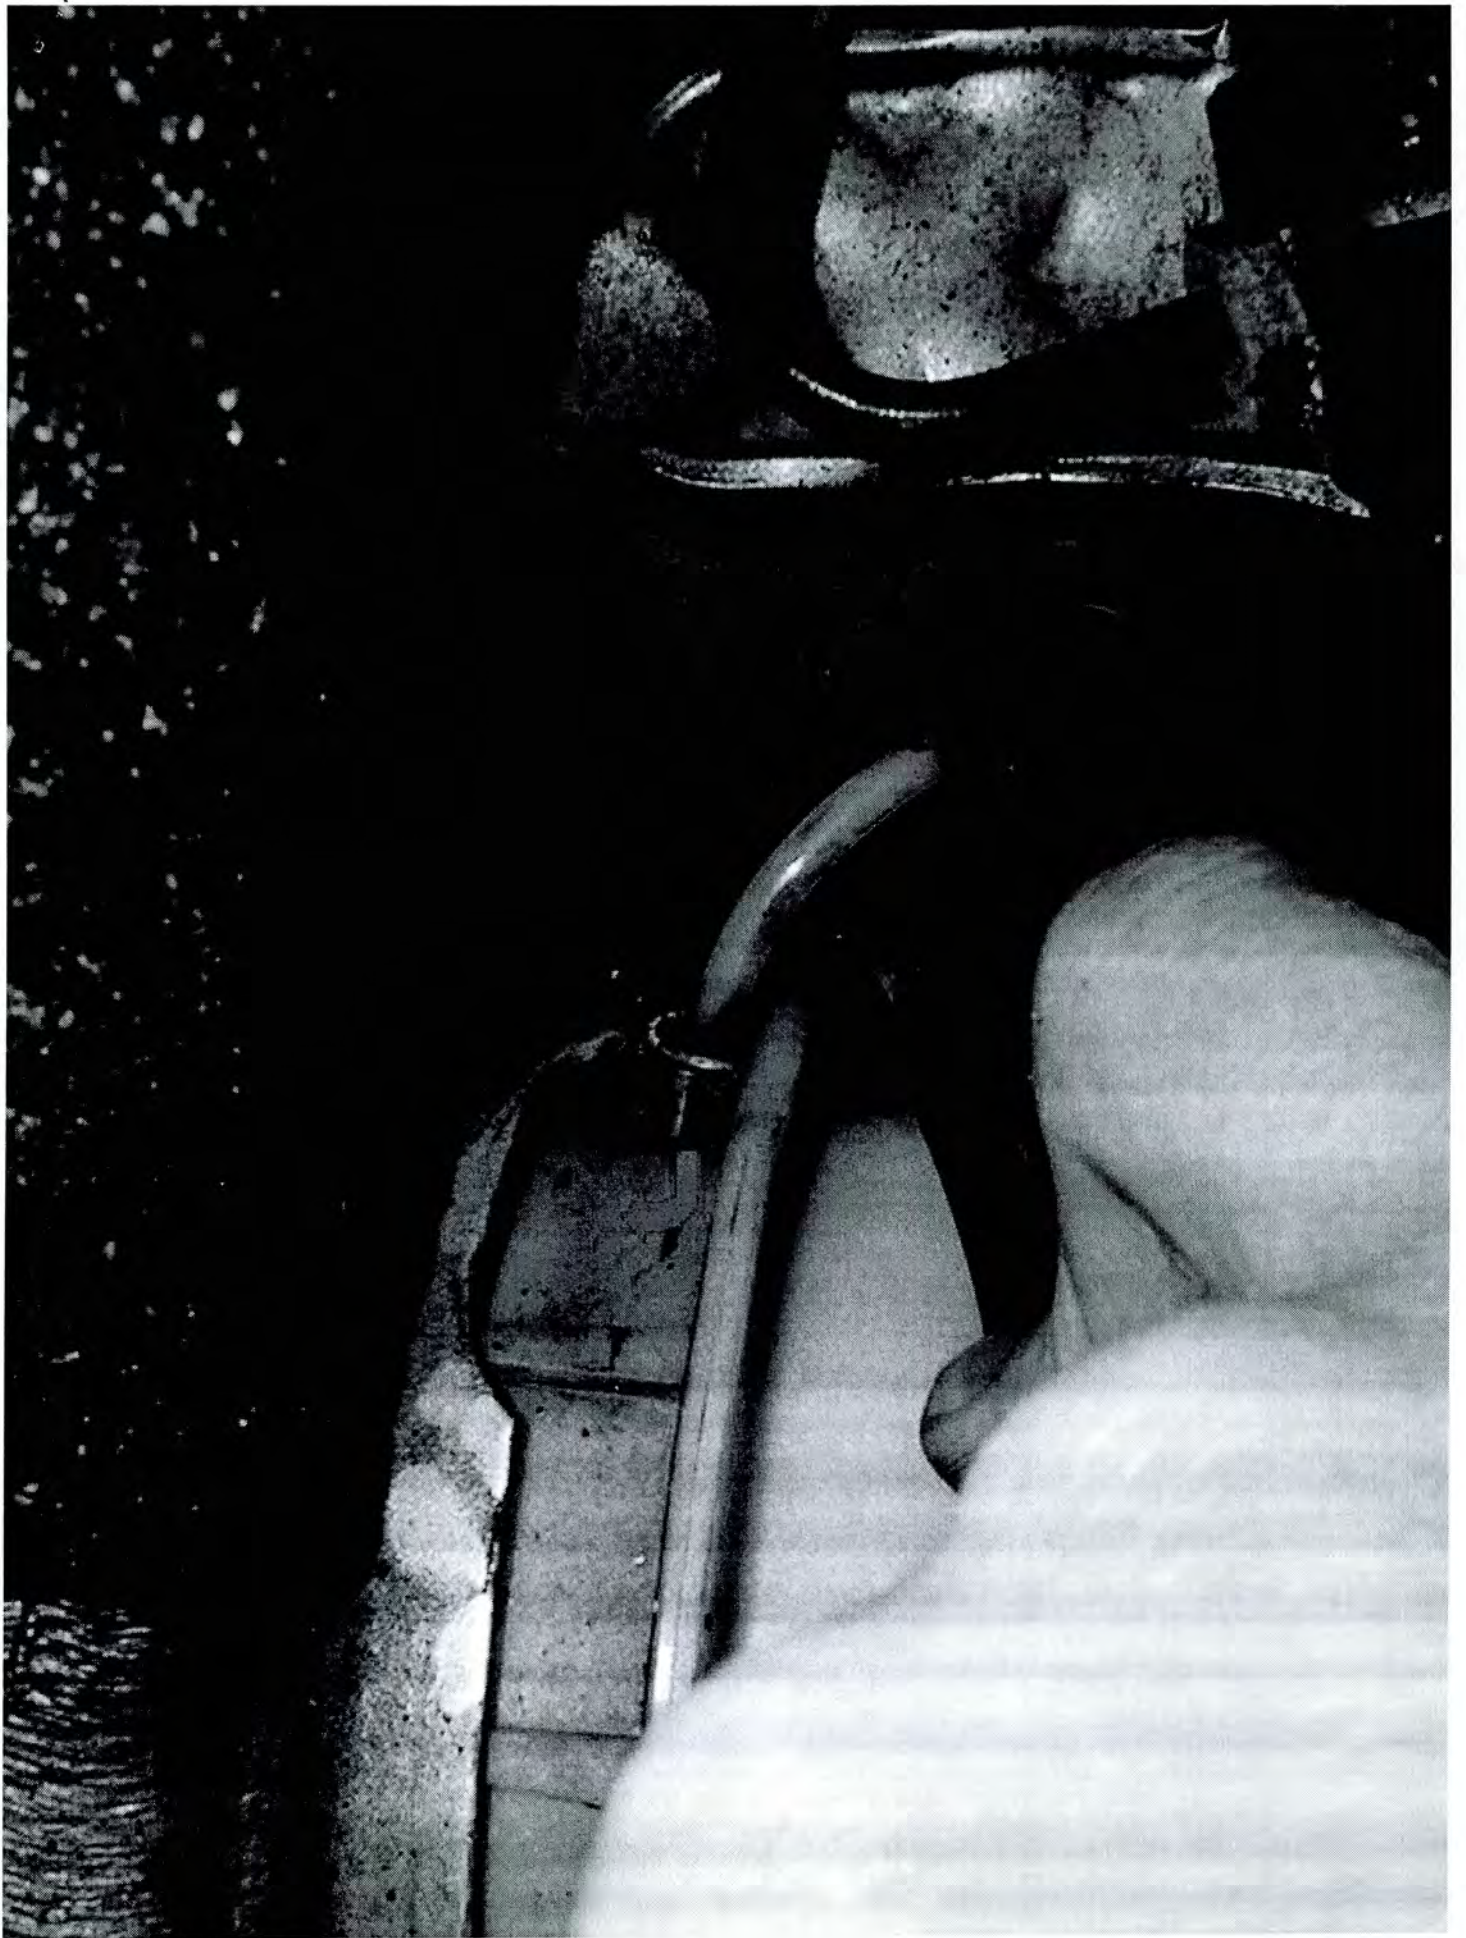
Attachments	
File	Designation
Vossanschluss verdreht an HA BR 212.jpg	Figure 1

1. Damaged sealing rings in the air suspension element on the rear axle can lead to a microscopic leak and thus to a gradual loss of air.
2. Air suspension element on the rear axle installed twisted (see Figure 1), leading to extreme load on the connection piece of the air pressure line and leakage at the thread.

3. Check installation position of air suspension element. The connection piece of the pressure line must not make contact with the centering socket (see Figure 1). If necessary, realign the air suspension element so that the connection piece of the air pressure line is located in the cutout.
