Applies To: 2011 Odyssey LX, EX, EX-L, and EX-L with RES – Check the iN VIN status for eligibility **June 15, 2012**

Product Update: Audio Unit Software Update for Security Code, Clock Reset, HFL, and Other Listed Issues

(Supersedes 10-081, dated October 28, 2011, to revise the information marked by the black bars) **(Replaces 10-067, Rear Entertainment System Displays "Parental Error" on Audio Display)**

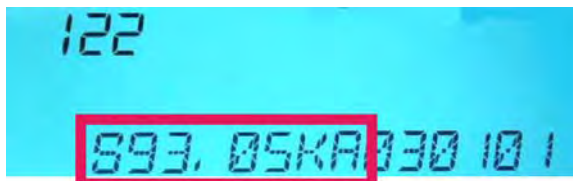
- To display the region, press and hold audio preset buttons No. 1, No. 3, and No. 5. While holding the preset buttons, press the VOL/POWER knob. The region should be **S93.05KA**.

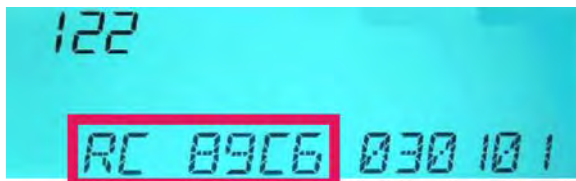
- To display the software version, press and hold the SCAN and the TITLE buttons until the software version appears. The software version should be **RC 89C6**.

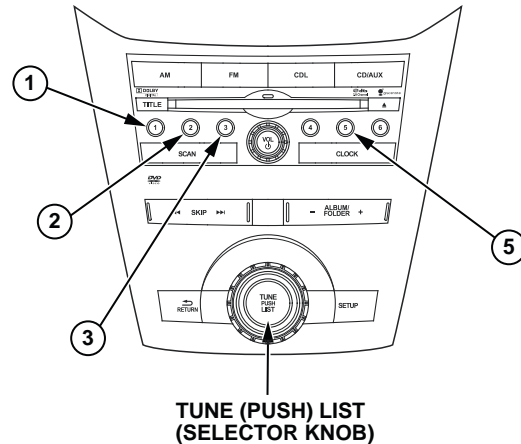
- Press and hold audio preset buttons No. 1, No. 2, No. 3, and No. 5.

- While holding the preset buttons, press and hold the TUNE (PUSH) LIST knob (selector knob) until the audio unit turns off; you will also hear a thump sound from the speakers. Release all the buttons.

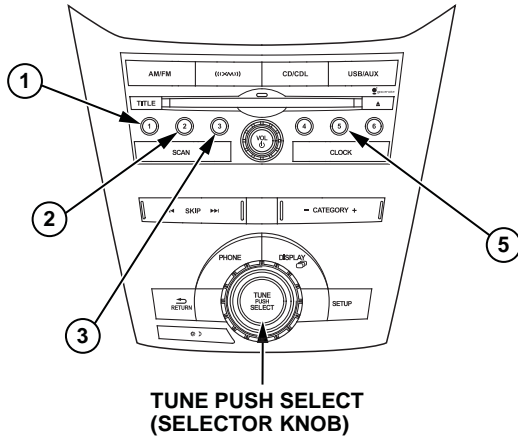
8. Apply the update:
 - Press and hold audio preset buttons No. 1, No. 2, No. 3, and No. 5.

- While holding the preset buttons, press and hold the TUNE (PUSH) SELECT knob (selector knob) until the audio unit turns off; you will also hear a thump sound from the speakers. Release all the buttons.
9. Verify the update by checking the region and the software version:

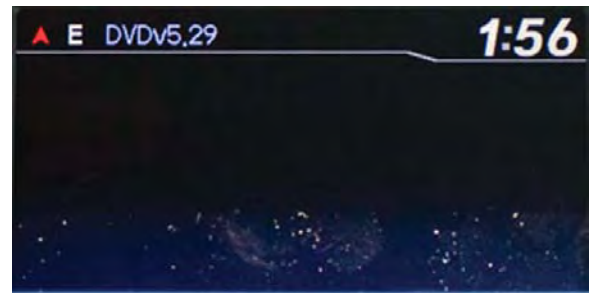
23. Check the RES version software to see if it needs an update:
 - Turn off the audio unit, then press and hold audio preset buttons No. 1, No. 3, and No. 5.
 - While holding the preset buttons, press and hold the POWER/VOLUME knob. Release all the buttons when the audio unit software appears on the display.
 - Press and hold the CD/CDL button for about 5 seconds until the CDL version appears.
 - Press the TITLE button. The RES version appears on the display.
 - If the current version is not at least **DVDv5.29**, go to step 24 and do the update procedure.
 - If the version is **DVDv5.29** or higher, the RES is updated. Go to step 29 to center-punch the VIN.

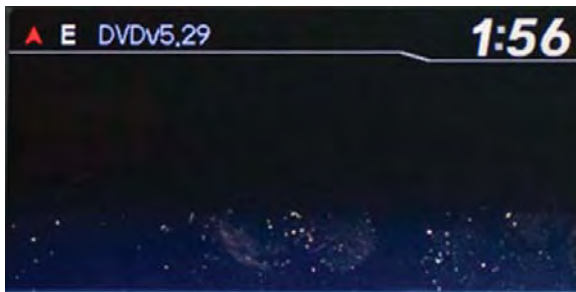
28. Verify the update by checking that the RES software is **DVDv5.29** or later. To check the software, do this:
- Turn off the audio unit, then press and hold audio preset buttons No. 1, No. 3, and No. 5.
 - While holding the preset buttons, press and hold the VOL/Power button. Release all the buttons when the audio unit software appears on the display.
 - Press and hold the CD/CDL button for about 5 seconds until the CDL version appears.
 - Press the TITLE button. The RES version appears on the display. If the current version is not at least **DVDv5.29**, go to step 21 and repeat the update procedure.

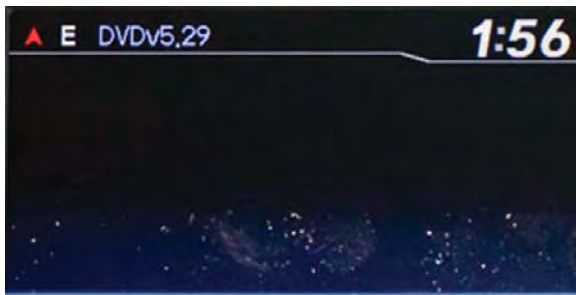
17. Check the RES version software to see if it needs an update:
 - Turn off the audio unit, then press and hold audio preset buttons No. 1, No. 3, and No. 5.
 - While holding the preset buttons, press and hold the VOL/Power button. Release all the buttons when the audio unit software appears on the display.
 - Press and hold the CD/CDL button for about 5 seconds until the CDL version appears.
 - Press the TITLE button. The RES version appears on the display.
 - If the current version is not at least **DVDv5.29**, go to step 18 and do the update procedure.
 - If the version is **DVDv5.29** or higher, the RES is updated. Go to step 24 to center-punch the VIN.

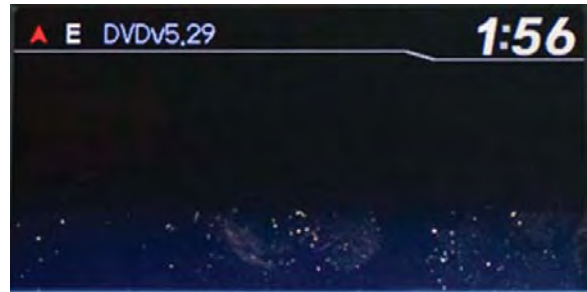
21. When the update is done, the RES automatically ejects the update CD.
22. Turn the ignition switch to LOCK (0), and wait at least 15 seconds.
23. Verify the update by checking that the RES software is **DVDv5.29** or later. To check the software, do this:
 - Turn off the audio unit, then press and hold audio preset buttons No. 1, No. 3, and No. 5.
 - While holding the preset buttons, press and hold the POWER/VOLUME knob. Release all the buttons when the audio unit software appears on the display.
 - Press and hold the CD/CDL button for about 5 seconds until the CDL version appears.
 - Press the TITLE button. The RES version appears on the display. If the current version is not at least **DVDv5.29**, go to step 18 and repeat the update procedure.
