Applies To: See VEHICLES AFFECTED

April 5, 2011

Product Update: Audio Unit Software Update for Security Code, Clock Reset, HFL, and Other Listed Issues

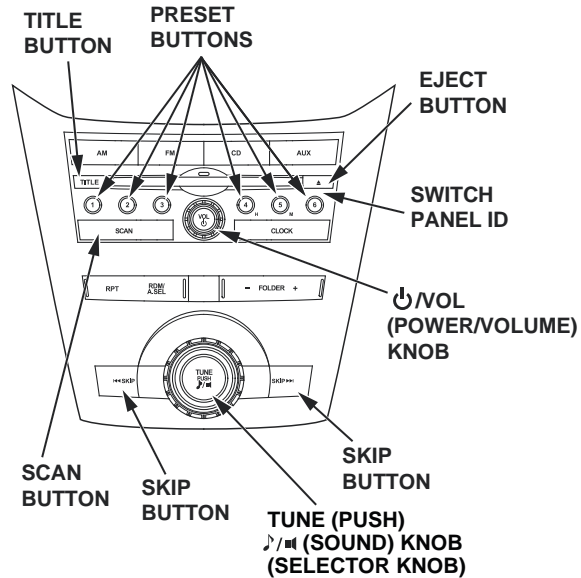
1. Verify that the vehicle is an LX model by making sure the audio unit switch panel ID starts with 1BU0.

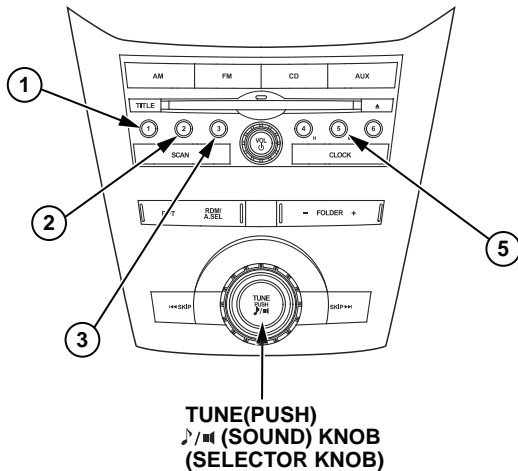
- Press and hold audio preset buttons No. 1, No. 2, No. 3, and No. 5.

- While holding the preset buttons, press and hold the TUNE(PUSH) (SOUND) knob (selector knob) until the audio unit turns off; you will also hear a thump sound from the speakers. Release all the buttons.

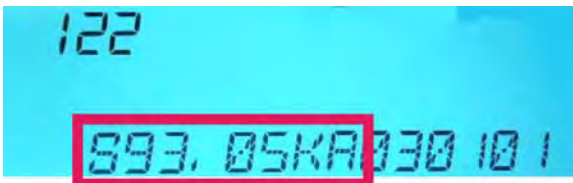
- To display the region, press and hold audio preset buttons No. 1, No. 3, and No. 5. While holding the preset buttons, press the VOL/POWER knob. The region should be **S93.05KA**.

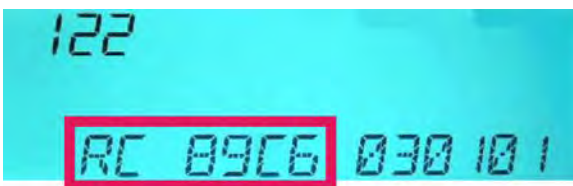
- To display the software version, press and hold the SCAN and the TITLE buttons until the software version appears. The software version should be **RC 89C6**.

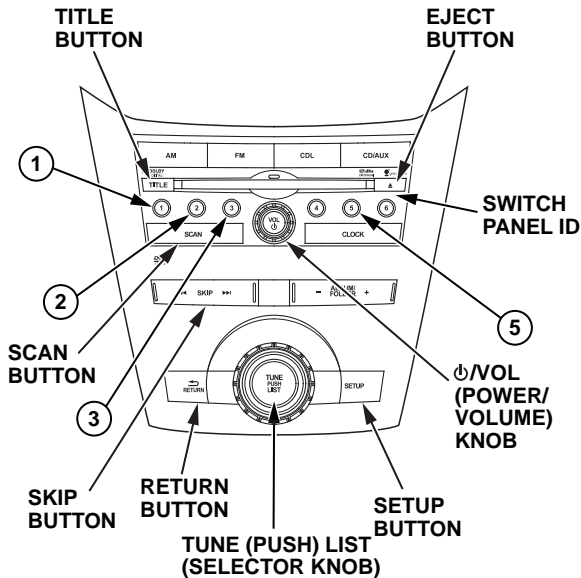
1. Verify that the vehicle is an EX model by making sure the audio unit switch panel ID starts with 1XU0.

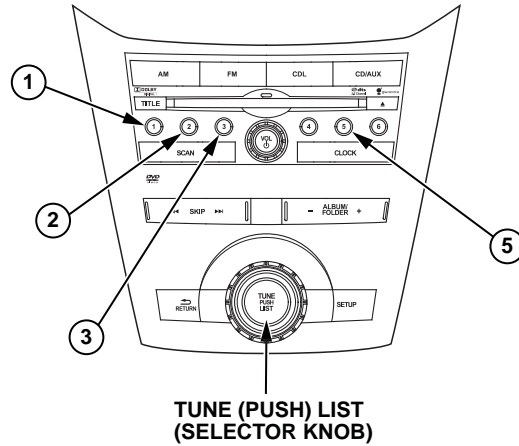
- Press and hold audio preset buttons No. 1, No. 2, No. 3, and No. 5.

- While holding the preset buttons, press and hold the TUNE (PUSH) LIST knob (selector knob) until the audio unit turns off; you will also hear a thump sound from the speakers. Release all the buttons.
7. Verify the update by checking the region and the software version:

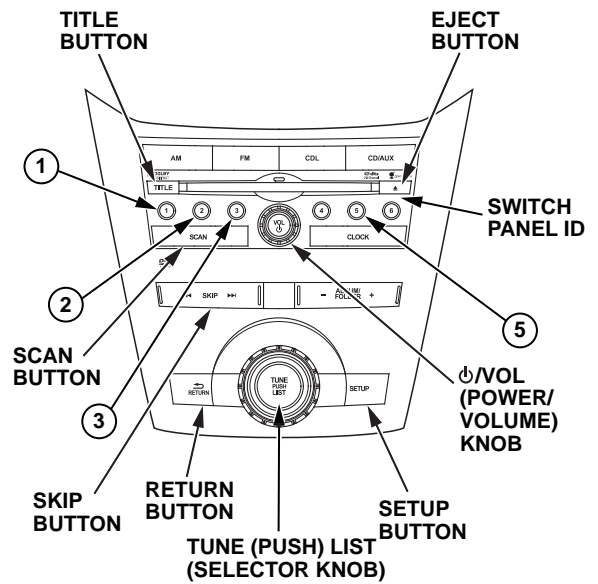
1. Verify that the vehicle is an EX model by making sure the audio unit switch panel ID starts with 1XU0.

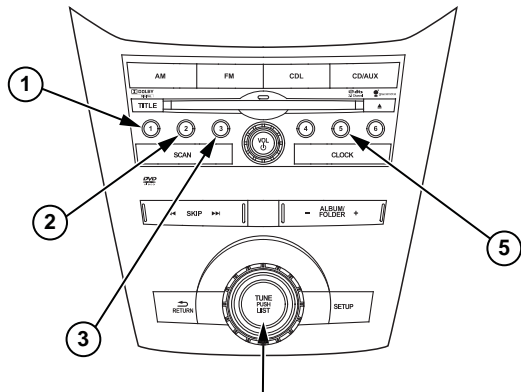
**TUNE (PUSH) LIST
(SELECTOR KNOB)**

- Press and hold audio preset buttons No. 1, No. 2, No. 3, and No. 5.

- While holding the preset buttons, press and hold the TUNE (PUSH) LIST knob (selector knob) until the audio unit turns off; you will also hear a thump sound from the speakers. Release all the buttons.

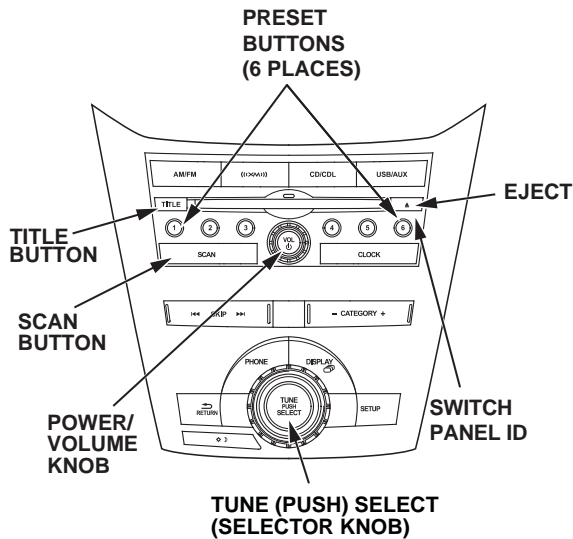
1. Verify that the vehicle is an EX-L model by making sure the audio unit switch panel ID starts with 1PU0.

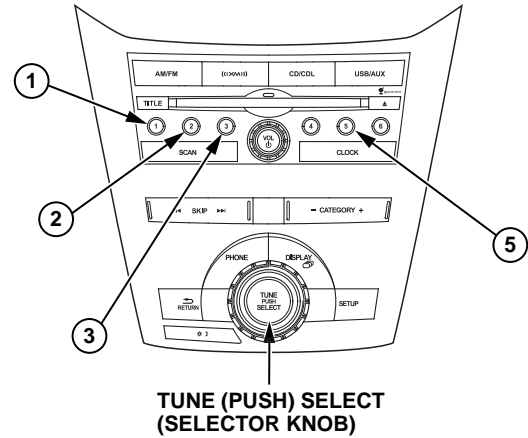
6. Apply the software update:
 - Press and hold audio preset buttons No. 1, No. 2, No. 3, and No. 5.

- While holding the preset buttons, press and hold the TUNE (PUSH) SELECT knob (selector knob) until the audio unit turns off; you will also hear a thump sound from the speakers. Release all the buttons.

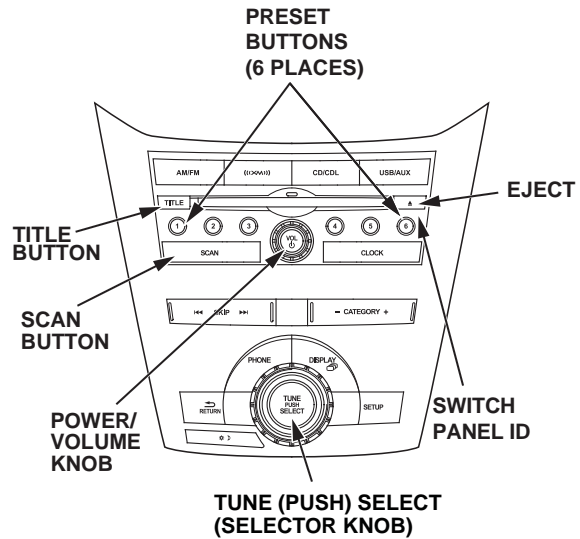
1. Verify that the vehicle is an EX-L model by making sure the audio unit switch panel ID starts with 1PU0.

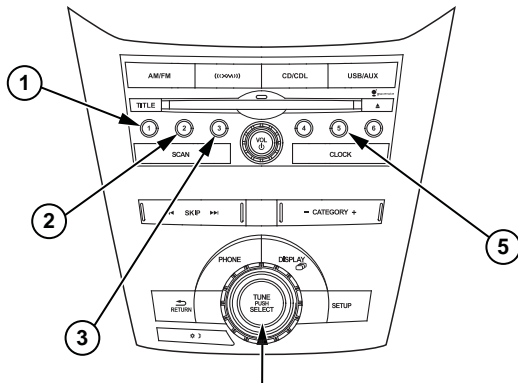
**TUNE (PUSH) SELECT
(SELECTOR KNOB)**

- Press and hold audio preset buttons No. 1, No. 2, No. 3, and No. 5.

- While holding the preset buttons, press and hold the TUNE (PUSH) SELECT knob (selector knob) until the audio unit turns off; you will also hear a thump sound from the speakers. Release all the buttons.

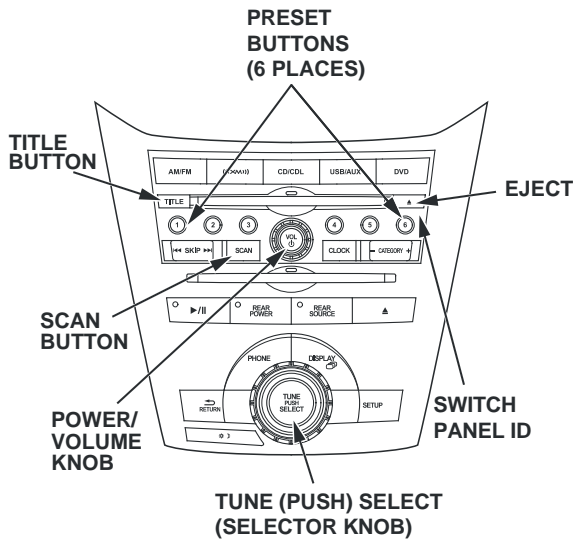
EX-L (WITH RES)

1. Verify that the vehicle is an EX-L with RES model by making sure the audio unit switch panel ID starts with 1PU5.

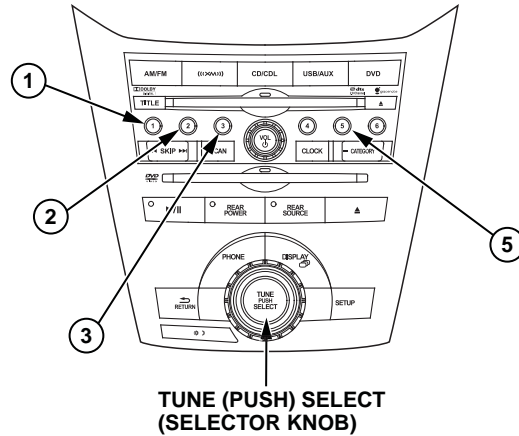
- Press and hold audio preset buttons No. 1, No. 2, No. 3, and No. 5.

- While holding the preset buttons, press and hold the TUNE (PUSH) SELECT knob (selector knob) until the audio unit turns off; you will also hear a thump sound from the speakers. Release all the buttons.
7. Verify the update by checking the region and the software version:

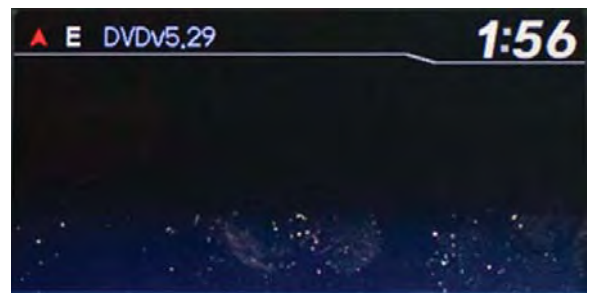
23. Check the RES version software to see if it needs an update:
 - Turn off the audio unit, then press and hold audio preset buttons No. 1, No. 3, and No. 5.
 - While holding the preset buttons, press and hold the POWER/VOLUME knob. Release all the buttons when the audio unit software appears on the display.
 - Press and hold the CD/CDL button for about 5 seconds until the CDL version appears.
 - Press the TITLE button. The RES version appears on the display.
 - If the current version is not at least **DVDv5.29**, go to step 23 and do the update procedure.
 - If the version is **DVDv5.29** or higher, the RES is updated. Go to step 28 to center-punch the VIN.

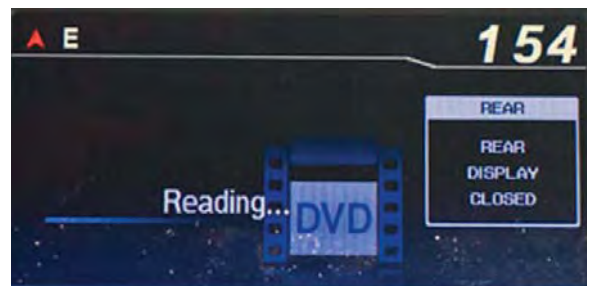
NOTE: Do not update the audio unit and RES unit at the same time. Do the audio unit first, then the RES unit.
25. Allow the RES to download the update CD. A reading message appears for about 2 minutes while the system updates.

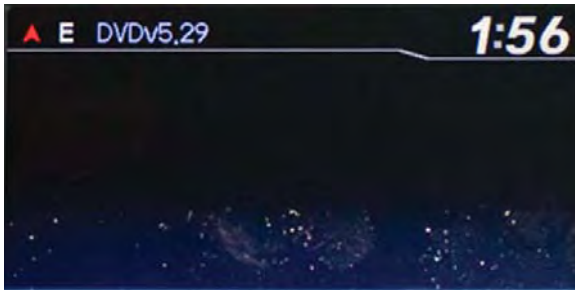
28. Verify the update by checking that the RES software is **DVDv5.29** or later. To check the software, do this:
- Turn off the audio unit, then press and hold audio preset buttons No. 1, No. 3, and No. 5.
 - While holding the preset buttons, press and hold the VOL/Power button. Release all the buttons when the audio unit software appears on the display.
 - Press and hold the CD/CDL button for about 5 seconds until the CDL version appears.
 - Press the TITLE button. The RES version appears on the display. If the current version is not at least **DVDv5.29**, go to step 21 and repeat the update procedure.

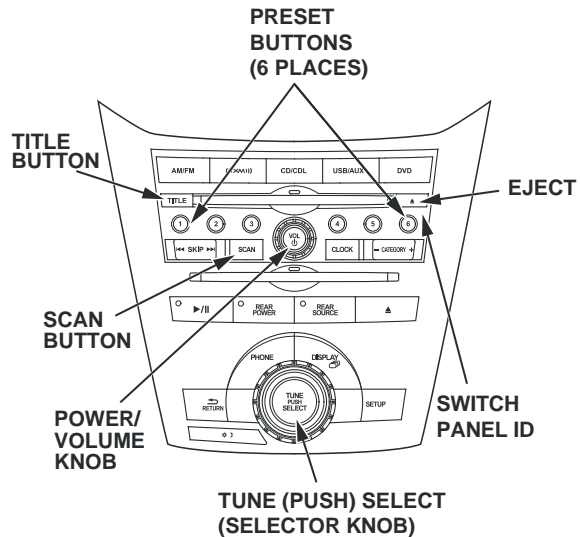
EX-L (WITH RES)

1. Verify that the vehicle is an EX-L with RES model by making sure the audio unit switch panel ID starts with 1PU5.

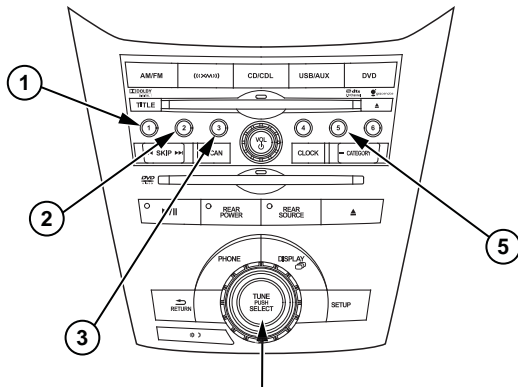
**TUNE (PUSH) SELECT
(SELECTOR KNOB)**

- Press and hold audio preset buttons No. 1, No. 2, No. 3, and No. 5.

- While holding the preset buttons, press and hold the TUNE (PUSH) SELECT knob (selector knob) until the audio unit turns off; you will also hear a thump sound from the speakers. Release all the buttons.

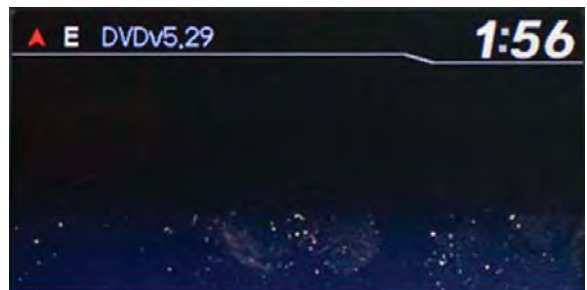
- Turn off the audio unit, then press and hold audio preset buttons No. 1, No. 3, and No. 5.
- While holding the preset buttons, press and hold the VOL/Power button. Release all the buttons when the audio unit software appears on the display.
- Press and hold the CD/CDL button for about 5 seconds until the CDL version appears.
- Press the TITLE button. The RES version appears on the display.
 - If the current version is not at least **DVDv5.29**, go to step 18 and do the update procedure.
 - If the version is **DVDv5.29** or higher, the RES is updated. Go to step 23 to center-punch the VIN.

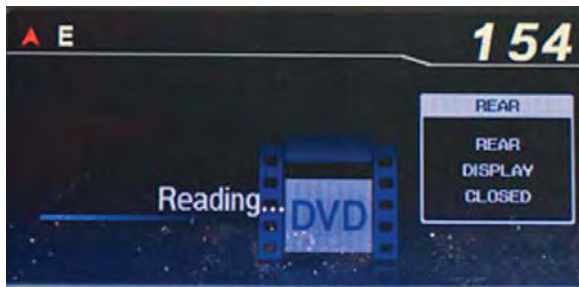
18. Start the engine.
19. Insert T/N 07AAZ-TK8A100 into the lower (RES) slot.
20. Allow the RES to download the update CD. A reading message appears for about 2 minutes while the system updates.

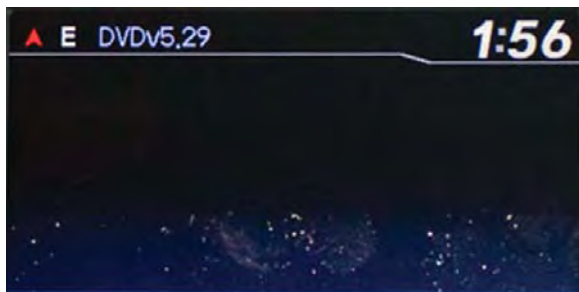
21. When the update is done, the RES automatically ejects the update CD.
22. Turn the ignition switch to LOCK (0), and wait at least 15 seconds.
23. Verify the update by checking that the RES software is **DVDv5.29** or later. To check the software, do this:
 - Turn off the audio unit, then press and hold audio preset buttons No. 1, No. 3, and No. 5.
 - While holding the preset buttons, press and hold the POWER/VOLUME knob. Release all the buttons when the audio unit software appears on the display.
 - Press and hold the CD/CDL button for about 5 seconds until the CDL version appears.
 - Press the TITLE button. The RES version appears on the display. If the current version is not at least **DVDv5.29**, go to step 16 and repeat the update procedure.

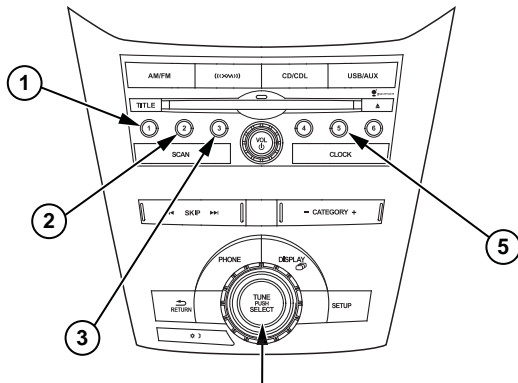
**TUNE (PUSH) SELECT
(SELECTOR KNOB)**

7. To verify that the recovery was successful:
 - Press and hold audio preset buttons No. 1, No. 2, No. 3, and No. 5.

- While holding the preset buttons, press and hold the TUNE (PUSH) SELECT knob (selector knob) until the audio unit turns off. Release all the buttons.
