SERVICE CAMPAIGN BULLETIN

NTB12-011

VOLUNTARY SERVICE CAMPAIGN 2007 – 2012 ALTIMA SEDAN & COUPE BRAKE MASTER CYLINDER

APPLIED VEHICLES: 2007 – 2012 Altima Sedan & Coupe (L32 & CL32)

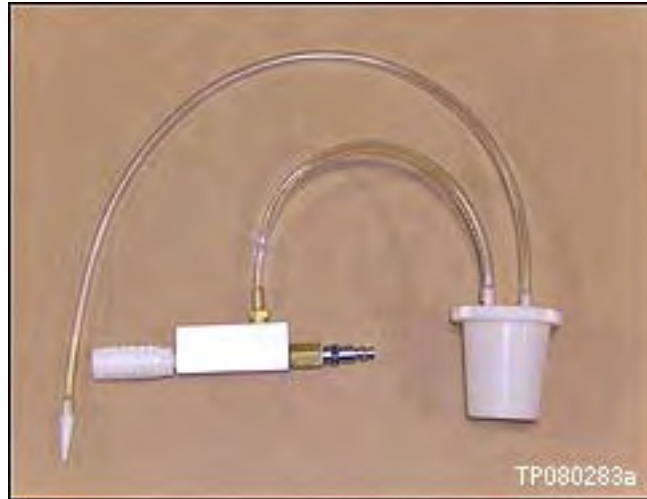
Figure A

REQUIRED SPECIAL TOOL J-49749

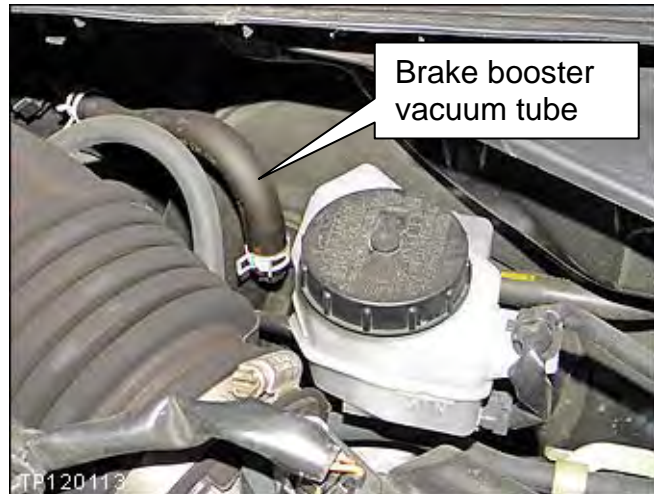
Figure 1

2. Locate the brake booster vacuum tube.
