SERVICE BULLETIN

Classification: EL12-034	Reference: NTB12-043	Date: May 4, 2012
-----------------------------	-------------------------	----------------------

2008 – 2012 ROGUE ENGINE HARNESS REPLACEMENT

APPLIED VEHICLES: 2008 – 2012 Rogue (S35)

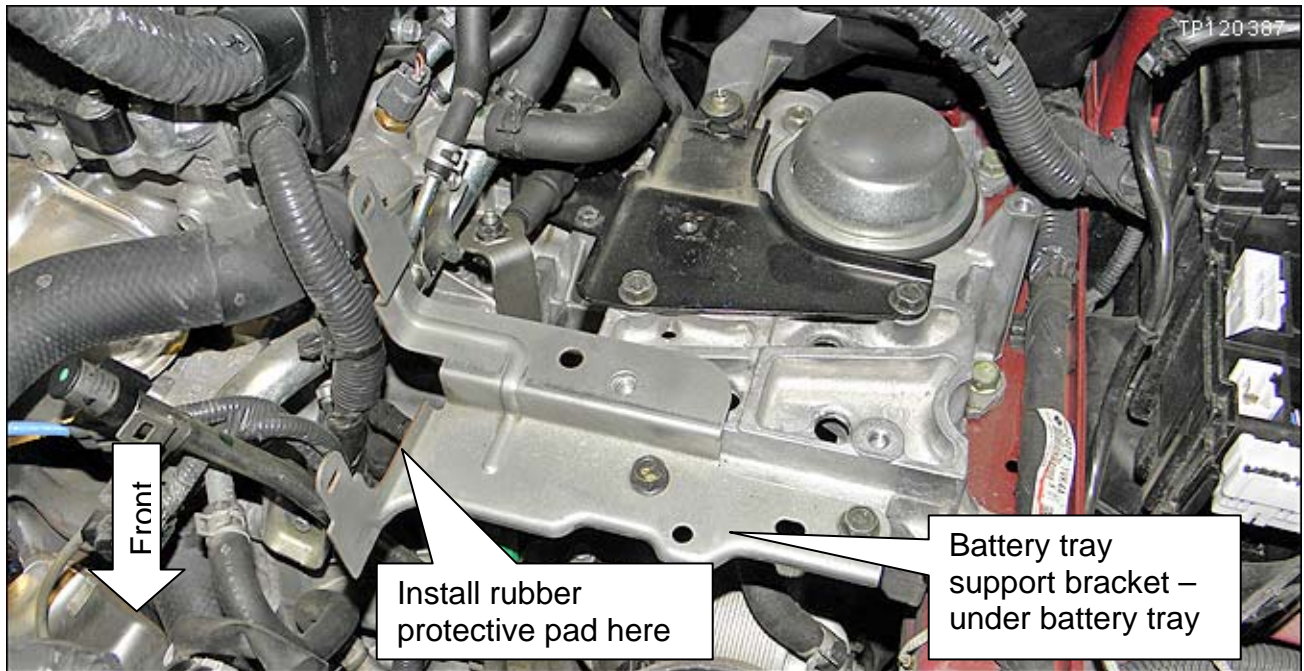
If for any reason the engine harness is replaced, during the replacement of the harness, install a rubber protective pad on the battery tray support bracket at the location shown in Figure 1 below. Refer to the Service Procedure for installation instructions.

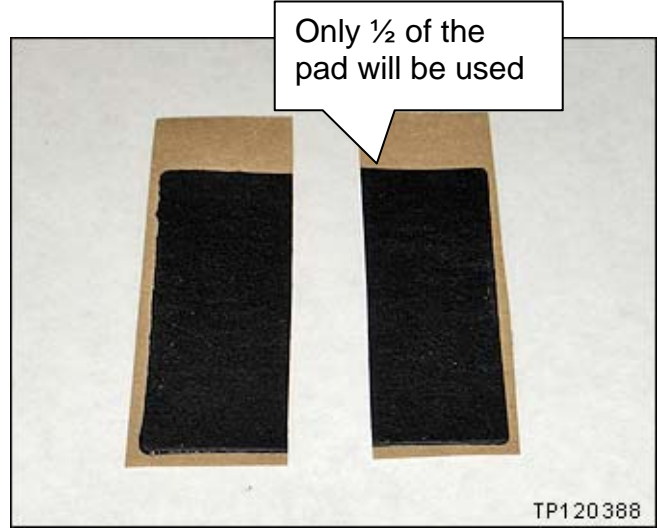
Figure 2

1. Cut the rubber protective pad in half, length wise.
 - Only $\frac{1}{2}$ (either half) of the pad will be used.

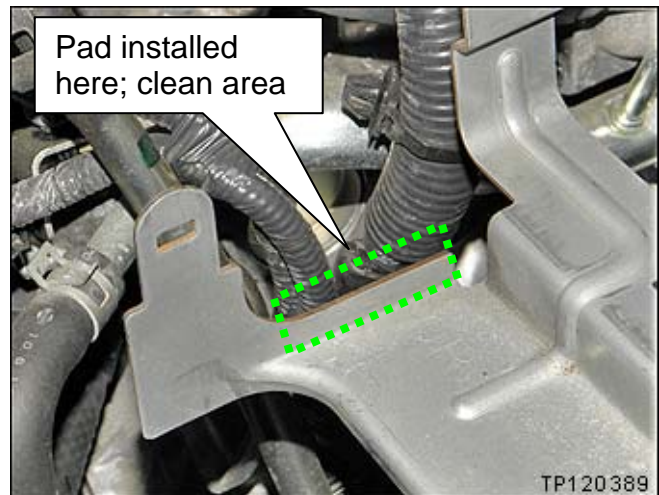
Figure 2

2. Clean the area where the protective pad will be installed.
 - Installation area is shown with dashed line.
 - Clean both sides of the bracket edge. Pad will be folded over and attached to both sides.

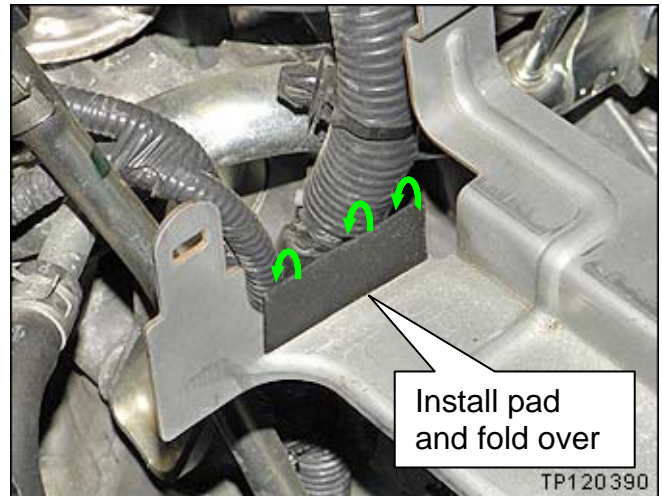
Figure 3

3. Attach the rubber protective pad as shown.
4. Fold the protective pad over the bracket edge so it covers and sticks to both side.
