SERVICE BULLETIN

Classification: EL12-034a	Reference: NTB12-043a	Date: May 18, 2012
------------------------------	--------------------------	-----------------------

2008 – 2012 ROGUE ENGINE HARNESS REPLACEMENT

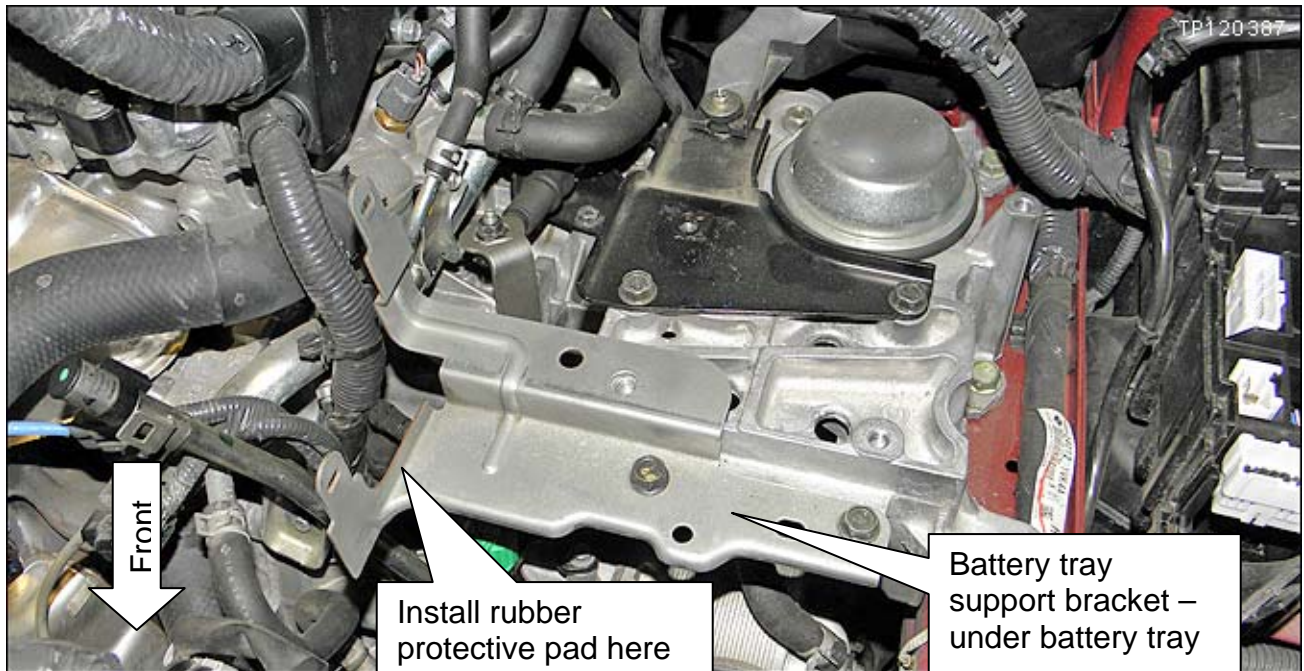
If for any reason the engine harness is replaced, during the replacement of the harness, install a rubber protective pad on the battery tray support bracket at the location shown in Figure 1 below. Refer to the Service Procedure for installation instructions.

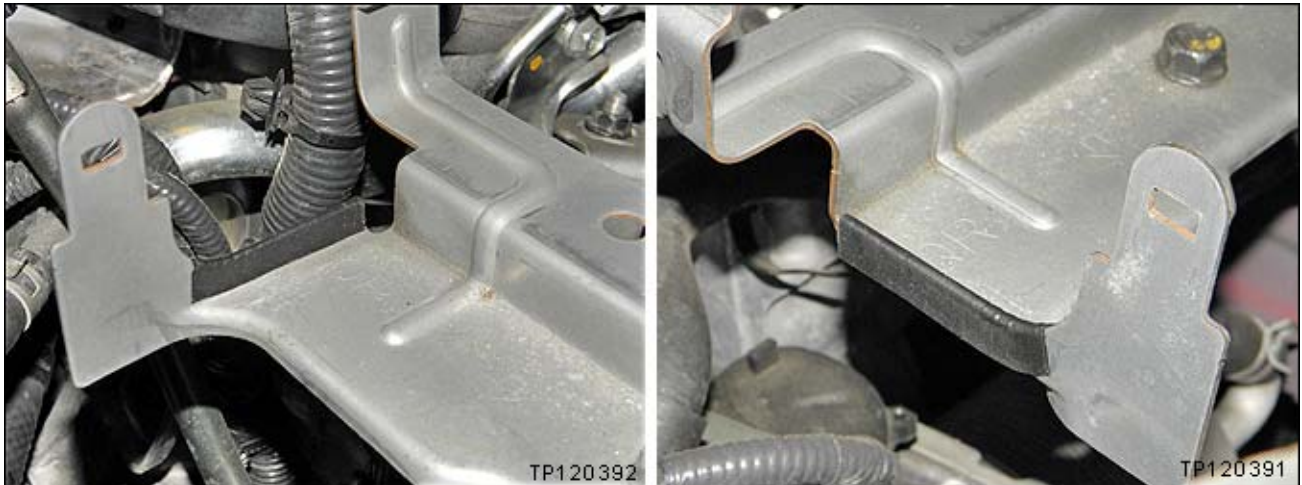
NOTE: Figure 4 shows the finished installation of the protective pad on both sides of the bracket.
