SERVICE BULLETIN

TS35-U06

Vehicle Model
 TS35 (EPA 10)

Front Door Control Improvement _ Buzzer Sound Improvement.

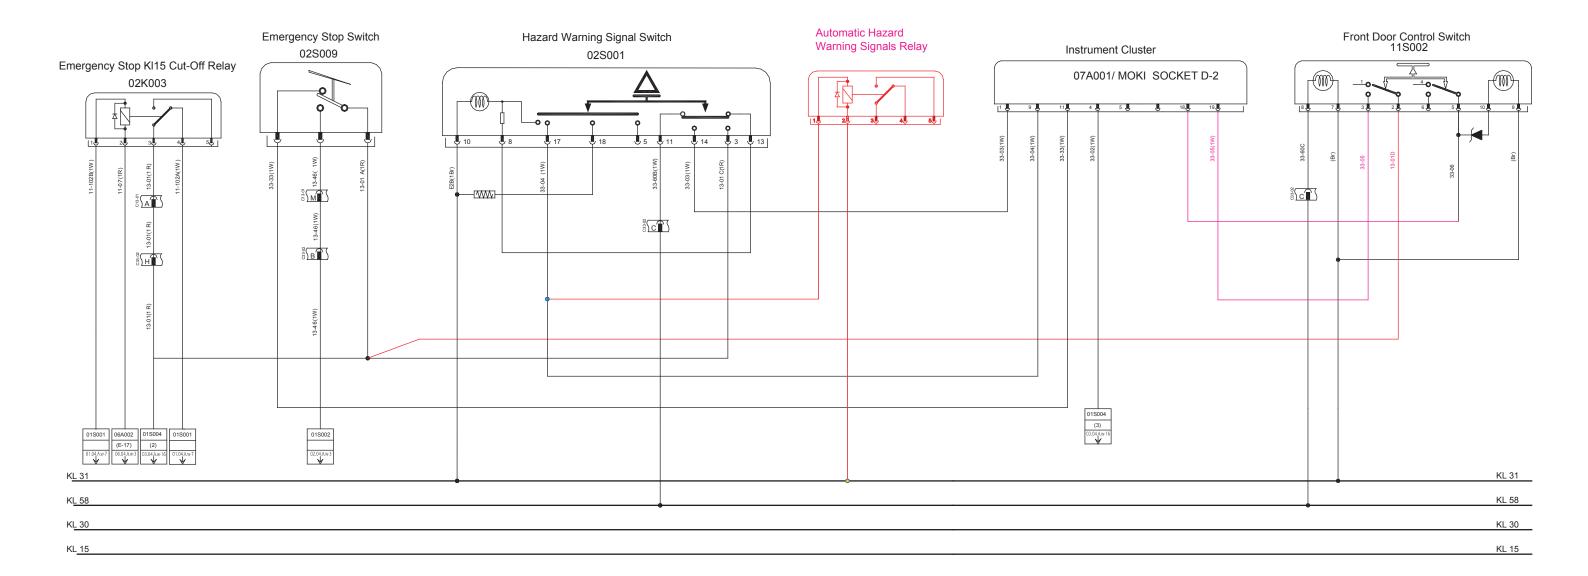
16.Check if door control button is working ignition on positon and ignition off position.

17.Then mount switches and covers to their places.

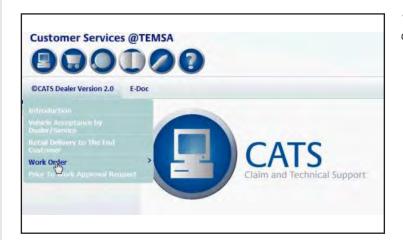
1. Under CATS tab click on "Work Order" to create the work order.

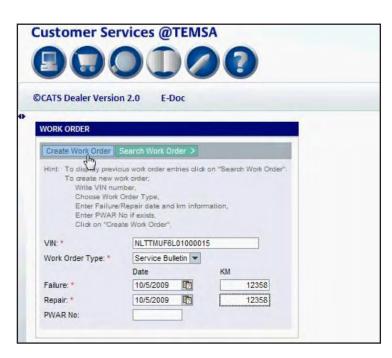
2. Enter the related chassis number, work order type, failure, repair dates and vehicle milage in order to create work order.

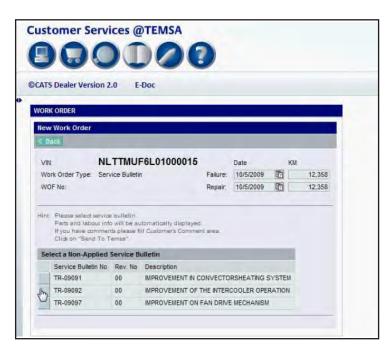
3. Select the applied bulletin.

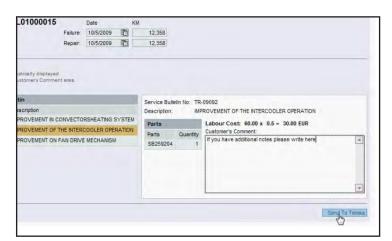
4. Please add your additional comments if necessary and click on "Send to Temsa" to complete your work order.
