SRS Airbag Light "ON" - B0111/B0116 Open Side Squib Circuit

Service Category Vehicle Interior

YEAR(S)	MODEL(S)	ADDITIONAL INFORMATION
2004 – 2009	Sienna

Some 2004 – 2009 model year Sienna vehicles may exhibit an SRS lamp "ON" condition with Diagnostic Trouble Code (DTC) B0111 and/or B0116. An updated repair procedure is available to address this condition. Follow the procedures in this bulletin to repair the floor harness and the side airbag squib circuit.

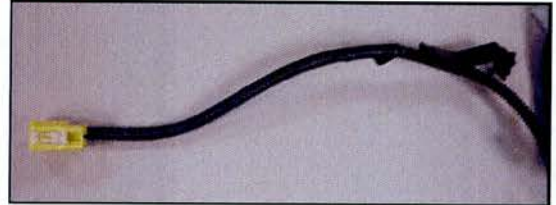
Figure 1.

- Remove the tape from around the corrugated tubing. Remove and save the corrugated tubing.

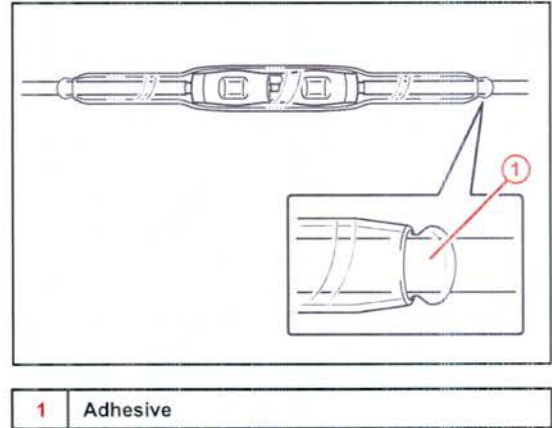
Figure 18.

During the sealing process, adhesive may seep from the thermo tubing. This is a normal condition and part of the sealing properties of the thermo tube.

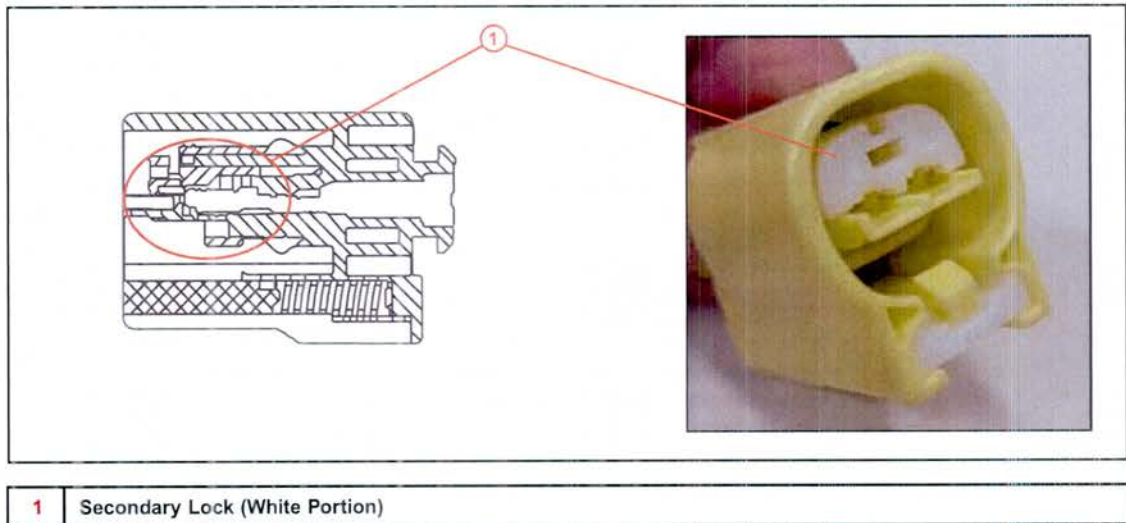
A. Confirm the secondary lock is in the half locked position.

Figure 19. Half Locked Position

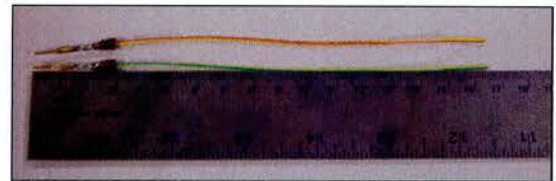
Figure 29.

- A. Measure from the tip of the male terminal and cut each wire.

Power Seat: 175 mm (6.89 in.)

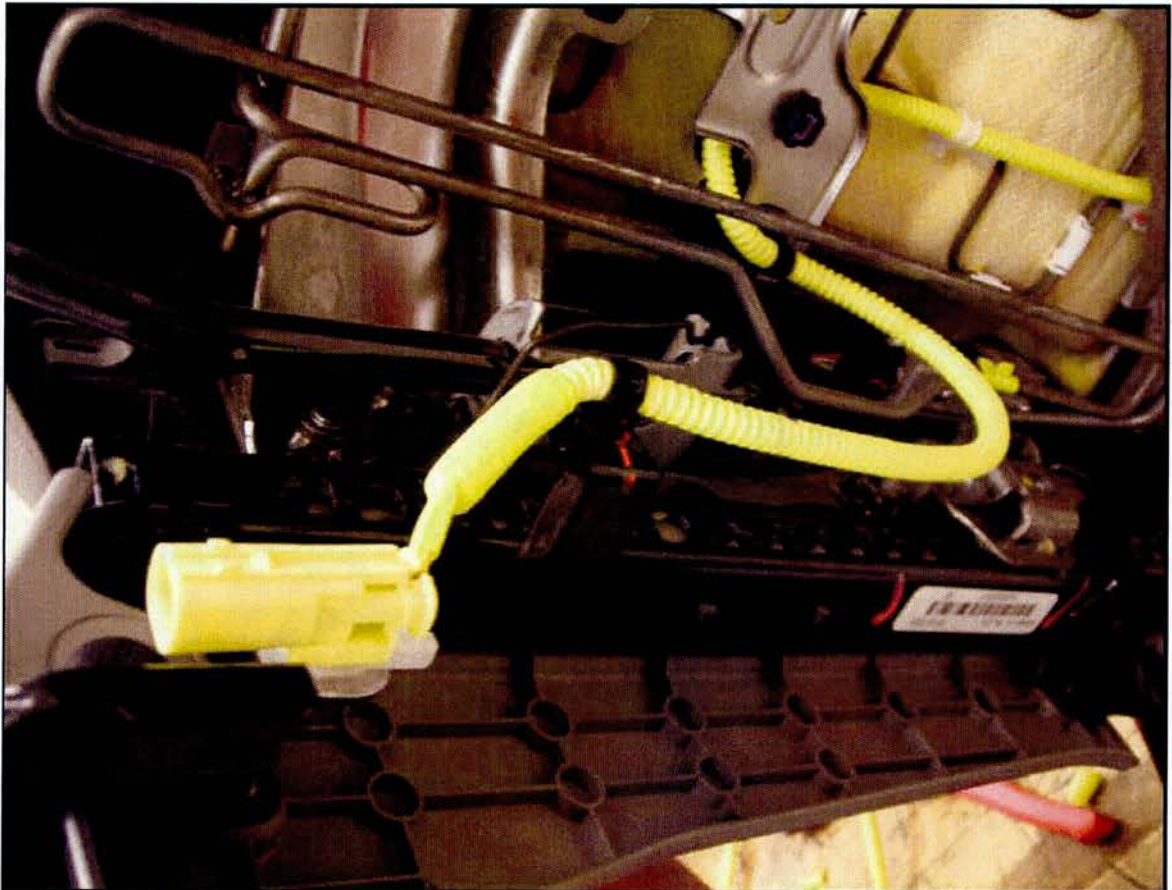
Figure 31.

1. Unclip the SRS seat harness connector. Remove the yellow corrugated tubing and discard.

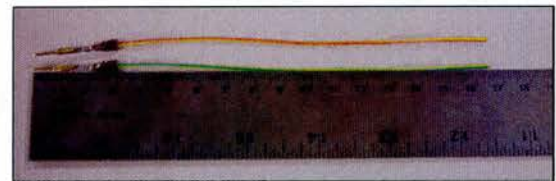
Figure 38.

- A. Measure from the ends of the male terminals and cut the new wires.

Manual Seat, Left: 95 mm (3.74 in.)
 Manual Seat, Right: 80 mm (3.15 in.)

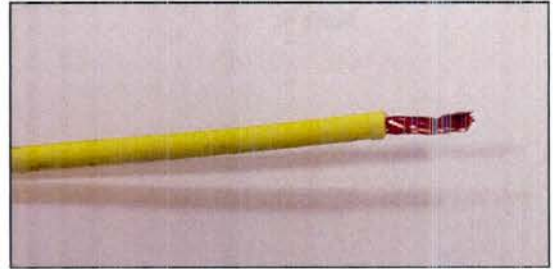
Figure 39.

- B. Remove 8 mm (0.32 in.) of insulation from the ends of the male terminal pig tails.

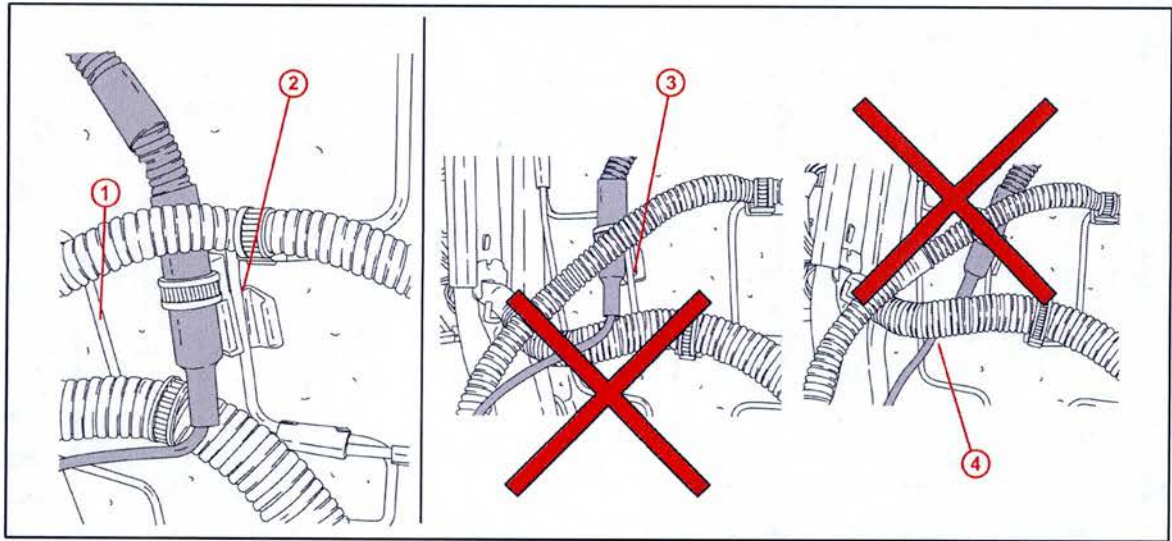
Figure 57.

1	Outside Spring
2	Detail of Clip No. 5 (Fix to INNER Spring)

3	Do NOT Fix to Outer Spring
4	Do NOT Route Under the Seat Wire Harness
