# Technical Bulletin

Model(s)	Year	Eng. Code	Trans. Code	VIN Range From	VIN Range To
All	2008-2013	2.0L (CCTA, CBFA)	All	All	All

15 12 01 July 23, 2012 2028302 Supersedes T.B. V151104 dated December 22, 2011 to remove European exhaust warning light reference in text and add additional model year applicability.

**Engine Rattling Noises after Start, Engine Doesn't Start, Timing Chain Slipped**

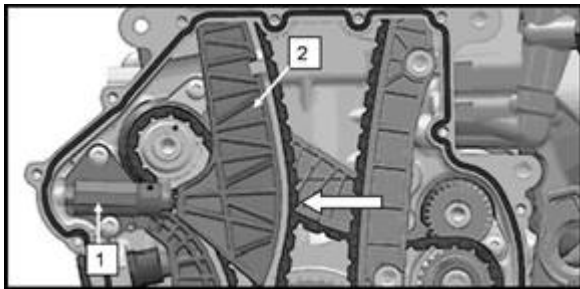
**Figure 1)** section of the timing chain drive.

Inset. 1: timing chain tensioner

Inset 2: tensioning rail the timing chain

arrow: Direction of pressure on the tensioning rail of the timing chain

- Complete the DTC entries according to guided fault finding (GFF).
- Remove the lower timing chain cover, see Repair Manual Group 15 in ElsaWeb.
- Check the timing chain tensioner as follows:
  - Compress the tensioning rail of the timing chain (Illustration 1, No. 2) by hand against the timing chain tensioner (Figure 1, No. 1).

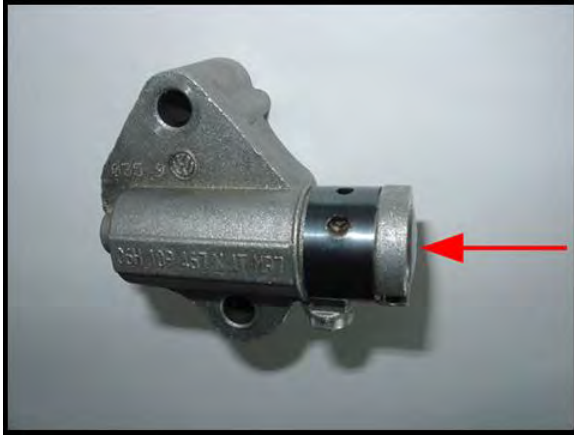
**Figure 2)**  
Timing chain tensioner incorrect

If the piston of the timing chain tensioner can be compressed in by hand (Figure 2, red arrow) the timing chain tensioner has failed, and further engine diagnosis may be required.

If engine noises or no start condition remain, inspect pistons and valves for contact damage. If engine damage is noted, cylinder head or engine may need to be replaced.

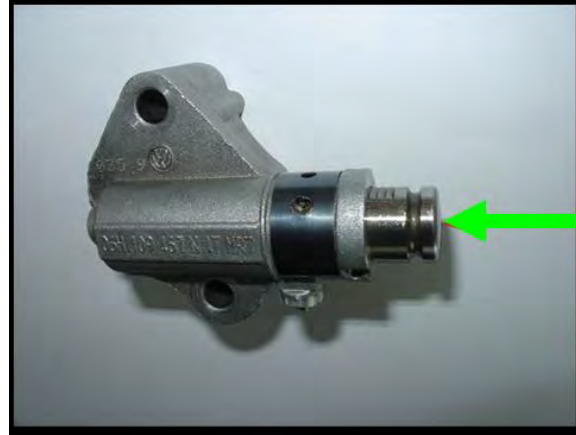
**Figure 3)**  
Timing chain tensioner correct

If the piston of the timing chain tensioner cannot be compressed by hand after several attempts (Figure 3, green arrow), further engine diagnosis is required.

Inspect intake camshaft and camshaft bearing for damage.
