Mack Trucks, Inc.
Greensboro, NC USA

Service Program Trucks

EGR Valve Modification
MP7 and MP8 US2010
CHU, CXU, GU, LEU, MRU

PI0796, EGR Valve Modification

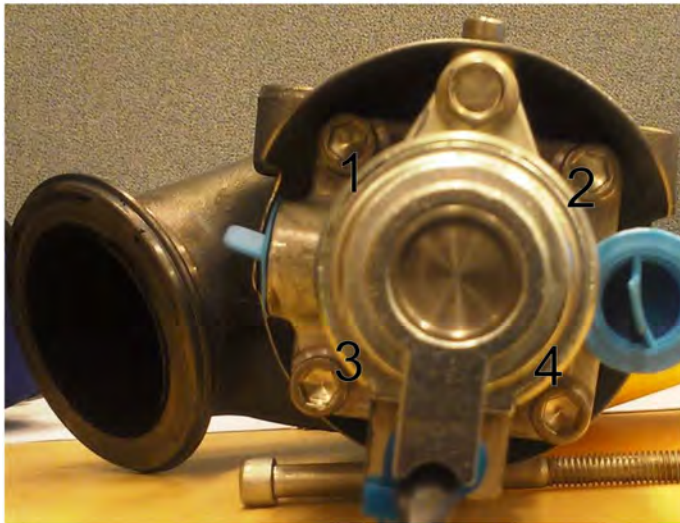
W2075169

- 1 Apply parking brake and place shift lever in neutral.
- 2 Remove all cables from ground (negative) battery terminals to prevent personal injury from electrical shock.
- 3 Remove EGR valve from engine. Refer to Function Group 29.
- 4 Secure valve in vise, do NOT clamp on the EGR valve mounting surface. Remove 4 fasteners from EGR valve. Remove hydraulic actuator with heat shield, end cap and poppet from casting. Retain spacer for reassembly.

Note: Mark orientation of actuator before removing from casting.

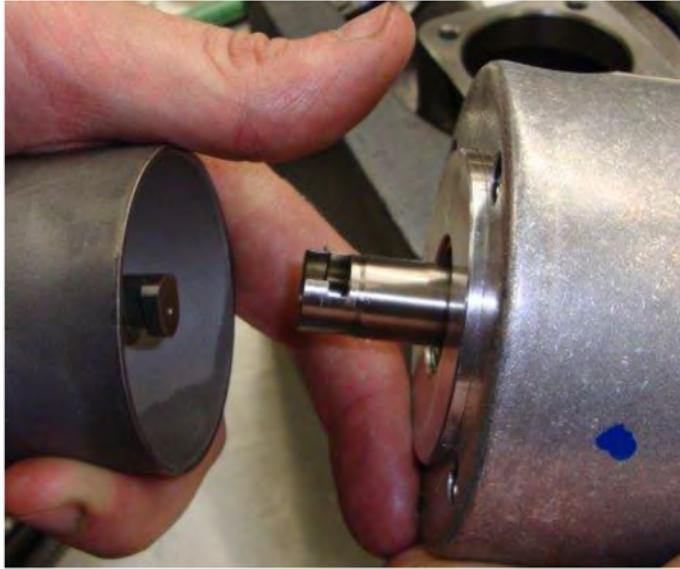
W2075291

- 5 Remove T-shaped clevis joint on shaft by pushing the shaft in opposite directions to separate actuator and heat shield from end cap and poppet.

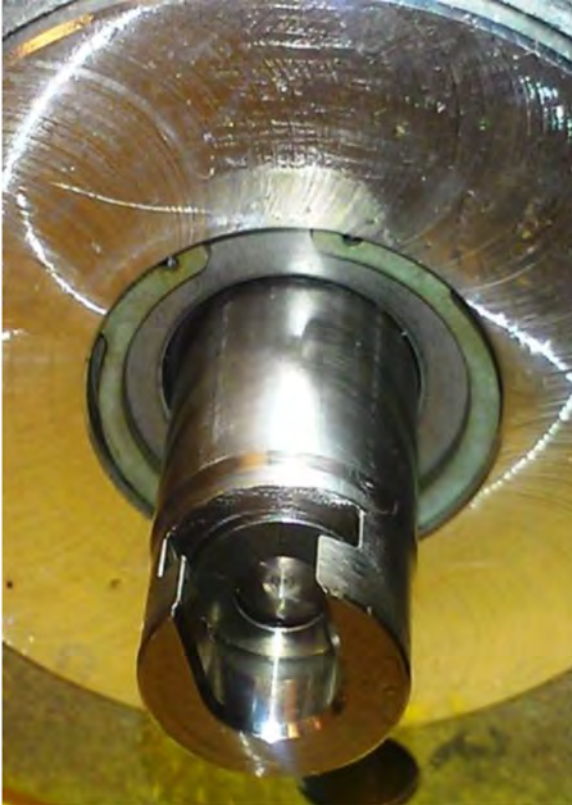
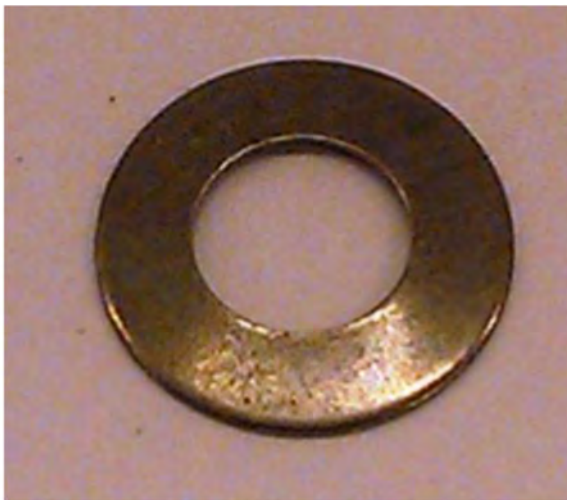
6 Retain the clevis joint washer for reassembly.

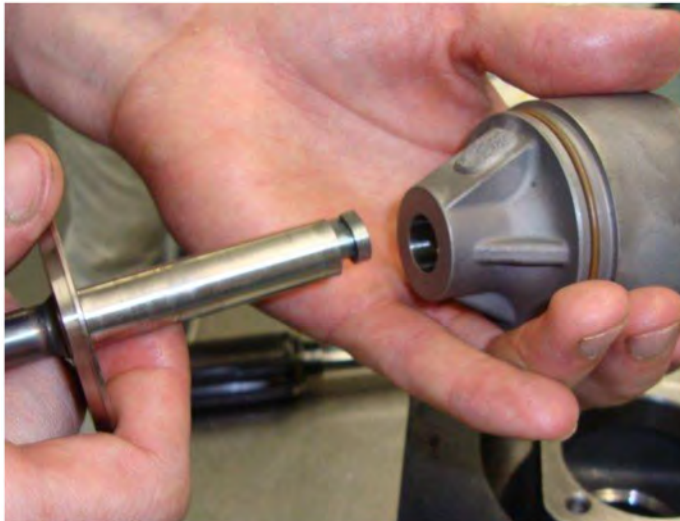
W2075295

- 7 Remove the poppet shaft from end cap.

Note: If the shaft is stuck and can not be removed from the casting, replace the EGR valve using part kit number 85133799.

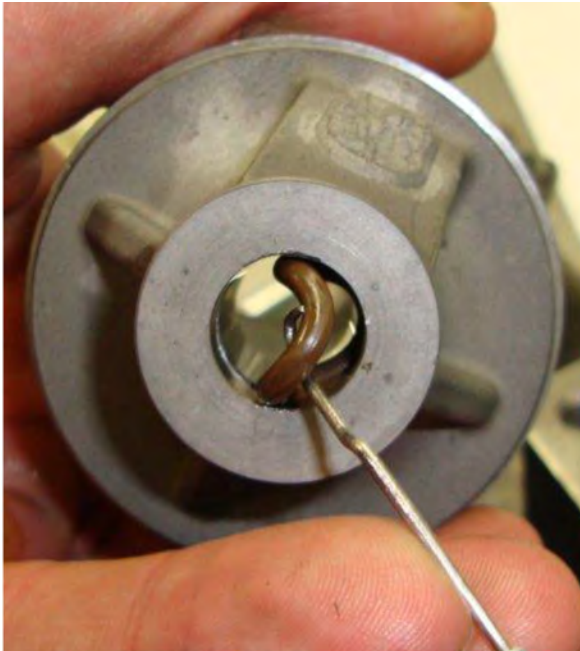
W2075167

- 8 Remove internal O-ring from end cap and discard. Check the bore surface and remove any additional debris.

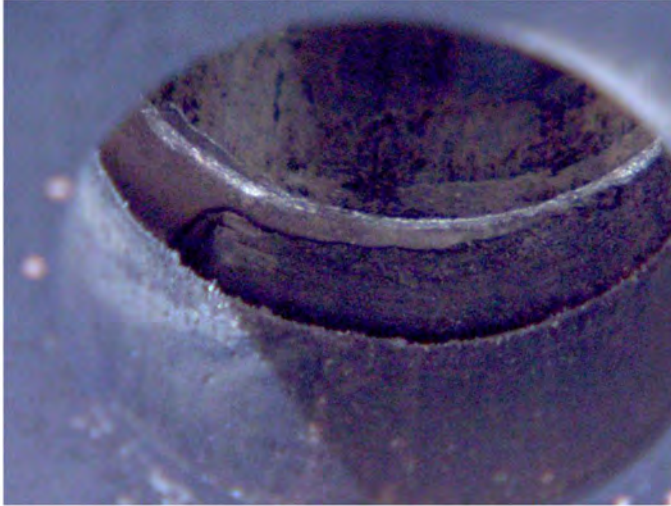
W2075306

9 If O-ring has been consumed, make sure any debris is thoroughly cleaned and removed.

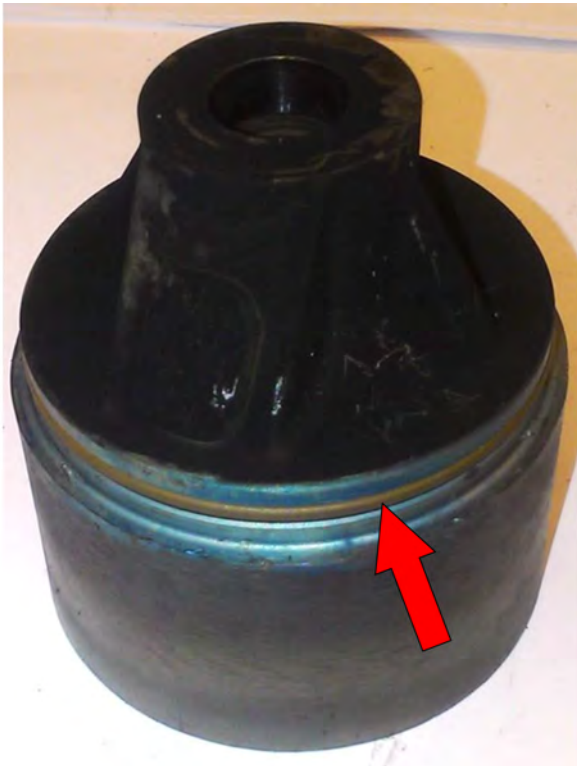
W2075168

10 Remove end cap external O-ring and discard.

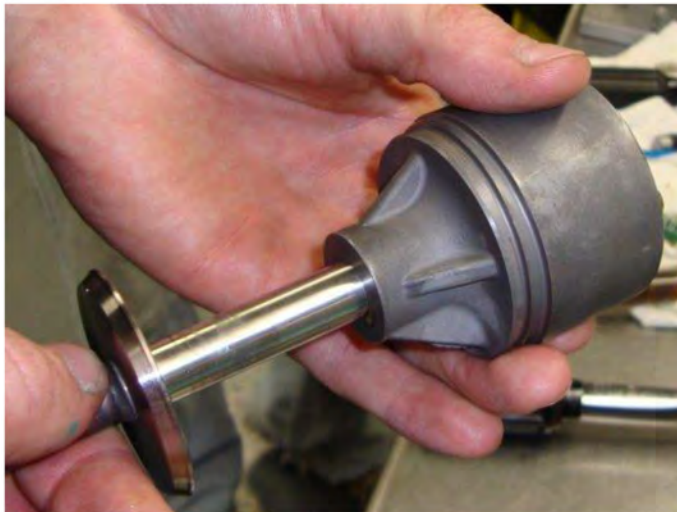
W2075282

- 12 Install poppet shaft in end cap. Slide the end cap to the poppet flange providing the maximum visibility and clearance for poppet and piston coupling.

Note: Shaft should slide with no interference in the end cap bore. If interference exists, make sure all debris is removed from end cap bore. If cleaning does not allow shaft to slide with no interference, replace EGR valve using part kit number 85133799 and file under standard warranty procedures.

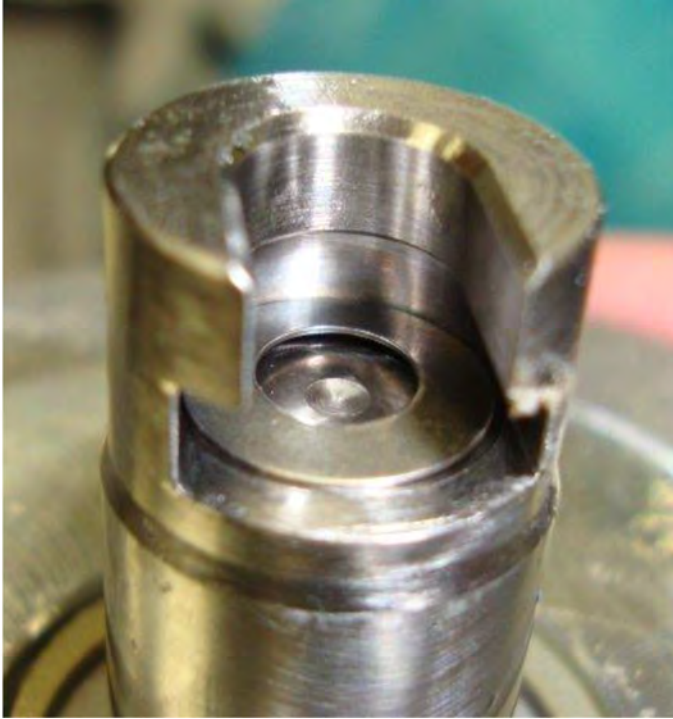
W2075281

13 Position clevis joint washer with dished side toward the hydraulic actuator.

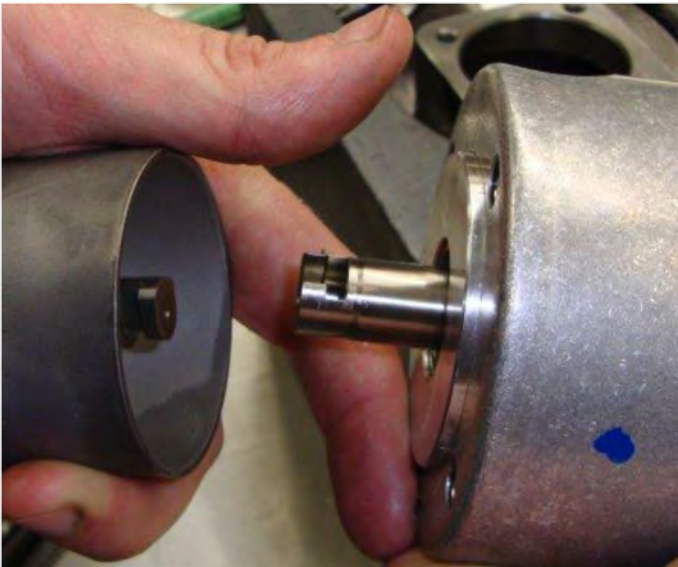
W2075291

14 Connect the shaft clevis joint.

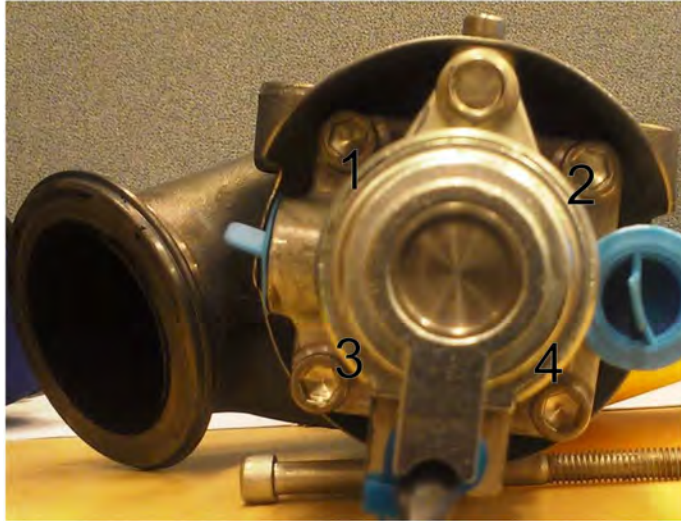
W2075169

16 Tighten fasteners in three stages as shown.

Stage 1	Tighten fasteners 1 and 4 to 40 in-lbs, then tighten fasteners 2 and 3 to 40 in-lbs.
Stage 2	Tighten fasteners 2 and 3 to 120 in-lbs, then tighten fasteners 1 and 4 to 120 in-lbs
Stage 3	Retighten fasteners 2 and 3 to 120 in-lbs, then tighten fasteners 1 and 4 to 120 in-lbs

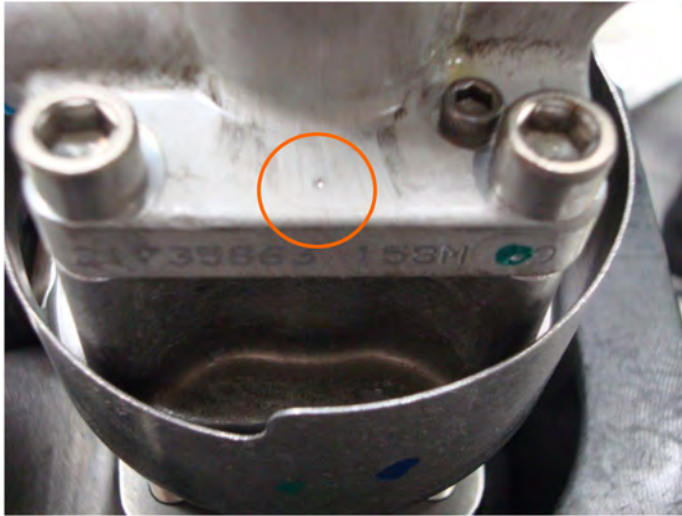
W2075266

18 Mark the valve with a punch to indicate work completed.

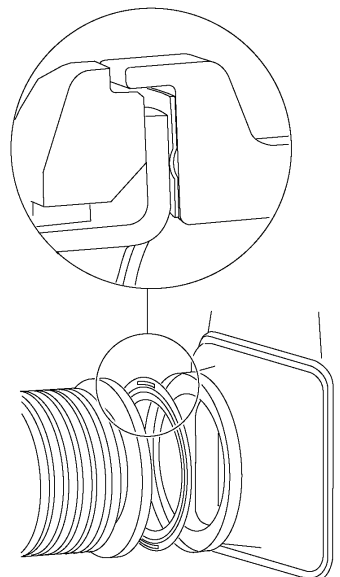
W2006187

19 Install new gaskets into the EGR valve end of the hot pipe and the inlet of the EGR cooler. Make sure the gaskets lay flat against the flange surfaces with the bead of the gaskets facing toward the hot pipe. Install EGR valve. Refer to Function Group 29. For this procedure the existing EGR mounting bolts and EGR hot pipe mounting clamps are to be reinstalled unless damaged.

Hot pipe gaskets can easily slip out of position causing damage to turbocharger. Please insure gaskets are securely in place when reinstalling pipe.

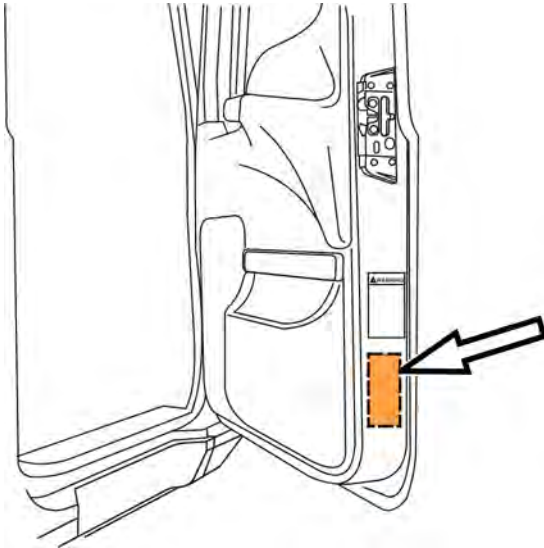
W8034103

- 20 Reconnect all previously removed cables to the negative (ground) battery terminals.
- 21 Start the engine. Check for leaks and proper operation.
- 22 To signify that the campaign has been completed, using a permanent-type marker (such as a Sharpie®) to write the campaign number (PI0796) and completion date in the spaces provided on the Campaign Completion label located inside the cab as shown in the illustration below. If a label is not already affixed inside the cab, apply a label (part number TS897) and supply the information as required. Campaign Completion labels are available in packs of 50 and can be ordered by faxing a completed BR313 to Pacesetters Business Services at 610-264-9465.
