SERVICE BULLETIN

HA08-004b

2007-2012 VERSA HATCHBACK / 2007 – 2011 VERSA SEDAN; DRIVER'S AND/OR PASSENGER FLOOR CARPET WET

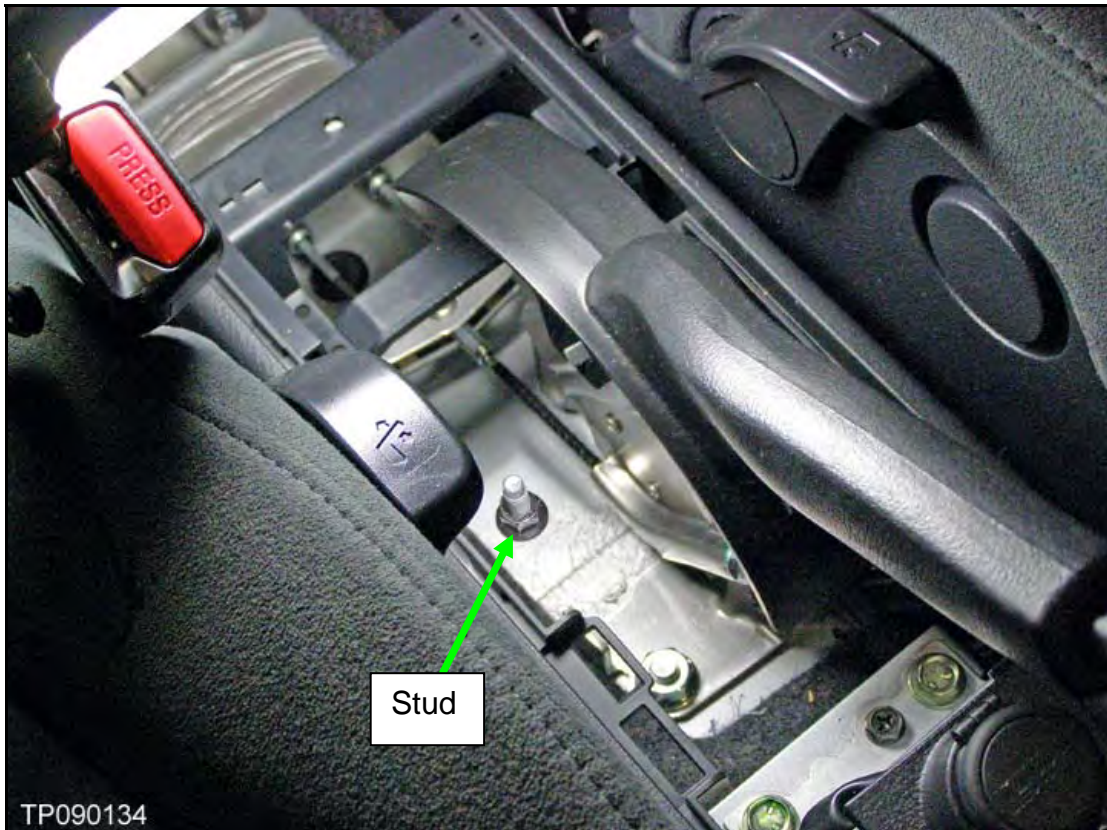
1. Remove the center console. Refer to section IP in the Electronic Service Manual (ESM) for removal procedure.
2. Look into the console body assembly and confirm the stud shown in Figure 1 has a nut installed.

3. If a nut is not installed, apply sealer around the base of the stud and fasten a plain washer and nut onto the stud.

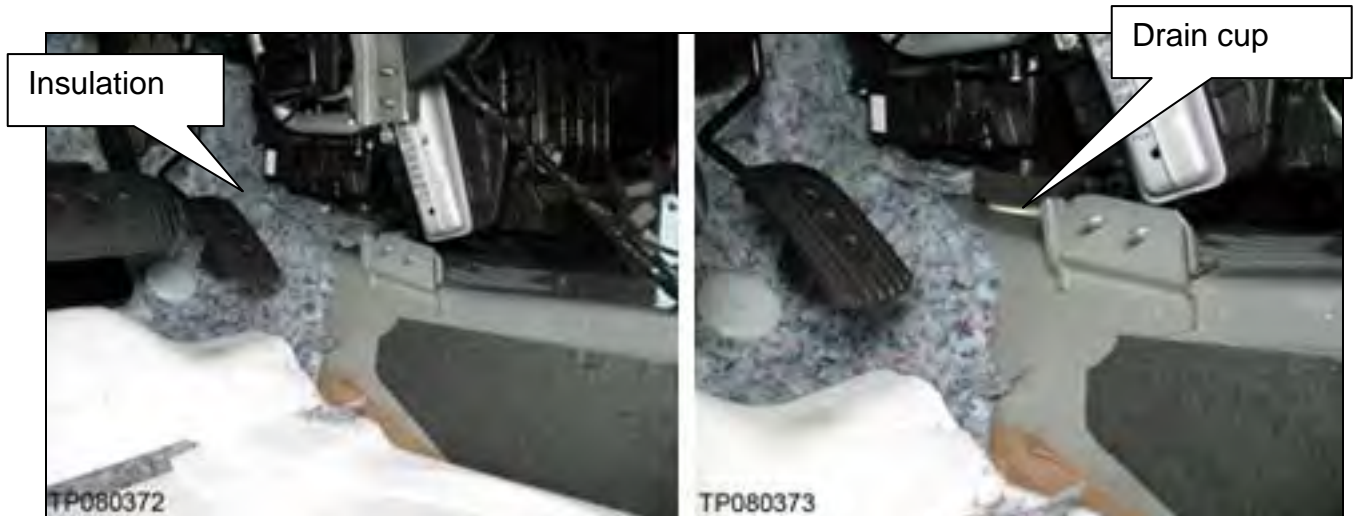
Figure 4

7. Pull the carpet back on the passenger and driver's side to expose insulation.

8. Cut the insulation so that it can be partially removed to expose the drain cup.

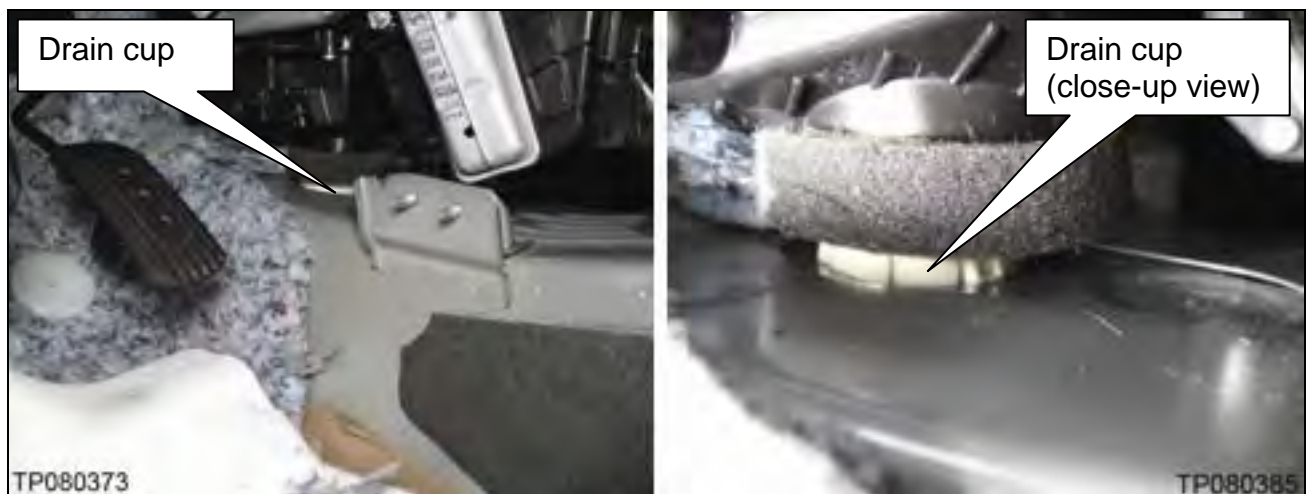
Figure 5

9. Start the engine. Turn on the A/C and set to full cold, fresh intake, and fan speed 4.

10. Confirm if water enters the vehicle.

- If water can be seen entering the vehicle between the drain cup and body, proceed with the rest of this TSB.
- If not, this TSB does not apply. Return to ASIST or the ESM for further diagnostic assistance.

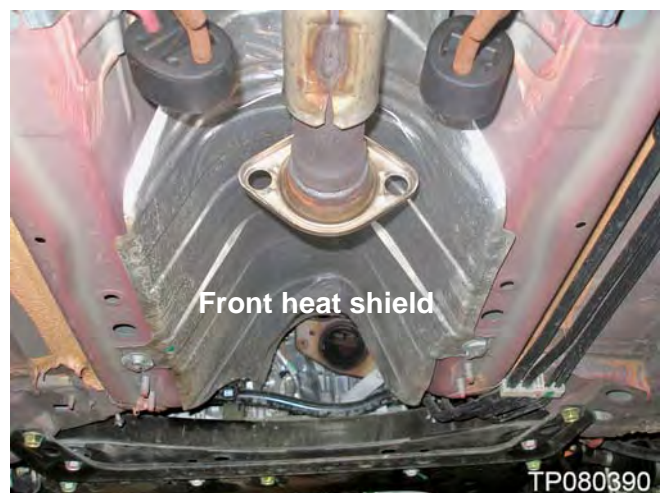
Figure 11

19. Remove the front heat shield.

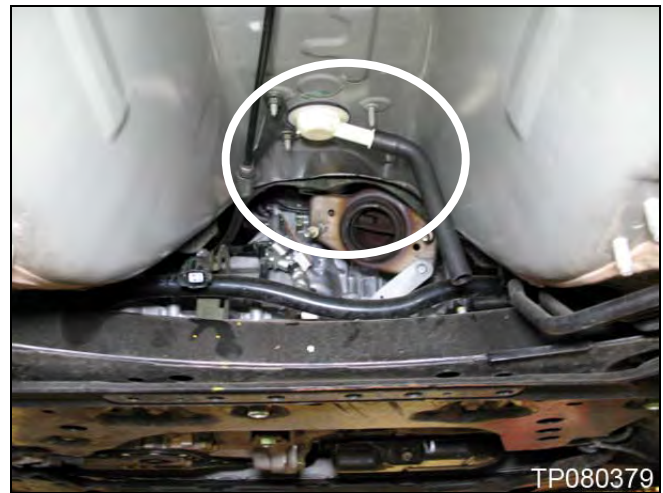
Figure 12

20. Remove the drain cup from vehicle body.

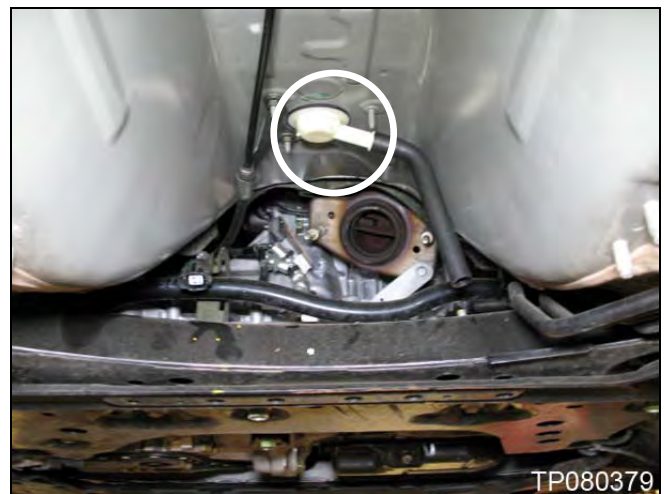
Figure 16

24. Install the drain cup.

25. Reinstall all parts removed in reverse order of removal.

- Install new exhaust seals.
