SI B12 25 12
Engine Electrical Systems

Vehicle Does Not Start: Loose Ground Z6000*4B

F30 with N20

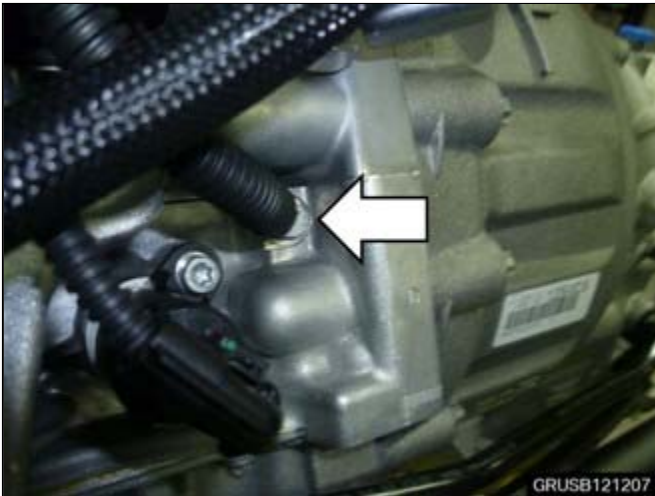
The ground point Z6000*4B on the engine block near the starter is loose.

1. Check and tighten the ground point Z6000*4B to 8 Nm, located on the engine block near the starter.
2. Clear all fault codes that might have been stored if the ground was found to be loose.
