Dealer Inventory Inspection

2013 Nissan LEAF Front Seat Bolts

Subject: **2013 Nissan LEAF Front Seat Bolts
Dealer Inventory Inspection**

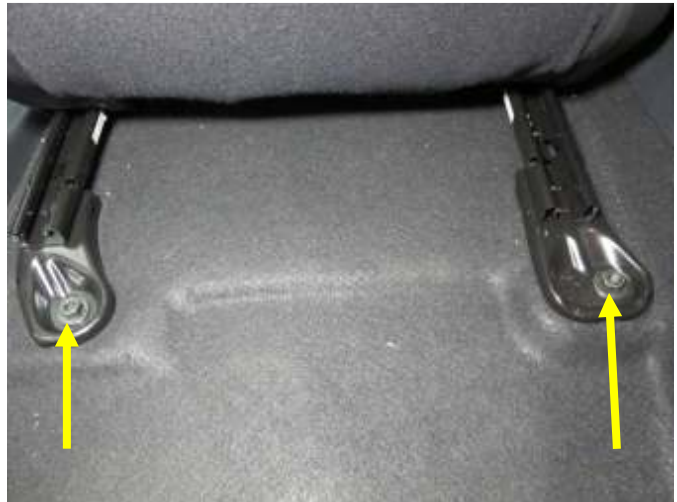
Figure 1

1. Move driver's seat to the most forward position.
2. Locate rear seat bolts.

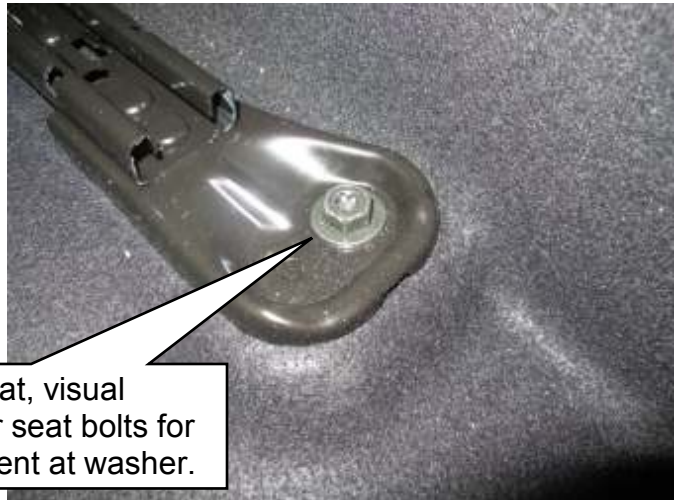
Figure 2

3. Using your hand on the head rest, rock the seat back and forth.
4. Visually inspect both rear seat bolts for a gap or movement at the washer.

- **If there is no gap and no movement is detected, no further action is needed, file claim using Op Code **PC2190**.**
- **If there is a gap and or movement is detected, please take a picture and send picture and VIN# to NNAFQASUPPORT@nissan-usa.com for further instructions.**

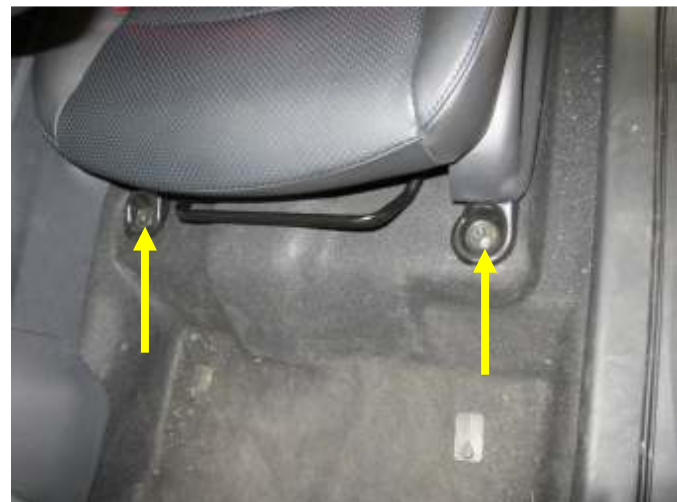
Figure 3

5. Slide seat to the most rearward position.
6. Locate front seat bolts.
7. Using hand on head rest, rock seat back and forth.
8. Visually inspect both front seat bolts for a gap or movement at the washer.
9. Repeat process on passenger-side front seat.
