# SERVICE BULLETIN TS-M16

Vehicle Model
 TS 30

Fire extinguisher detection tube (sensor) route update

Fire extinguisher detection tube route has been updated.

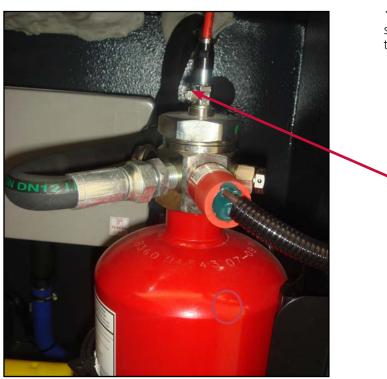
Photo 1

**1.** Deactivate the suppression system by slowly rotating the valve clockwise, located on the head of the cylinder.

► Valve

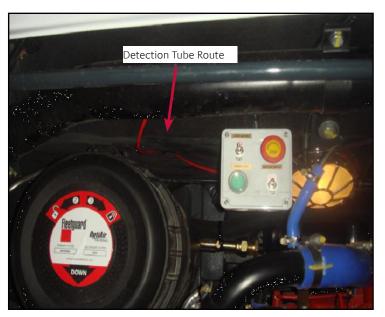
Photo 3

**3.** First, pull the detection tube to air filter side, and then pull it to exhaust room, in order to get enough length to cover exhaust region. The length, which will cover the exhaust area, would be around 1.5m. So, there will be a need to an extra 1.5m long detection tube, to do an addition.

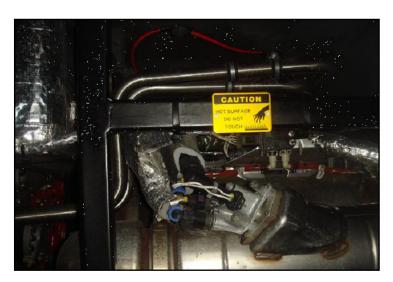
Photo 4

**4.** In the exhaust room, mount the detection tube to the isolation nail and pipe bracket by using cable clips and protective hose, as seen in below pictures.

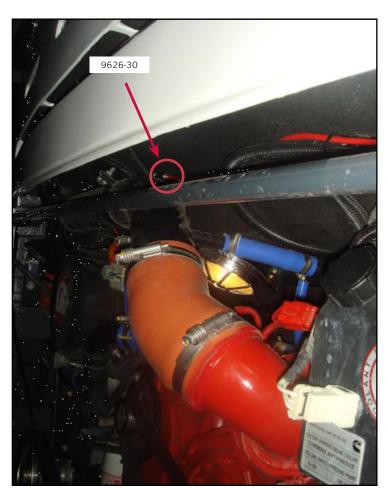
Photo 6

**5.** In the exhaust room, mount the detection tube to the isolation nail and pipe bracket by using cable clips and protective hose, as seen in below pictures.

**5.** Lastly, an addition will be added to the end point of the detection tube, in order to lenghten it back to the pressure gauge. Mount the detection tubes from the both sides of the included 9626-30 fitting. Detection tube must be pushed into the 9626-30 fitting, until the "click" sound is heard.

**6.** Assemble the pressure gauge back, and pressurize the detection tube to 13.5 bar value with nitrogen. Wait 1 hour to observe a possible leakage. If there is no leakage, activate the system by turning the valve slowly, which is located on the head of the cylinder.

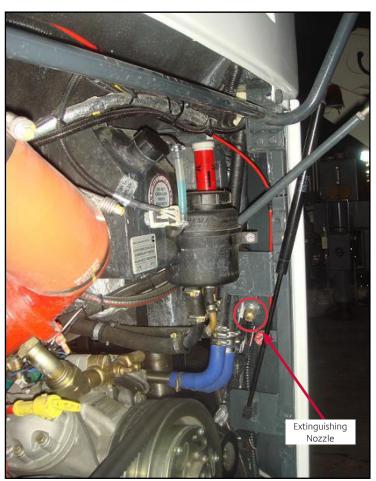
Photo 7

7. Other than the detection tube routing, a nozzle location must be changed as well. Shown in the below first picture, dismount the extinguishing nozzle and mount it to the carrier bracket, located under the steering reservoir (2nd picture).
