HYUNDAI NEW THINKING. NEW POSSIBILITIES. Technical Service Bulletin	GROUP CAMPAIGN	NUMBER 14-01-018
	DATE MAY 2014	MODEL(S) Tucson (JM)

SUBJECT: FRONT AND REAR UNDER BODY
CORROSION PREVENTION TREATMENT
SERVICE CAMPAIGN TT2

Description: This bulletin provides a preventative procedure to apply cavity wax and undercoating to the front and rear under body.

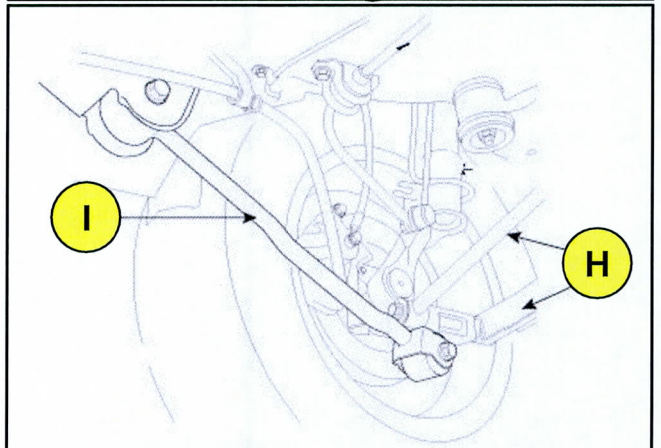
2WD rear crossmember (G), suspension arms (H), trailing arms (I), and brackets (J).

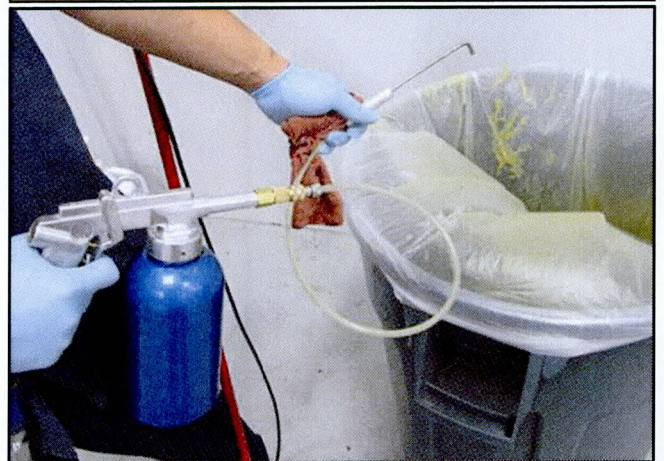
When spraying the wax, a light mist should be visible. If no mist is seen, point the nozzle in a safe direction, and press the gun's trigger until a mist is visible.

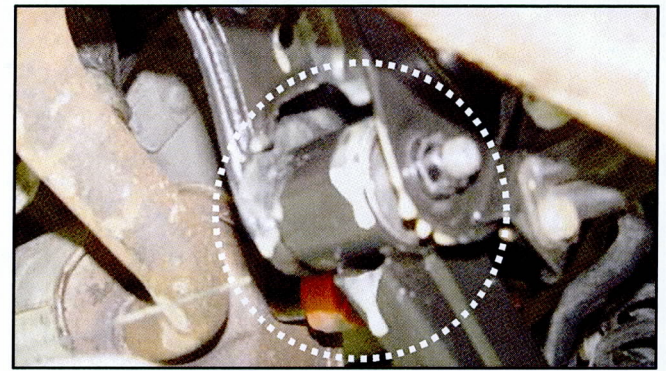
- 8. Wipe off the excess wax that may have flowed out.

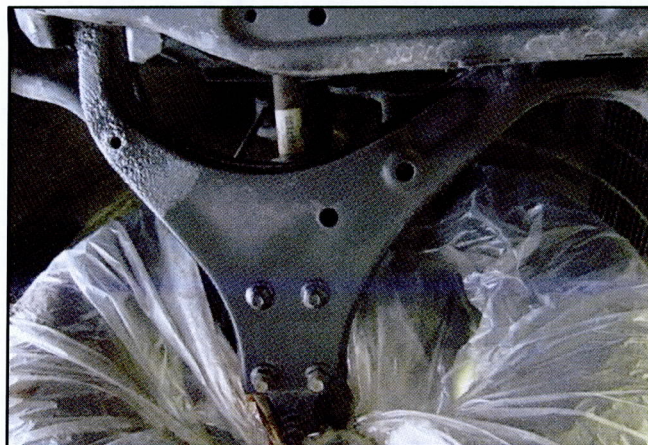
Left and right front lower arms.

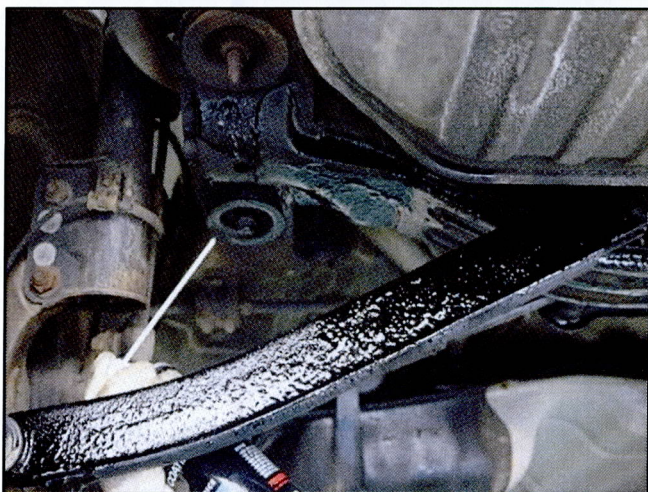
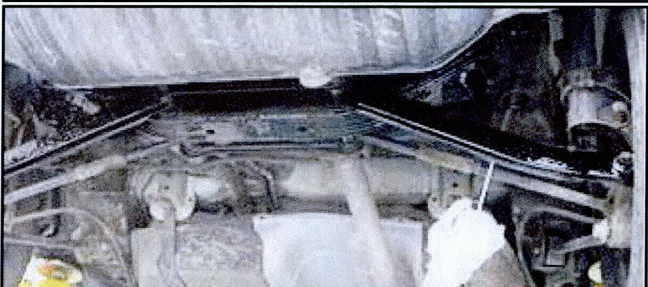
Rear crossmember, left and right rear suspension, left and right trailing arms, and brackets.

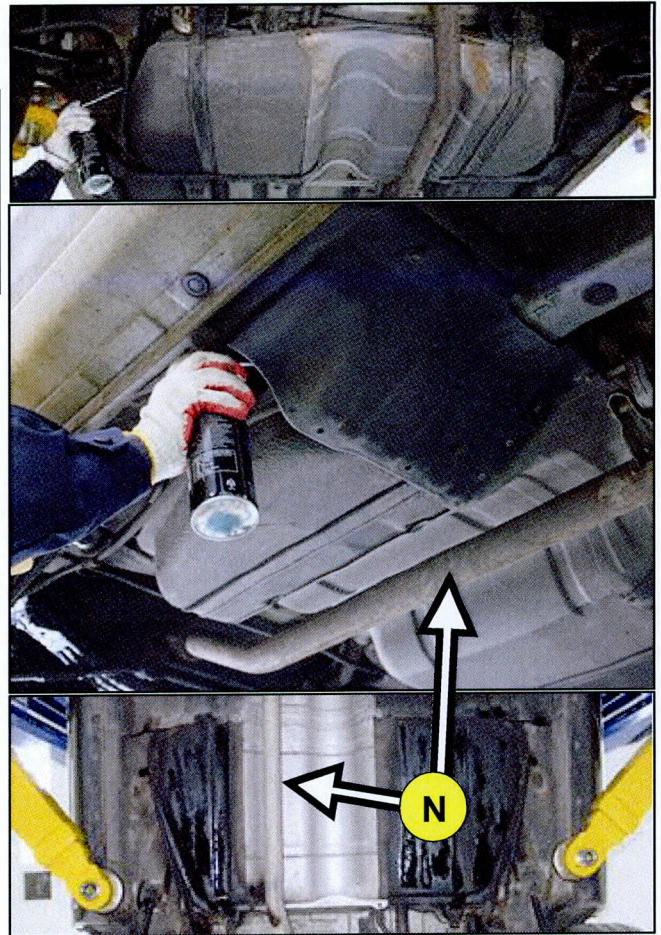
Fuel tank.

Spray undercoating on all exposed areas of the fuel tank, including the top half.

Avoid spraying the exhaust tube (N).
