## SB-10056127-4688

Subject: **Special Service Campaign - 14R1**  
Certain 2012 through 2014 Toyota Prius V Vehicles Equipped with Non-Toyota Seat Heater

Gulf States Toyota, Inc.  
GST SSC - 14R1  
2012-2014 Prius V Seat Heater  
P/N 00012-J1448-21 Power Harness Update  
Technical Instructions

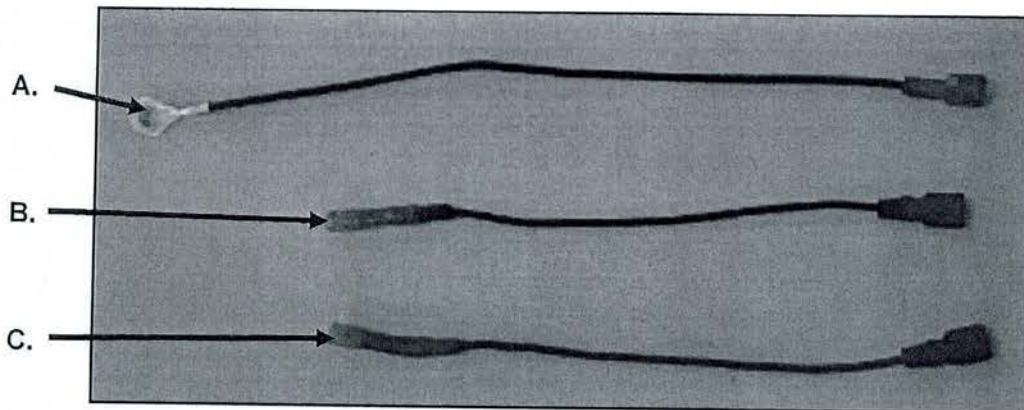
1. The update kit should include the following parts ...
  - A. (1) System Ground Extension (BROWN) Wire.
  - B. (1) Passenger Front Seat Power Extension (BLUE) Wire.
  - C. (1) Driver's Seat Power Extension (RED) Wire.
  - D. (3) 6" Long Cable Ties (not shown in diagram).

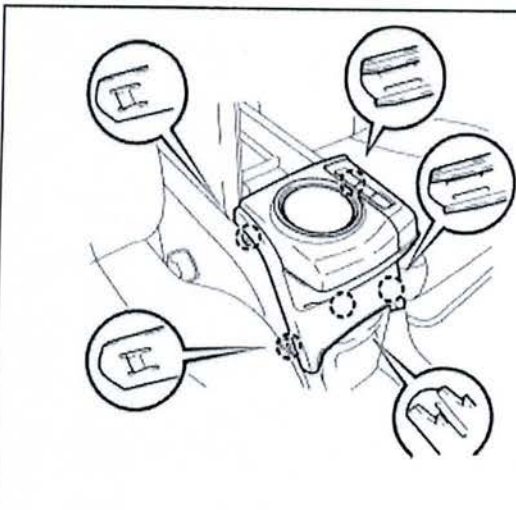
Figure 3a.

3. To remove the Upper Console Panel, carefully disengage the 5 claws, then unplug the connector and place the panel aside where it cannot be damaged.

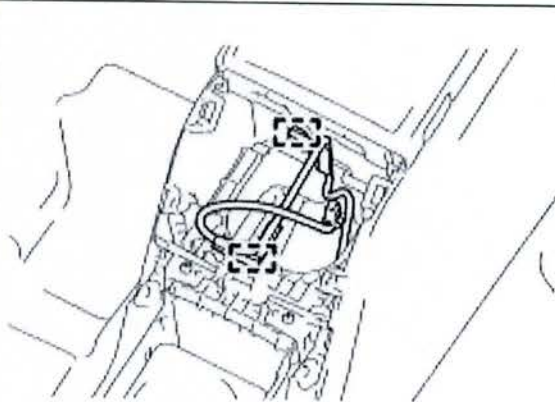
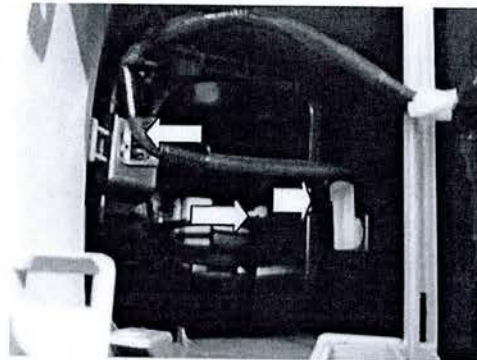
Figure 4a.

4. Disengage (3) harness clamps from the console box.

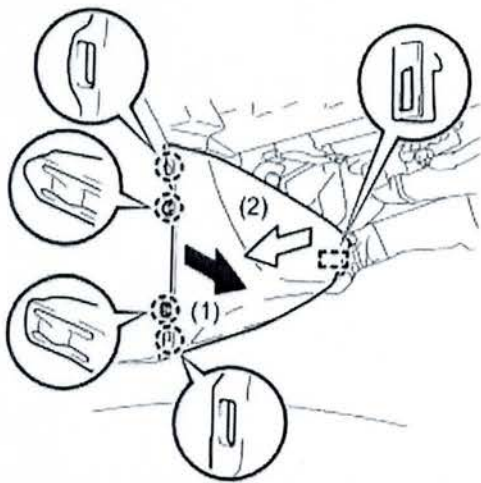
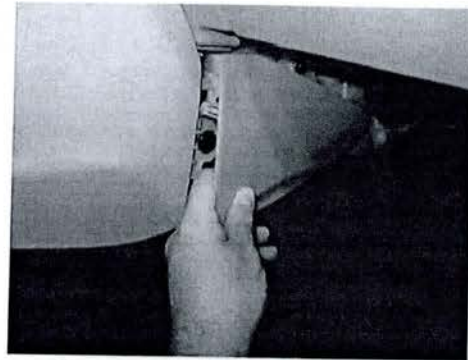
Figure 5a.

5. Carefully remove the Right Front center floor carpet cover panel and set it aside where it cannot be damaged.

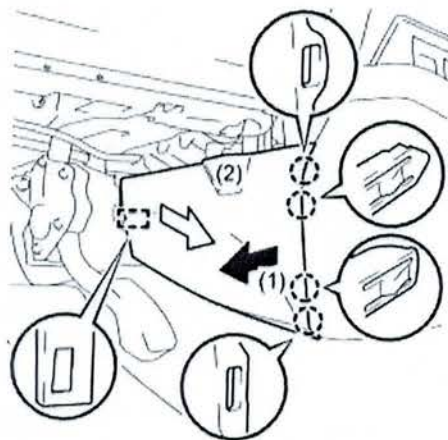
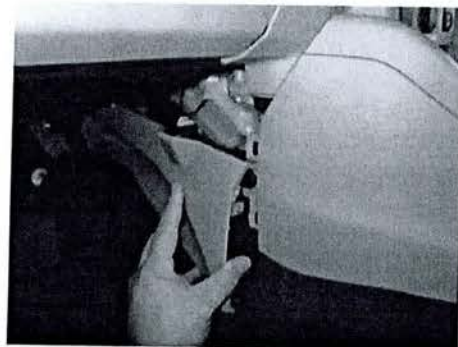
Figure 6a.

6. Carefully remove the Left Front center floor carpet cover panel and set it aside where it cannot be damaged.

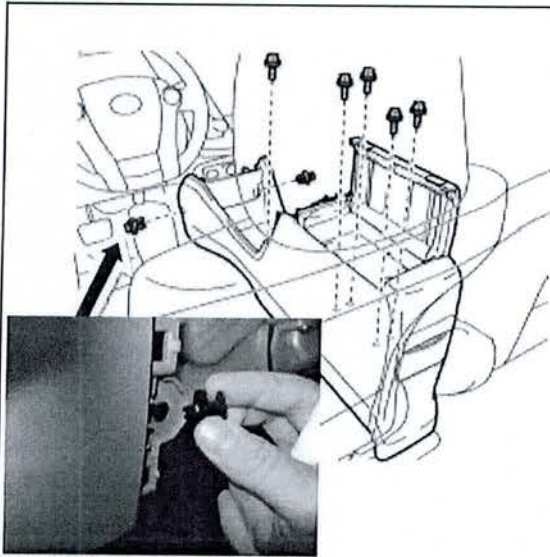
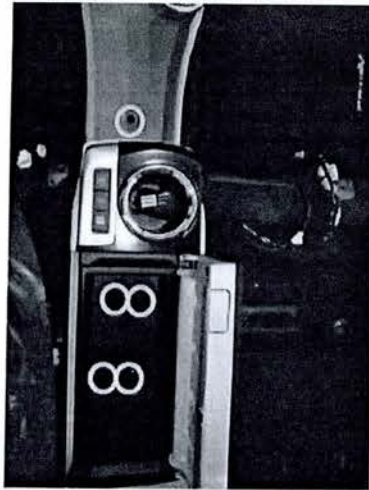
Figure 7a.

7. Remove the (5) 10mm bolts from the center console, then remove the clip from each front corner, and remove the console and set it aside where it cannot be damaged.

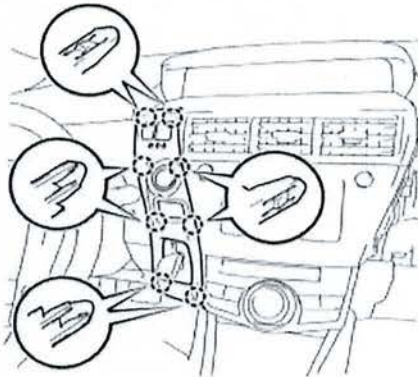
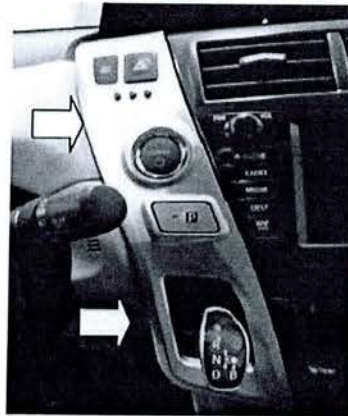
Figure 8a.

8. Disengage the (8) claws, disconnect the connectors, then remove the integration control panel and set it aside where it cannot be damaged.

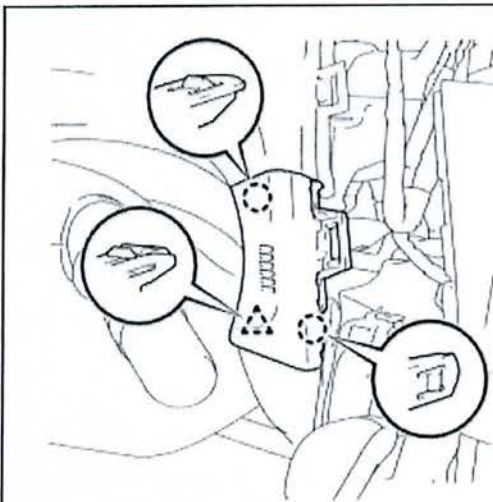
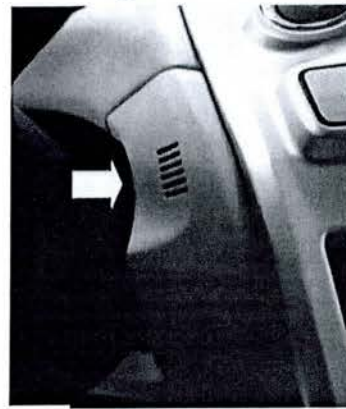
Figure 9a.

9. Disengage the (2) claws and the clip, then remove the upper instrument panel finish panel and set it aside where it cannot be damaged.

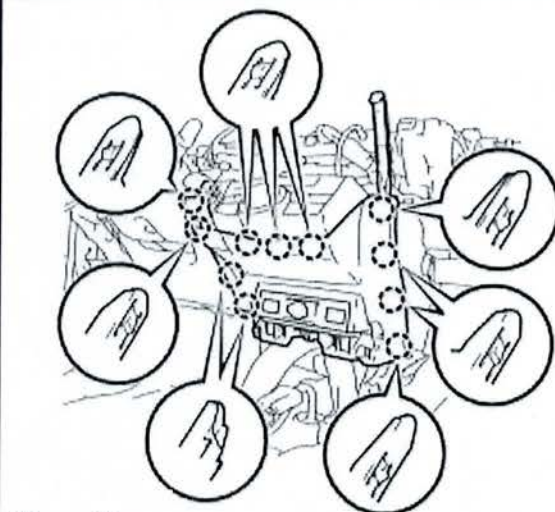
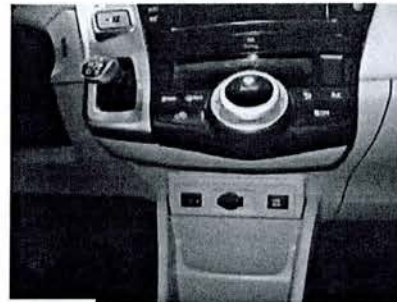
Figure 10a.

10. Disengage the (11) claws and a single clamp, disconnect the connectors, then remove the lower instrument finish panel sub-assembly and set it aside where it cannot be damaged.

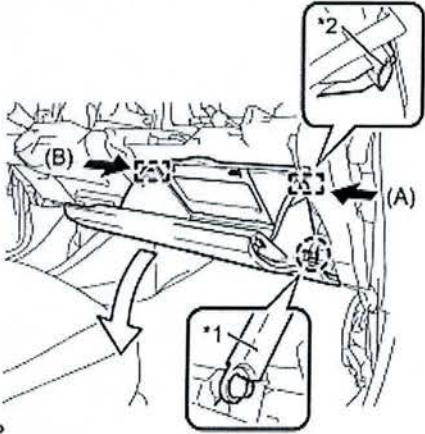
Figure 11

11. Open the glove compartment door, disengage the claw and release the glove compartment door stopper sub-assembly. Then slightly bend stoppers (A & B) in the direction of the arrows shown and pull the glove compartment door assembly until the stoppers are released.

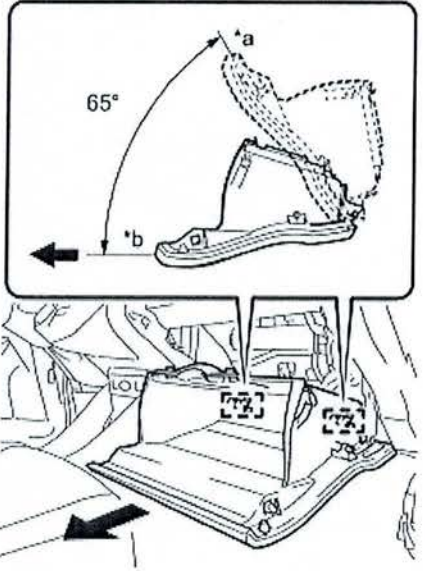
Figure 12

12. Open the glove compartment door assembly to approximately 65 degrees, then carefully pull it horizontally in the direction of the arrow to disengage the (2) hinges. Set it aside where it cannot be damaged.

NOTE: Use care and pull horizontally so the hinges will not be damaged.

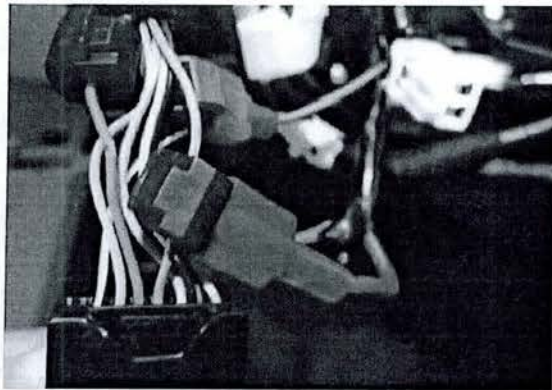
Figure 13

13. Locate connector L26 in the lower center console opening. This is an 8 pin black connector which will have (3) wires from the Seat Heater connected to it.

Seat Heater Wire Color	OEM Wire Color	Connector L26 Pin Number
BR	W-B	2
R	R	4
L	BR	5

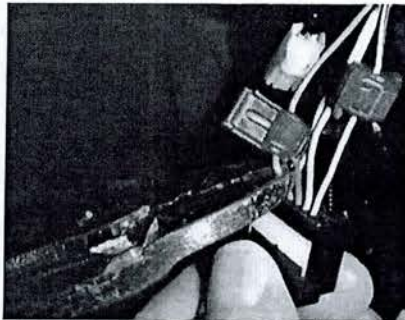
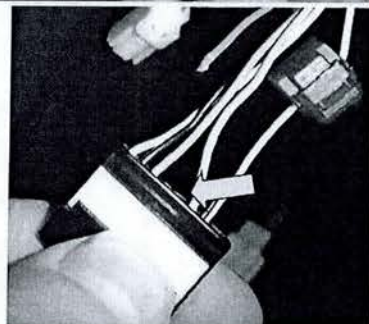
Figure 14

14. Unplug the (3) Seat Heater Wires from the T-Tap terminals at the back of connector L26. Then, cut the T-Tap terminals off the RED and the BROWN OEM wires, cutting the OE wire at both sides of the T-Tap. BE SURE TO CUT THE RED AND BROWN WIRES AS CLOSE TO CONNECTOR L26 AS POSSIBLE, AS INDICATED BY THE YELLOW ARROW BELOW LEFT.

NOTE: The 3rd T-Tap should remain connected to the OEM WHITE/BLACK striped wire.

**IMPORTANT !!!** Save the (2) T-Taps that were cut from the harness. These parts **MUST BE** returned to the PDC when the LIO Warranty claim is filed. Claims will not be paid and VINs will not be cleared until the (2) parts with wire are received at the Parts Distribution Center.

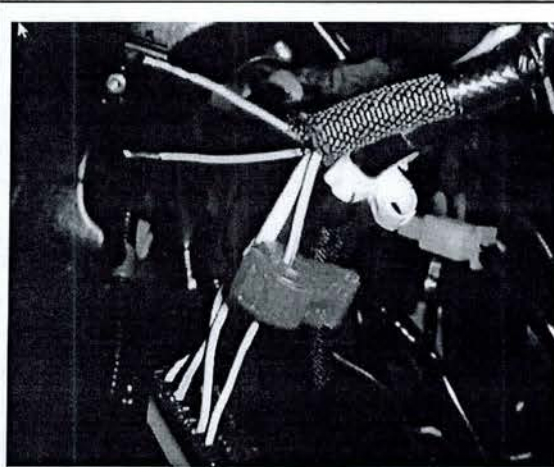
Figure 15

15. Carefully strip back 3/8" of insulation from the OEM Red and Brown wires, at the harness side of the wire.

**IMPORTANT !** This is a 22 AWG wire. Be sure to use the correct wire stripping tool, and be sure that no copper wire strands are removed from the wire during the stripping process.

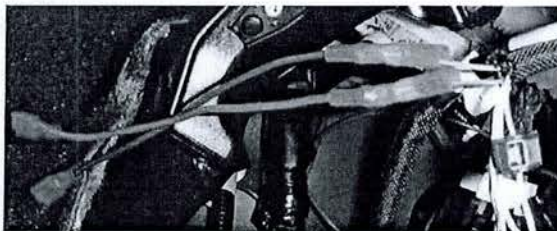
Figure 16

16. Using 3M crimp tool TH-440 or equivalent, crimp the Passenger Front Seat Power Extension (BLUE) Wire included in this kit to the OEM BROWN wire previously inserted into Connector L26, Pin 5.

Crimp the Driver's Seat Power Extension (RED) Wire included in this kit to the OEM RED wire previously inserted into Connector L26, Pin 4.

**IMPORTANT !** After crimping each wire, apply 11 lbs of pull force to ensure the crimp is secure.

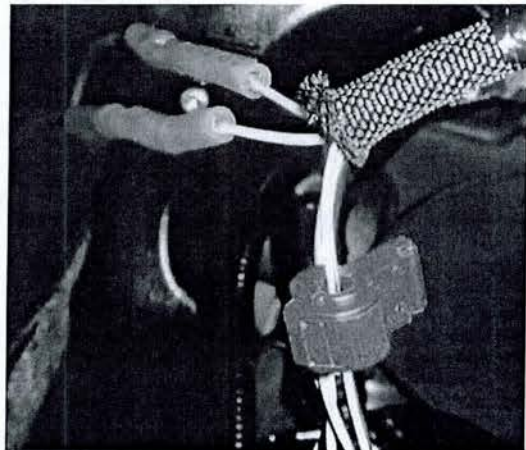
Figure 17

17. Using a concentrated heat source or heat gun at **MEDIUM** setting, shrink the insulation at the crimped end of the butt splice down over the OEM wire insulation.

**IMPORTANT !** Be sure to protect all finish panels and parts including OEM connectors from the heat source. Use extreme care and demonstrate patience when shrinking the tubing.

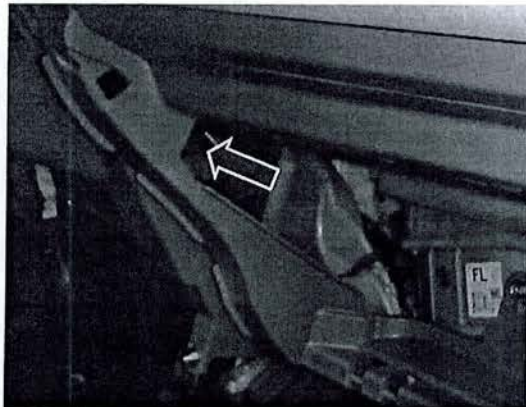
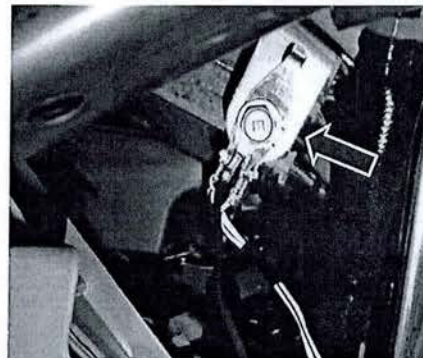
Figure 18

18. Locate the factory ground location L2 behind the upper left corner of the glove box opening. Using a 10mm socket, connect the ring terminal on the System Ground Extension (BROWN) Wire included in this kit to factory ground location L2 and torque to factory specification.

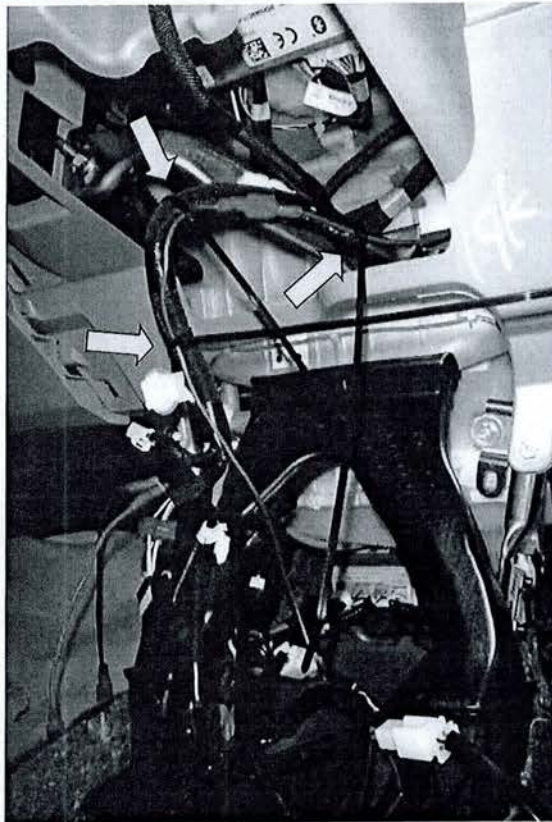
Figure 19

19. Route the insulated female terminal end of the BROWN extension wire into the center console area, and plug it into the male insulated terminal on the end of the BROWN wire from the seat heater harness.

Plug the insulated female terminal end of the RED extension wire into the male insulated terminal on the end of the RED wire from the seat heater harness.

Plug the insulated female terminal end of the BLUE extension wire into the male insulated terminal on the end of the BLUE wire from the seat heater harness.

Install the (3) wire ties as shown at the three yellow arrows. Be sure to trim the excess wire tie extension prior to re-assembly.
