Engine has no output

Topic number	LI09.10-P-059184
Version	1
Design group	09.10 Air cleaner
Date	06-16-2014
Validity	222.177/178 up to VIN #A 023218
Reason for change	
Reason for block

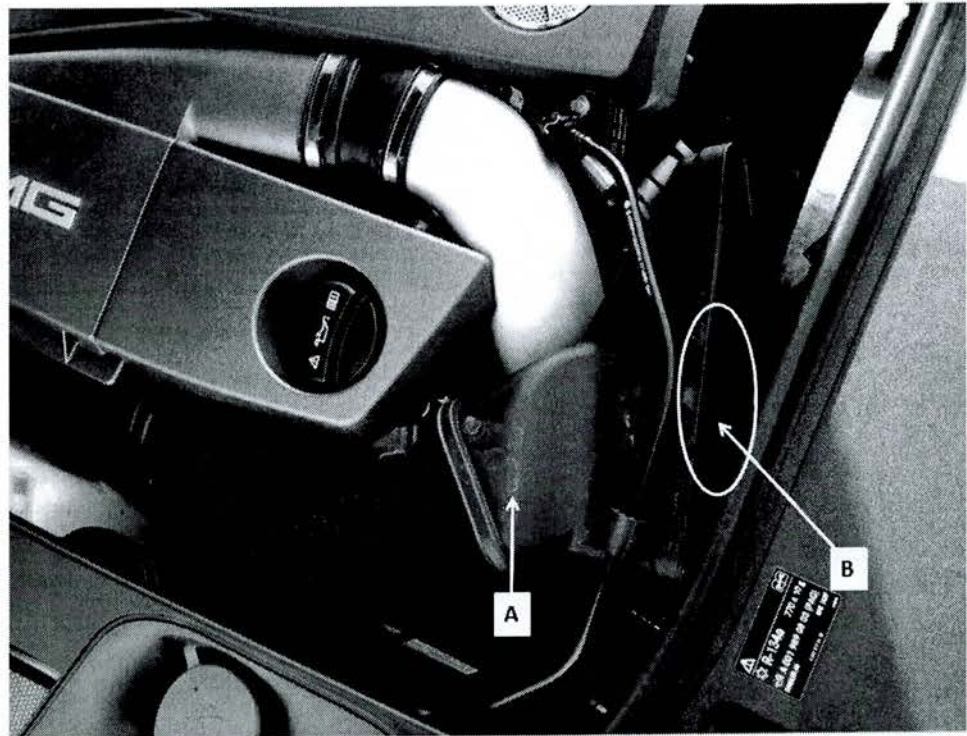
Abbildung 1.JPG:

Right air intake is loose in the area of radiator shroud

Affix right air intake (Figure 1, item A) at a lower locking point on the shroud (Figure 1, item B) using bracket (Figure 2, item C).
