Product Improvement Campaign

No: C1007410 Issued: November 26, 2014 Re: Turbocharger Linkage Group: 15 Models: FE/FG Expires: November 26, 2015

SUBJECT: Product Improvement Campaign C1007410 – Turbocharger Linkage

Turbocharger Linkage Lubrication Procedure

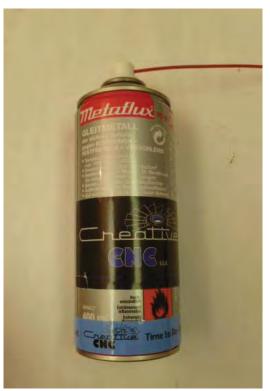
5. Attach the 40cm nozzle extension to the METAFLEX 70-81 can. Spray the upper & lower sections of the linkage.

6. Make sure that grease is applied evenly. Reassemble the removed parts. Remove and clean the nozzle extension.

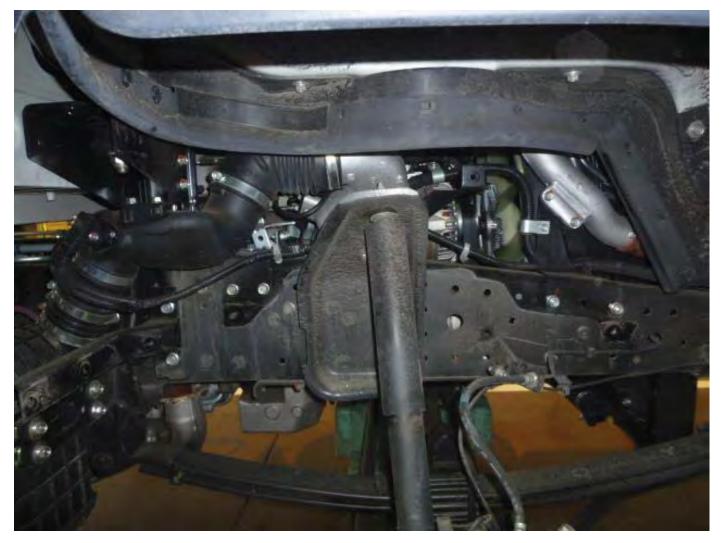
2. Remove the right front tire. Remove the splash guard.

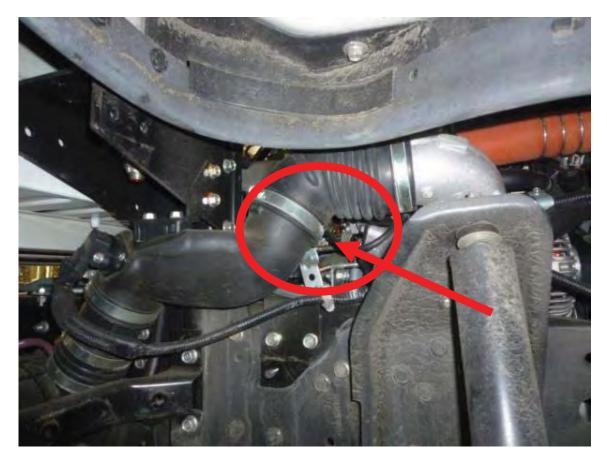
3. Locate the turbocharger linkage and pivot.

4. Attach the 40cm nozzle extension to the Kano AeroKroil can. Spray the upper & lower sections of the linkage.

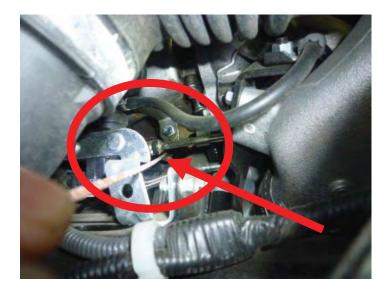
6. Attach the 40cm nozzle extension to the METAFLEX 70-81 can. Spray the upper & lower sections of the linkage.

7. Make sure that grease is applied evenly. Reassemble the removed parts.
