**NUMBER:** 08-034-15**GROUP:** Electrical**DATE:** April 07, 2015

Wire Harness Hanging Down From Rear Bumper Fascia

This bulletin involves attaching the park assist and/or blind spot detection wire harness to the rear bumper fascia.

2011 - 2014 (RT)

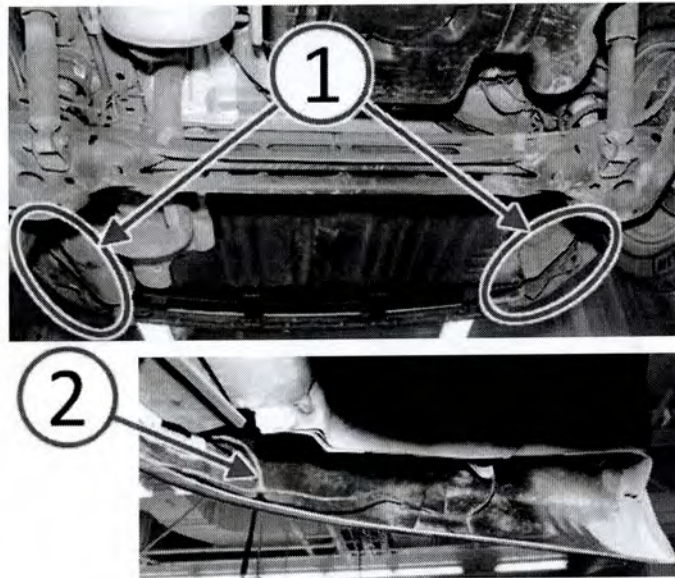
***Fig. 1 Wire Harness Loose Not Securely Attached***

The customer may describe a wire harness hanging down from the rear bumper fascia.

1 - Inspection Areas

2 - Loose Wire Harness

1. Is the park assist and/or blind spot detection working properly?
  - a. YES>>> Continue with the Repair Procedure Step #2.
  - b. NO>>> Problems with park assist and/or blind spot detection should be repaired first before continuing with this bulletin. Normal diagnosis should be performed.
2. Inspect the wire harness on the right and left side of the rear fascia (1) for looseness, wire harness (2) not securely attached to the rear fascia (Fig. 1).
3. Is the wire harness loose, not securely attached to the rear fascia? (2) (Fig. 1).
  - a. YES>>> Continue with the Repair Procedure Step #4.
  - b. NO>>> This Bulletin does not apply. Normal diagnosis should be performed.

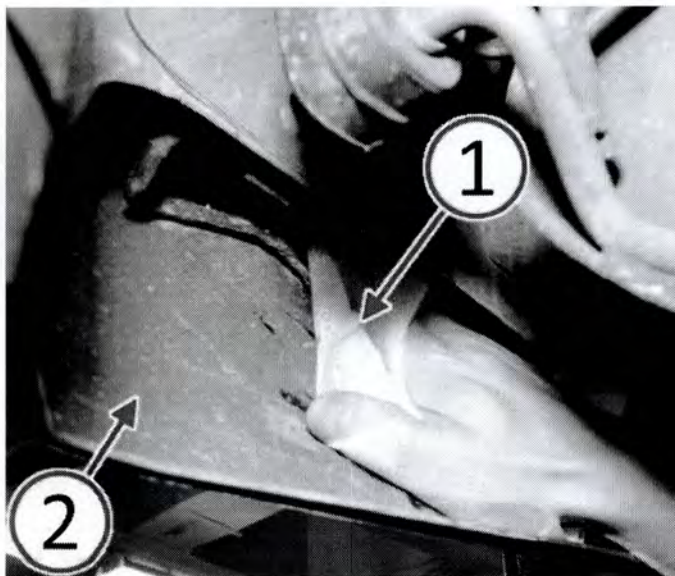
**Fig. 2 Clean Rear Fascia Inside Surface**

- 1 - Clean Rag
- 2 - Rear Fascia Inside Surface

**NOTE: Surface must be free of all dirt, debris, wax, road tar, grease, and oil in the tape application area.**

4. Using a clean rag (1), thoroughly clean the wire harness and the inside surface of the rear fascia (2) on the right and left sides with wax and grease remover then isopropyl alcohol (Fig. 2).

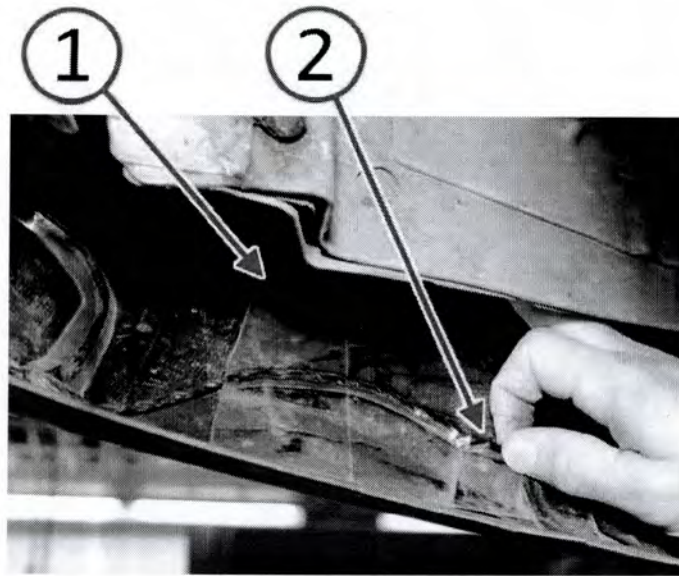
**Fig. 4 Apply Tape**

- 1 - Tape
  - 2 - Pinch Tape Around Wire Harness
-

- 7. Apply the tape (1) to the wire harness pinching the tape (2) around the harness to reduce gaps and voids before smoothing the tape out against the fascia inner surface (Fig. 4).

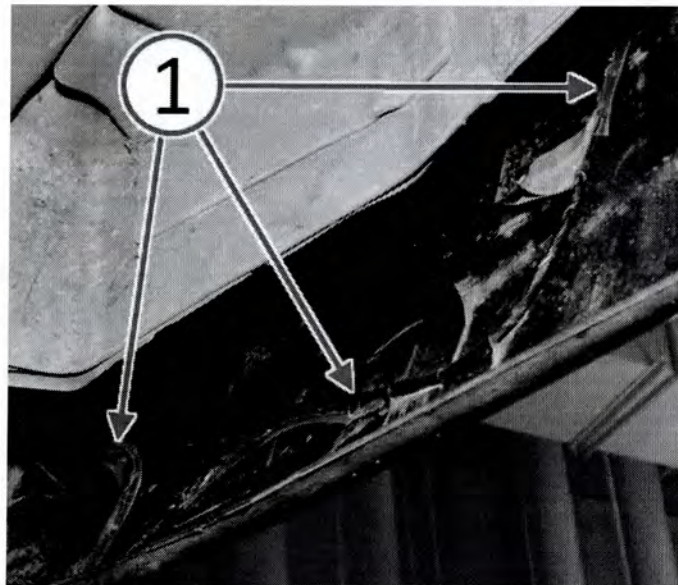
**Fig. 5 Wire Harness Securely Attached**

- 1 - Wire Harness Taped Flat
-

8. Ensure the wire harness lays flat and the three pieces of tape are firmly applied to the fascia inner surface with as few bubbles and voids as possible (Fig. 5).
