6.7L CUMMINS DIESEL ENGINE WITH HYDRAULIC BRAKES - CHECK ENGINE LIGHT WITH CUMMINS DTC 4526	TSB 15-0110
--	--------------------

FORD:

2013 F-650, F-750

2015 F-650, F-750

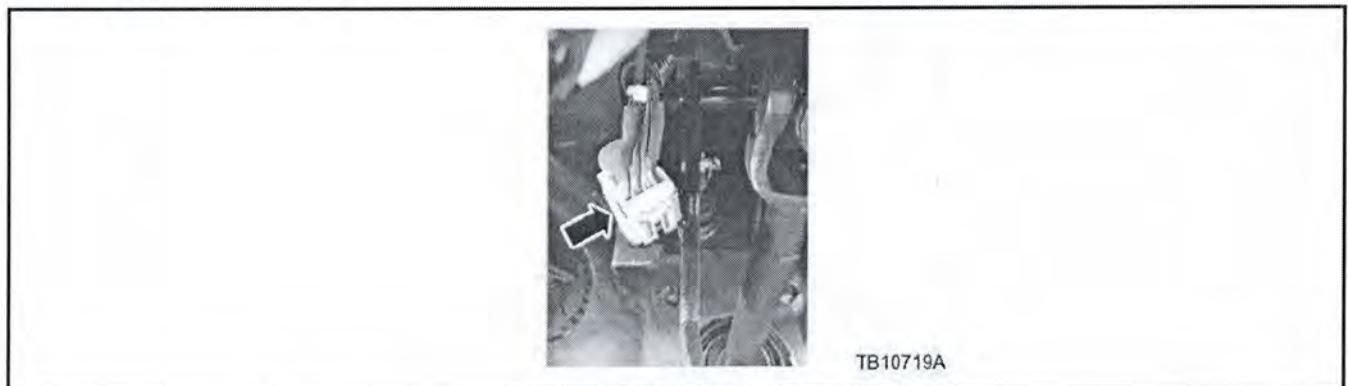
Figure 1 - Article 15-0110

1. Retrieve DTCs using the Cummins InSite software program. Is DTC 4526 present in the Cummins engine control module (ECM)?
 - a. Yes - proceed to Step 2.
 - b. No - this article does not apply. Refer to normal Cummins ECM diagnostics.
2. Inspect the orientation of the brake pedal position (BPP) switch. When installed correctly the BPP switch will be oriented approximately 45 degrees from vertical. Is the BPP switch oriented correctly? (Figure 1)

- 3. Does the BPP switch plunger move freely in/out with tension and are both black cams present and unbroken? (Figure 2)
 - a. Yes - carefully reinstall the original BPP switch, place the BPP switch body flush against the bracket at a vertical and rotate it counterclockwise to seat. Proceed to Step 4. (Figure 1)

- b. No - replace the BPP switch. Carefully install the new BPP switch by placing the BPP switch body flush against the bracket at a vertical and rotate it counterclockwise to seat. Repair is complete. (Figure 1)

- a. Yes - proceed to Step 6.
 - b. No - replace the BPP switch. Carefully install the BPP switch by placing the BPP switch body flush against the bracket at a vertical and rotate it counterclockwise to seat. Repair is complete. (Figure 1)

- a. Yes - refer to Cummins ECM diagnosis and repair publications.
 - b. No - replace the BPP switch. Carefully install the new BPP switch by placing the BPP switch body flush against the bracket at a vertical and rotate it counterclockwise to seat. Repair is complete. (Figure 1)

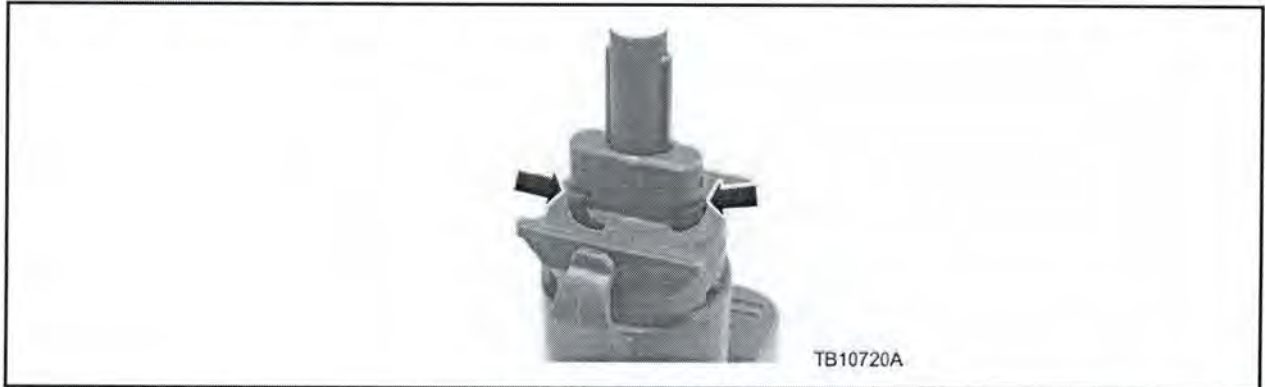
Figure 2 - Article 15-0110

- b. No - remove the BPP switch by rotating it clockwise, and proceed to Step 3.
 - (1) When removing or installing the BPP switch, use only fingertip force to rotate the switch body. Excessive force could damage the black switch cams. Make sure the brake pedal is at its rest position and is not moved during BPP switch installation. (Figure 2)
