Technical Service Bulletin

23 MIL on, rough running, no start (DTCs P0087, P0088, and/or P0191) (TDI only)

23 15 35 2036668/3 June 30, 2015. Supersedes Technical Service Bulletin Group 01 number 14-75 dated March 20, 2014 for reasons listed below.

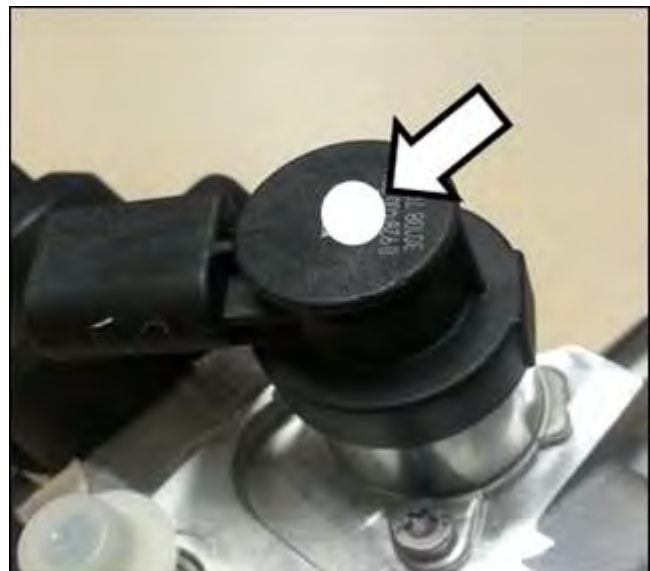
Figure 6. White dot on N290 fuel metering valve.

2. Use light pressure to reinstall the N290 fuel metering valve into the valve bore.
3. Install and hand tighten both M5 fasteners, ensuring that the threads are clean and dry. Pre-tighten to 2 Nm, then to 6.5 – 7 Nm.
4. Use a paint marker or equivalent to mark the top of the N290 fuel metering valve with a white dot (Figure 6).
