Service Bulletin

SB-10058745-1261

SUBJECT: Special Coverage Adjustment – Cracked Fuel Tank Inlet Control Valve

**MODELS: 2006-2008 Chevrolet Cobalt
2006 Pontiac Pursuit, G4
2007-2008 Pontiac G5
2006-2007 Saturn ION**

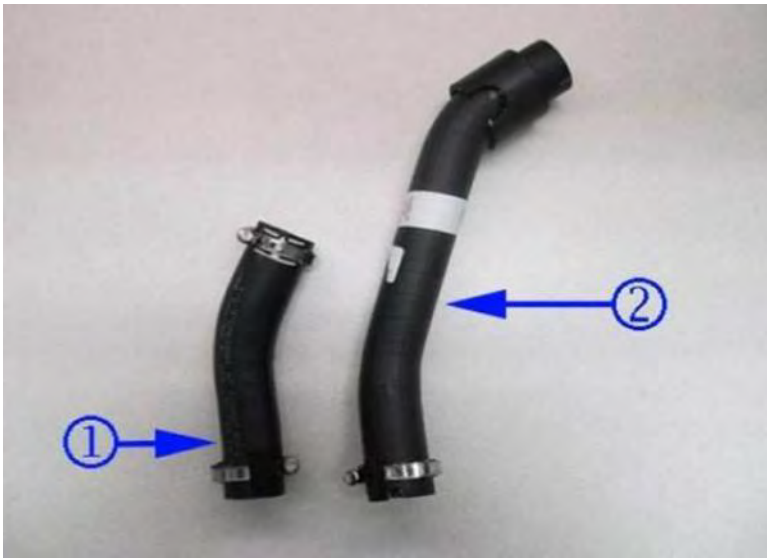
4109439

2. Match the new hose (2) to the original (1), aligning side by side.

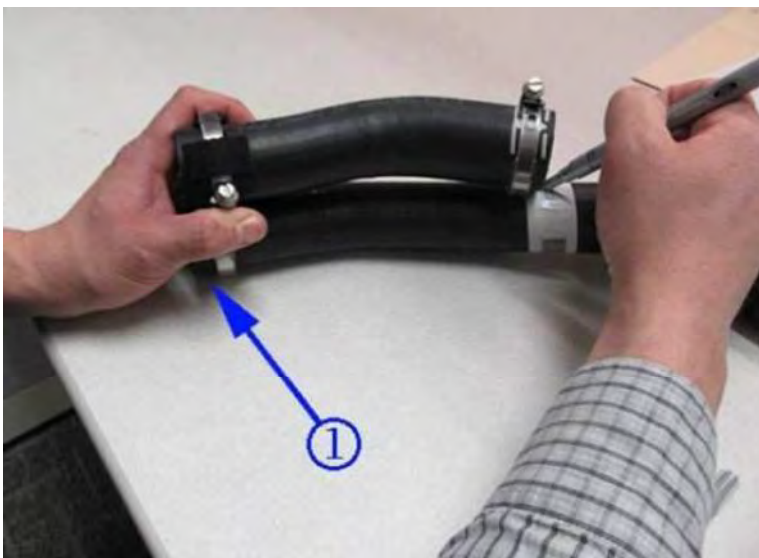
4109445

3. Using a paint pen or equivalent, mark the new hose to the original, starting with the notched fuel tank ends of the hoses so that both hoses are the same length.

Note: When cutting the hose, be sure the cut is as straight as possible. Use a hose clamp or tape as a guide. Failure to cut the hose straight could result in leaks.

4. Cut the hose **from the fill end** opposite of the side with the notch (1) to match the length.

5. Transfer the clamp on the newly cut hose.
6. Install the new trimmed hose to vehicle mounted fill pipe, and to the tank.
