**star bulletin**

Date: December 11, 2014  
Order No.: S-B-42.10/123a  
Supersedes: S-B-42.10/123, June 3, 2013  
Group: 42

**SUBJECT: MY-All, Models All**

### **Cleaning Axle Hubs When Installing Brake Discs**

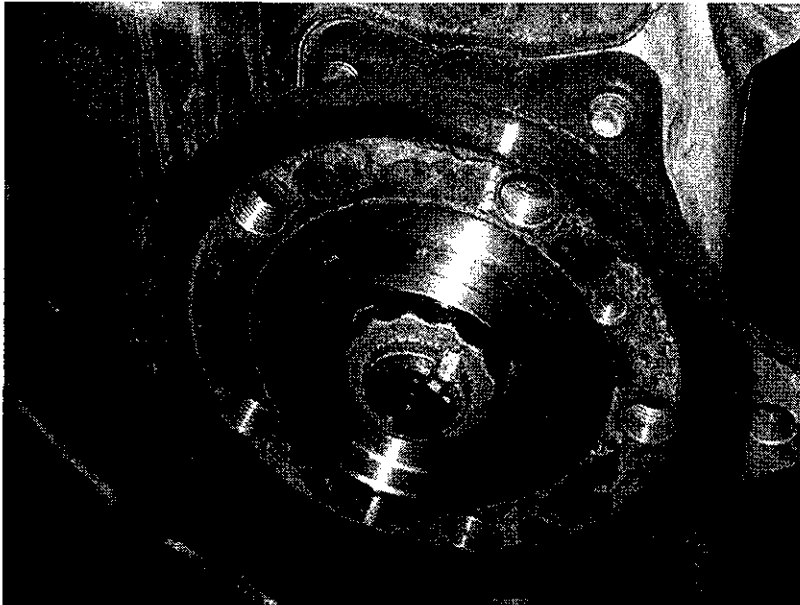
**Figure 1.**

It is imperative that when installing brake discs (front or rear) the excessive corrosion / scaling (Figure 1), which may have developed on the axle hub, be removed. Use the "ATE Teves Hub Cleaning Kit" released via automatic delivery to remove the corrosion / scaling over the entire area where the brake disc mounts to the hub flange.

Failure to remove the corrosion / scaling may cause an excessive build-up which can create adverse forces that may result in brake vibrations / judder.

**i** Note: Please reference Special Tools & Equipment Newschannel update dated November 12, 2014 for further information regarding the "ATE Teves Hub Cleaning Kit".
