**Subject:****SEAT TRACK ASSEMBLY SURFACE CORROSION OR RUST****Bulletin No:** 09-027/13**Last Issued:** 10/31/2013**APPLICABLE MODEL(S)/VINS**

2009-2011 Tribute

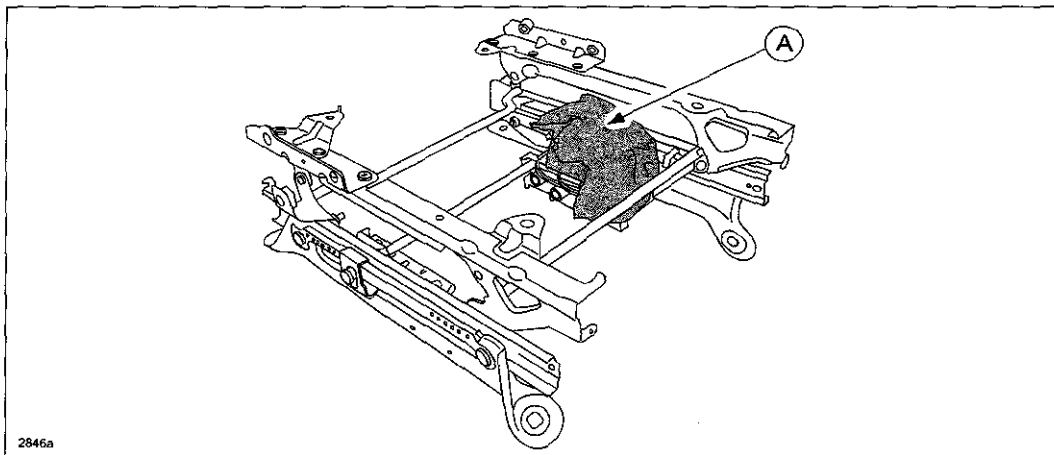
Some vehicles may exhibit rust or corrosion on the front seat track assemblies.

1. Verify customer concern.
2. Remove the affected front seat assembly. Refer to MS3 online or Workshop Manual (section 09-13 FRONT SEAT REMOVAL/INSTALLATION).
3. Remove seat track from seat base. Refer to MS3 online or Workshop Manual (section 09-13 SEAT TRACK REMOVAL/INSTALLATION).
4. Clean the track assembly with a wax and grease remover and allow to dry. Use Mazda Brake Parts Cleaner or equivalent.
5. Remove rust and corrosion using 220-grit sandpaper.
6. Blow loose material from the seat track with compressed air, and clean again with Mazda Brake Parts Cleaner or equivalent.
7. Mask the motor and harness (A).

8. Paint the seat track using Semi-Gloss Black Engine Paint or equivalent. Allow adequate time for drying.
9. Install seat track. Refer to MS3 online or Workshop Manual (section 09-13 SEAT TRACK REMOVAL/INSTALLATION).
10. Install seat. Refer to MS3 online or Workshop Manual (section 09-13 FRONT SEAT REMOVAL/INSTALLATION).
11. Verify repair.
