**HYUNDAI**NEW THINKING.
NEW POSSIBILITIES.**Technical Service Bulletin**

GROUP	NUMBER
HVAC	13-HA-002
DATE	MODEL
APRIL 2013	GENESIS (BH), EQUUS (VI)

SUBJECT	A/C COMPRESSOR REPAIR PROCEDURE (PULLEY, DISC & HUB REPLACEMENT)
---------	---

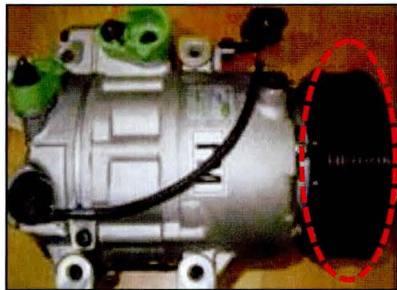
Replace only the affected parts shown.

**Pulley**

**Disc & Hub****Applicable Vehicles:**
