**HYUNDAI**NEW THINKING.
NEW POSSIBILITIES.**Technical Service Bulletin**

GROUP	NUMBER
HVAC	13-HA-002-1
DATE	MODEL
SEPTEMBER 2013	GENESIS (BH), EQUUS (VI)

**SUBJECT A/C COMPRESSOR REPAIR PROCEDURE
 (PULLEY, DISC & HUB REPLACEMENT)**

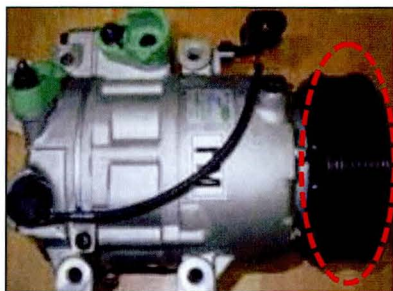
Replace only
the affected
parts shown.

Pulley

Disc & Hub

Follow the procedure outlined in this bulletin to replace the A/C Pulley Assembly and the A/C Disc & Hub Assembly to correct this condition.

***** DO NOT REPLACE THE ENTIRE A/C COMPRESSOR TO REPAIR THIS CONDITION. *****

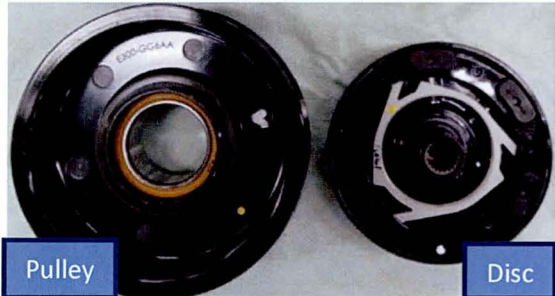
Part Name	Part Number	QTY	Description
Pulley Assy - A/C Compressor	97643-3M000	1

Disc & Hub Assy - A/C Compressor	97644-3M000	1
