NUMBER: 08-075-14

Heated Mirror Feature Inoperable

This bulletin involves installing the correct HVAC control head, updating vehicle configuration and installing an overlay harness as necessary.

2014 (VF) ProMaster

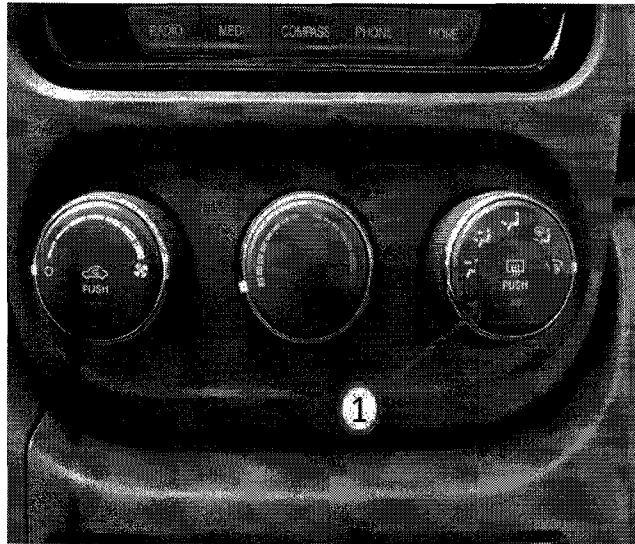
Fig. 1 HVAC Control Head

1 - Defrost Button

1. Does the HVAC control head contain the heat/defrost button (See Figure 1)?
 - a. If Yes>>> Proceed to Step 2.
 - b. If No>>> Proceed to Step 3.

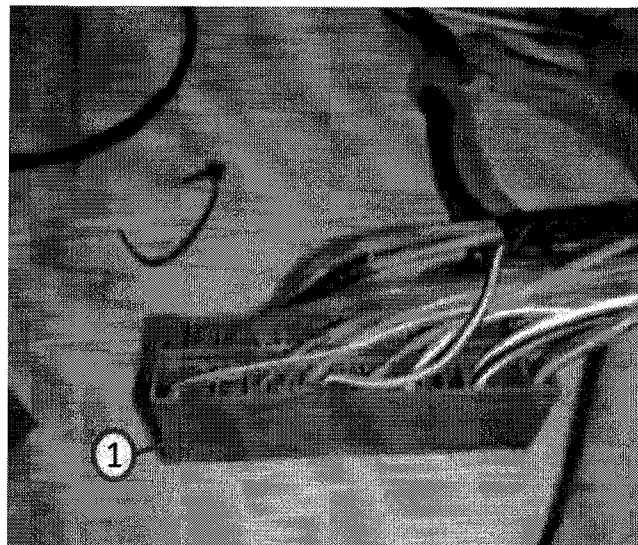
Fig. 10 PDC Connector C1 Cavity 23

- 1 - Cavity 23 YL/BK Circuit

12. Insert the YL/BK circuit terminal into cavity 23 of connector C1. Next, insert the untagged RD/GN circuit terminal into cavity 5. Finally, insert the tagged RD/GN circuit terminal into cavity 4 (See Figure 9, 10 & 11).

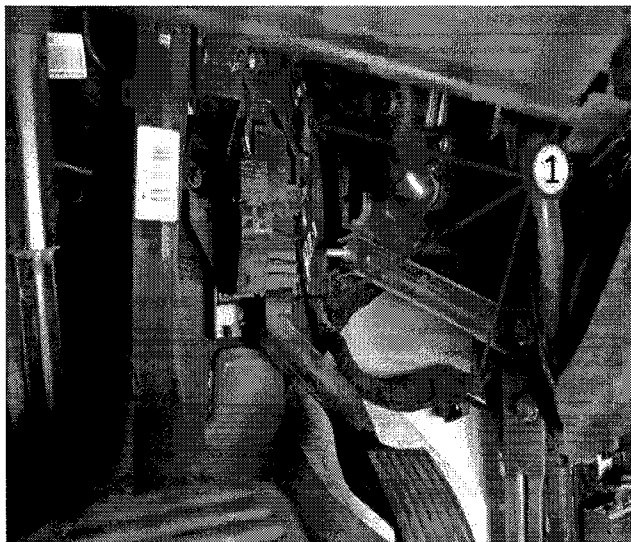
Fig. 17 Overlay Harness Routing

1 - Route harness along this path and secure using provided electrical tape

23. Route the remaining portion of the overlay harness around the pedal assembly bracket and secure to the existing harness using electrical tape (See Figure 17).

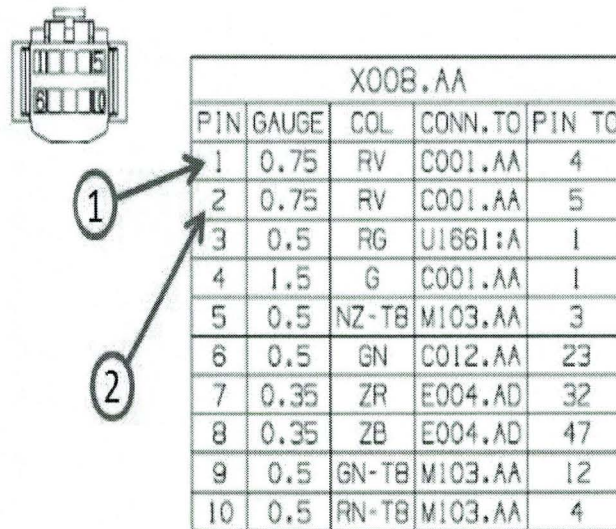
Fig. 21 Inline Connector 1008A Pinout

1 - Cavity 1 RD/GN Circuit With White Tag

2 - Cavity 2 RD/GN Circuit Without Tag

30. Insert the untagged RD/GN circuit terminal into cavity 2. Next, insert the tagged RD/GN into cavity 1 (See Figure 21).
