NUMBER: 23-014-13 REV. A

Sunroof Opens But Will Not Close And/Or Cycles Back To Open And/Or Sunroof Glass Scratched

This bulletin involves inspecting sunroof glass clearance and if necessary, modifying the sunroof reinforcement to allow adequate clearance for sunroof glass travel.

2012- 2013 (RT) Caravan/Town and Country

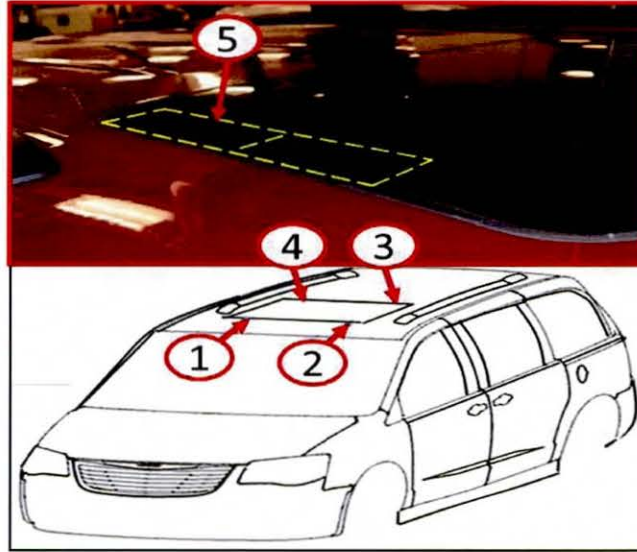
Fig. 1 Apply Tape

- 1 - Driver Side Front Panel Flushness (Adjust to 2mm Underflush)
 - 2 - Passenger Side Front Panel Flushness (Adjust to 2mm Underflush)
 - 3 - Driver Side Rear Panel Flushness (Adjust to 0mm-Flush)
 - 4 - Passenger Side Rear Panel Flushness (Adjust to 0mm-Flush)
 - 5 - Felt/Flock Tape PN 05019055AA (2pcs per Side)
-

1. Adjust sunroof panel flushness along the front of the glass (1)&(2) to 2mm underflush. Adjust the rear of the sunroof glass panel (3)&(4) to zero/flush (Fig. 1).

NOTE: Once the proper glass position has been achieved, tighten the six glass panel attaching screws to 3.5 Nm (31 in. lbs.).

2. Apply two pieces of felt/flock tape p/n 05019055AA to each side of the sunroof glass panel. Apply the tape end to end along the side edge of the sunroof glass panel (5) starting at the end of the rear corner radius running forward (Fig. 1).

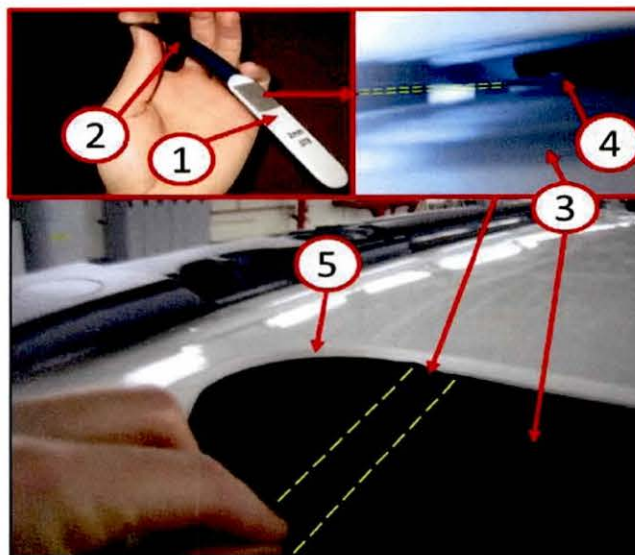
Fig. 2 Inspect

Cycle the sunroof panel to the full open position and use a 2mm feeler gage (1) to check left and right sunroof glass (3) to inner sheet metal reinforcement (4) gap. Use a flashlight to locate the lowest point between the sheet metal reinforcement (4) and sunroof glass (3) (Fig. 2).

- 1 - Feeler Gage (2mm-taped to extension device)
- 2 - Lock Out Tool/"Slim Jim" (or equivalent device)
- 3 - Sunroof Glass Panel
- 4 - Sheet Metal Reinforcement (inner sunroof structure shown)
- 5 - Sunroof Opening (rear passenger corner shown)

-
3. Is the clearance between the inner sunroof sheet metal reinforcement and sunroof glass 2mm or greater?
 - a. Yes>>> This bulletin does not apply, further diagnosis required.
 - b. No>>> Cycle the sunroof to the fully closed position and remove the felt/flock tape. Proceed to [Step #4](#).
 4. Remove the sunroof module. Refer to the detailed procedures available in DealerConnect> TechCONNECT under: Service info> 23-Body> Sunroof> SUNROOF> Removal.

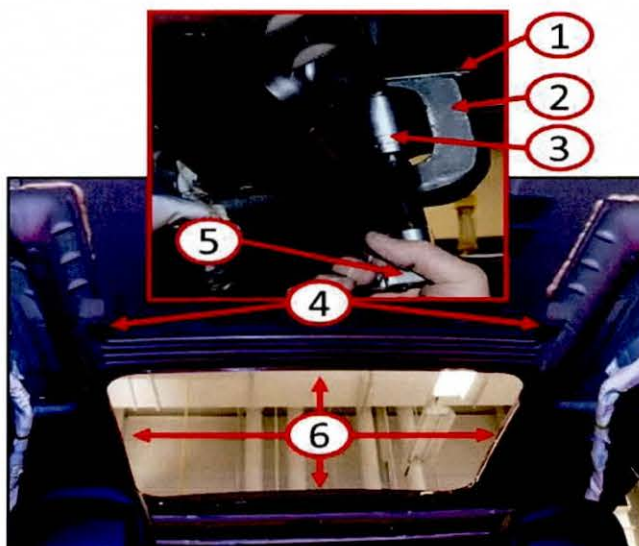
Fig. 3 Modify Using Special Tool

- 1 - Backer Plate (scrap metal shown)
 - 2 - C-4150A Ball Joint Press/Special Tool
 - 3 - Socket (30mm shown)
 - 4 - Sunroof Reinforcement (low hanging features shown)
 - 5 - Ratchet
 - 6 - Sunroof Opening (view from inside vehicle)
-

5. Using a backer plate (1) or heavy (3/8"/10mm minimum thickness) cardboard to protect and disburse any pressure applied against the outer roof sheet metal, insert the C-4150A ball joint press/special tool (2) into the low hanging sunroof reinforcement feature (4) (Fig. 3).
6. Insert a 30mm socket or equivalent (3) between the sunroof reinforcement and spindle of the C-4150A ball joint press/special tool to take up space between the frame and spindle of the press. Carefully tighten the spindle of the press to compress the center of the sunroof reinforcement upward (Fig. 3).

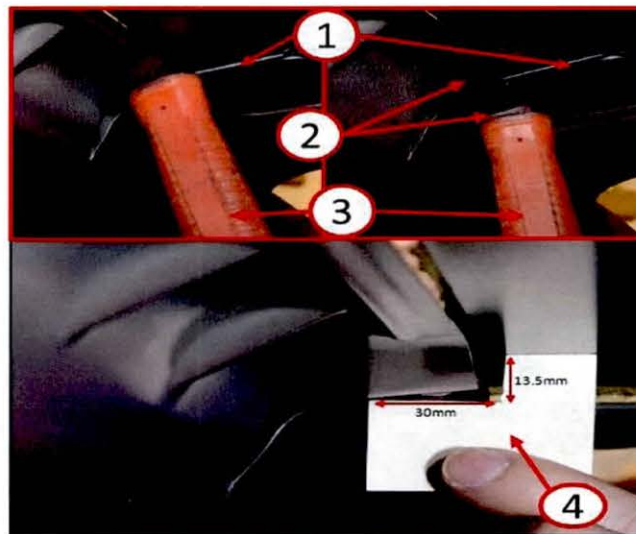
Fig. 4 Verify Modification

- 1 - Backer Plate (scrap metal shown)
- 2 - Left and Right Side (sunroof reinforcement to be modified)
- 3 - Blunt Tool (hammer handle shown)
- 4 - Verification Gage (desired clearance shown)

7. Using a backer plate (1) or heavy (3/8"/10mm minimum thickness) cardboard to protect and disburse any pressure applied against the outer roof sheet metal, carefully push the remaining left and right side of the low hanging sunroof reinforcement feature (2) upward using a hammer handle or equivalent blunt tool (3) to provide additional clearance (Fig. 4).

WARNING:A backer plate must be used to protect the exterior roof sheet metal panel from deformation and evenly disburse any pressure placed on the exterior roof panel. Failure to do so will result in damage to the outer roof panel as the raised center of the reinforcement will contact the outer panel creating a dimple or dent from focused pressure at the point of contact.

8. Using an index card or folder stock, create a verification gage (4) that will ensure the proper clearance is achieved as a result of modifying the sunroof reinforcement. The gage should measure 13.5mm down from the outer roof panel and 30mm inward from the outer edge of the sunroof reinforcement. Move the verification gage back and forth along this area to ensure proper clearance is achieved (Fig. 4).

NOTE: Repeat the modification procedure for the opposite side of the vehicle or on existing side until desired clearance is achieved.
