NUMBER: 23-016-13
GROUP: Body
DATE: April 20, 2013

SUBJECT:
 Driver And/Or Passenger Seat Fore/Aft Movement During Acceleration And/Or Braking

OVERVIEW:
 This bulletin involves replacing the power seat track drive block bolts on front driver and/or passenger seat.

2011- 2013	(LC)	Challenger
2011- 2013	(LD)	Charger
2011- 2013	(LX)	300

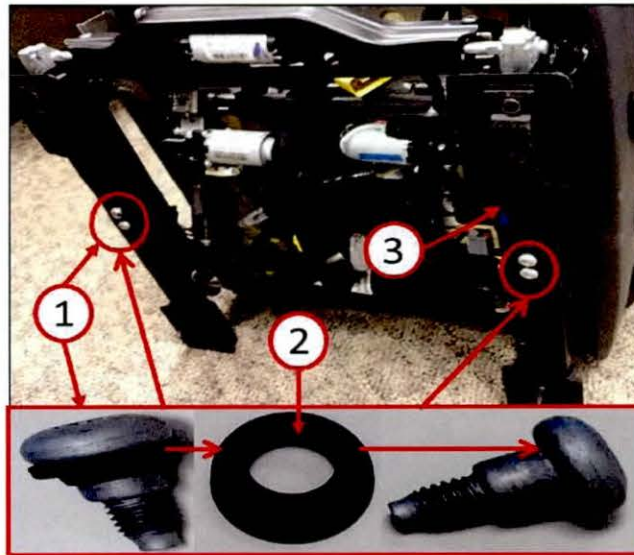
Fig. 1 Replace Drive Block Bolts

SYMPTOM/CONDITION:
 The customer may experience up to 1mm(1/32") fore/aft movement of the driver and/or passenger seat during acceleration and/or braking.

- 1 - Drive Block Bolts (bottom of seat frame)
- 2 - Plastic Drive Block Spacer (transfer from old to new bolt)
- 3 - Seat Frame (view from bottom)

2. Remove one of the drive block bolts (1) from the bottom of the seat frame at a time and remove the plastic spacer (2) from the old bolt and reinstall it on the new bolt p/n 68203613AA.
3. Reinstall the new bolt into the bottom of the seat frame (3) and tighten it to 15Nm(11ft/lbs.). Repeat for the remaining bolts and/or seat.
