Technical Service Bulletin

30 Clutch pedal makes noises when pressed

30 13 17 2032224/2 January 8, 2013. Supersedes Technical Service Bulletin Group 30 number 12-16 dated December 21, 2012 for reasons listed below.

Model(s)	Year	VIN Range	Vehicle-Specific Equipment
TT	2012-13	All	Manual transmission
A3

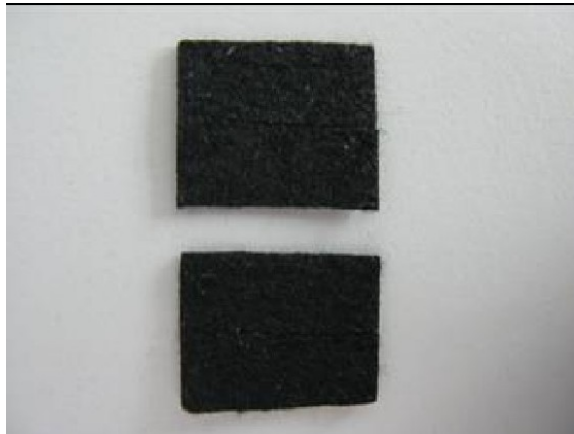
Figure 1. Felt pieces.

1. Remove the mounting on the clutch pedal (Figure 3) according to the repair manual and discard.
2. From part number: **533 867 910 A** cut two felt pieces 16mm long. (Figure 1)

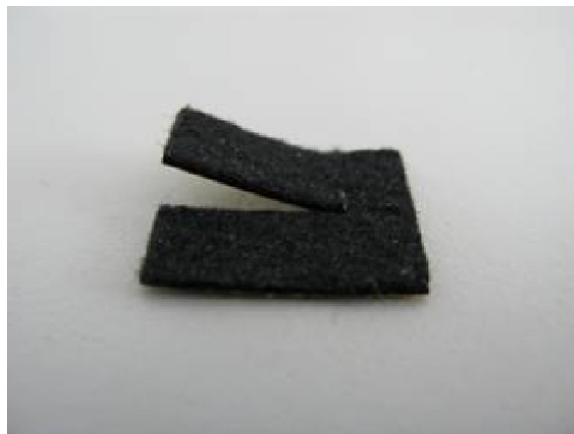
Figure 2. Cutting felt.

3. On the short side cut into the felt pieces to approximately half the length (Figure 2)

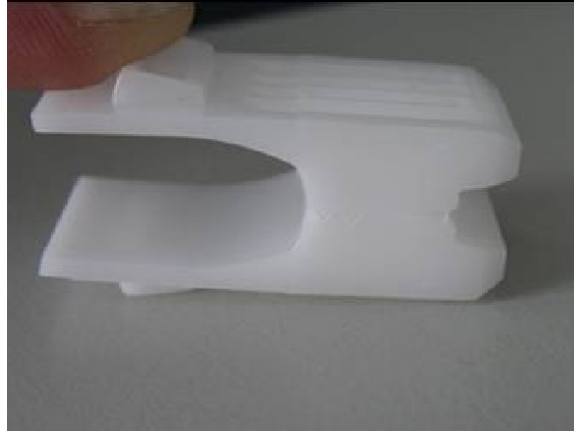
Figure 3. Mounting held together before installing felt.

4. While holding the mounting (part number: **1K0 721 357 A**) closed (Figure 3), install felt strip onto both sides of mounting.

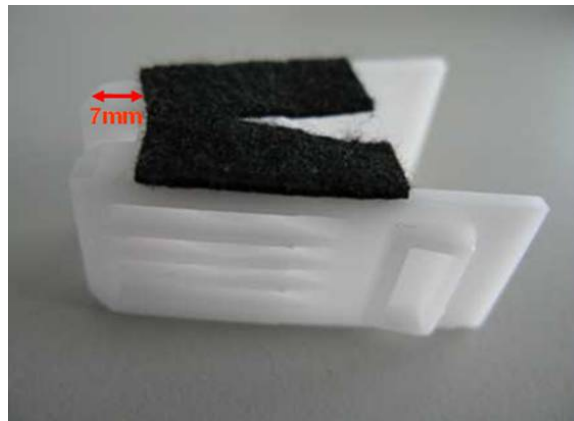
Figure 4. Distance of felt installed from end.

Tip: Figure 4 shows the relaxed condition of the mounting.

5. Install the felt a distance of 7 mm from tip on the depressed mounting on both sides. (Figure 4).
