Service Bulletin

Bulletin No.: PI0488D

Subject: Diagnostic Information for Transmission No Forward, No Reverse, Slips, Cracked/Split Fluid Filter

Models: 2010-2014 Cadillac CTS-V, Escalade Models
2010-2013 Chevrolet Avalanche
2010-2014 Chevrolet Camaro, Corvette, Express, Silverado, Suburban, Tahoe
2011-2014 Chevrolet Caprice PPV
2014 Chevrolet SS
2010-2014 GMC Savana, Sierra Models, Yukon Models
Equipped with 6L80 or 6L90 6-Speed Automatic Transmission (RPO MYC or MYD)

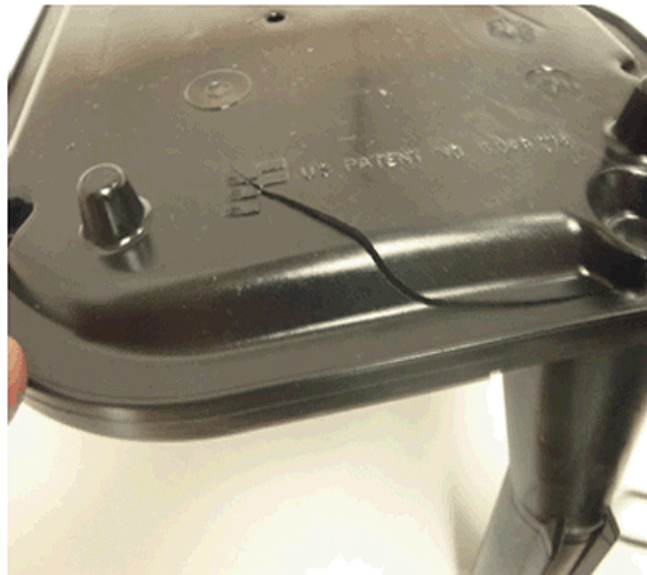
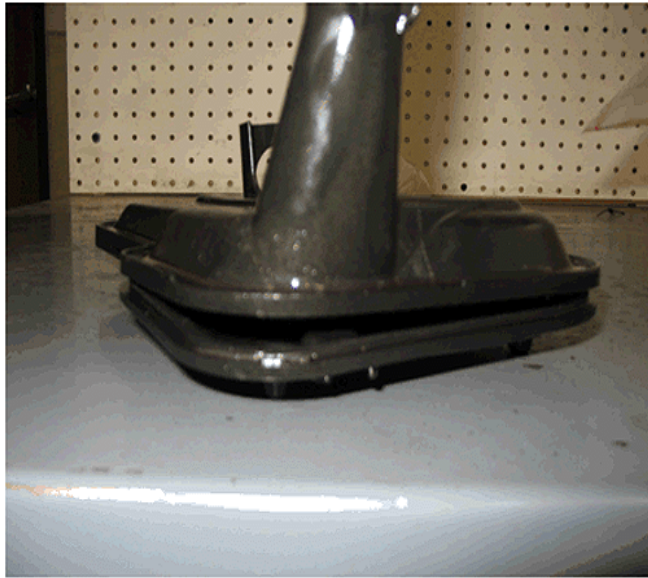
2665171

When diagnosing a confirmed condition of no forward or no reverse or slipping, be sure to thoroughly visually inspect the transmission fluid filter assembly. The filter may be cracked or split as shown in the photos below.

Testing and analysis of transmissions found to have split or damaged filters has shown that this condition may be caused by a damaged pump.

A damaged pump can send a high pressure fluid spike down the filter neck on a cold start, resulting in the filter body cracking or the filter seam splitting.

The filter is not defective and this is not a filter quality issue.

If a cracked or split filter is found, the fluid pump should be disassembled and inspected for possible damage.

Inspect for any of the following conditions:

- Scored pump rotor or pump vanes
- Scored pump cover or pump rotor pocket
- Cracked pump slide

The transmission should also be evaluated for any possible distress to the clutches.

Important: Do not replace the filter without inspecting the pump. Failure to inspect the pump and clutches could lead to a repeat condition.
