Service Bulletin

Bulletin No.: PI0488C

Subject: Diagnostic Information for Transmission No Forward, No Reverse, Slips, Cracked/Split Fluid Filter

Models: 2010-2013 Cadillac CTS-V, Escalade Models
2010-2013 Chevrolet Avalanche
2010-2013 Chevrolet Camaro, Corvette, Express, Silverado, Suburban, Tahoe
2010-2013 GMC Savana, Sierra Models, Yukon Models
Equipped with 6L80 or 6L90 6-Speed Automatic Transmission (RPO MYC or MYD)

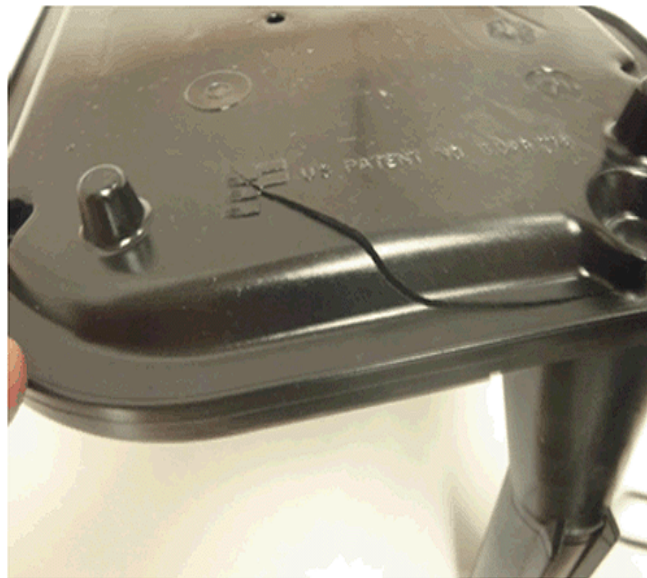
When diagnosing a confirmed condition of no forward or no reverse or slipping, be sure to thoroughly visually inspect the transmission fluid filter assembly. The filter may be cracked or split as shown in the photos below.

Testing and analysis of transmissions found to have split or damaged filters has shown that this condition may be caused by a damaged pump.

A damaged pump can send a high pressure fluid spike down the filter neck on a cold start, resulting in the filter body cracking or the filter seam splitting.

The filter is not defective and this is not a filter quality issue.

If a cracked or split filter is found, the fluid pump should be disassembled and inspected for possible damage.

Inspect for any of the following conditions:

- Scored pump rotor or pump vanes
- Scored pump cover or pump rotor pocket
- Cracked pump slide

The transmission should also be evaluated for any possible distress to the clutches.

Important: Do not replace the filter without inspecting the pump. Failure to inspect the pump and clutches could lead to a repeat condition.
