# Tech Tips

TT 37-12-04

## 2011-2013 Touareg – Correct Vacuum Line Connections at Coolant Shut-Off Valve N82 and Change Over Valve N180

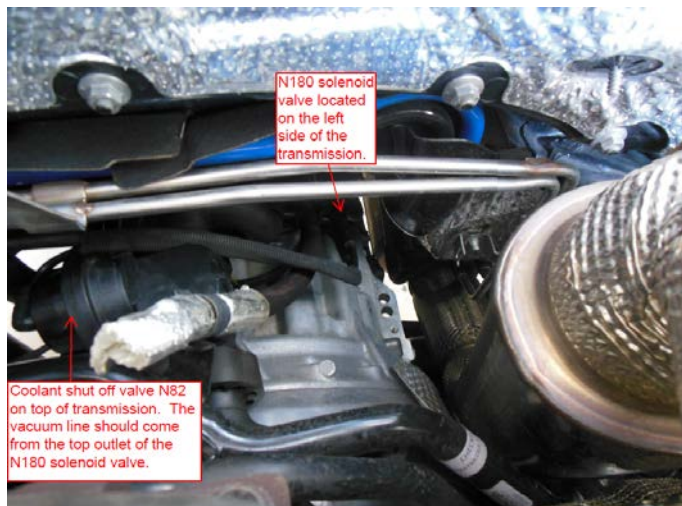
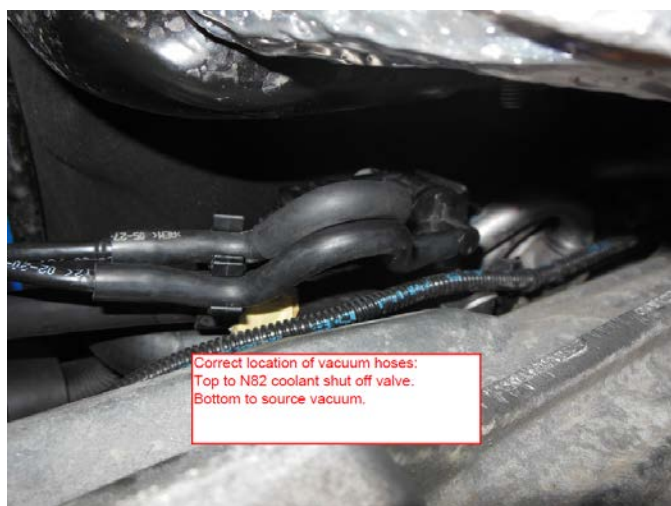
After completing repairs that require removal of the vacuum lines at coolant shut off valve N82 and change over valve N180, ensure vacuum lines are correctly reinstalled. At the N180, source vacuum must be connected to the bottom connection and the vacuum line to the N82 must be connected to the upper connection.
