Service Bulletin

Bulletin No.: 15-NA-019

Subject: Fuel Odor During Fuel Filling or During Idle, Possible P0442 or P0455 DTCs Set

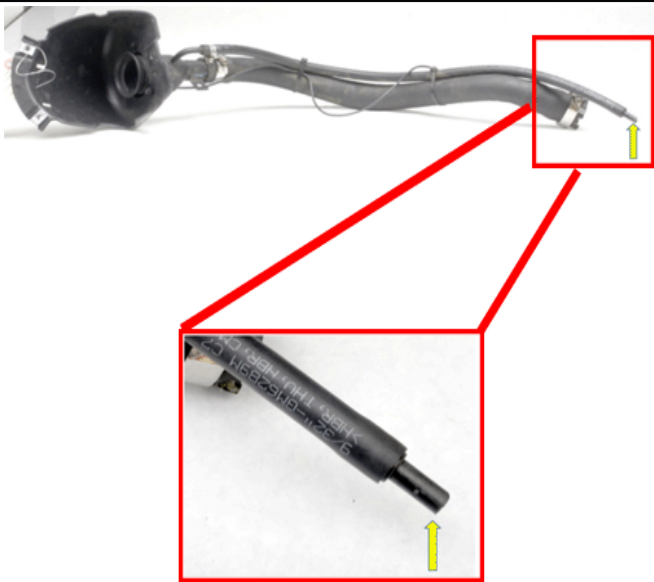
Condition	Some customers may comment on a strong fuel odor during fuel filling or during vehicle idle.
Cause

<p style="text-align: right;">4283370</p> <p>This may be caused by the fracture or breaking of the gasoline filler neck recirculation line connector.</p>

1. Raise the vehicle and visually inspect the fuel tank filler vent hose connector for damage. Refer to Lifting and Jacking the Vehicle in SI.
 - If connector is damaged, replace the fuel tank filler vent hose. Refer to Fuel Tank Filler Vent Hose Replacement in SI.
 - If there is no damage to the connector, continue diagnosis referring to SI.
