Service Bulletin

SUBJECT: Special Coverage Adjustment – Cracked Fuel Tank Inlet Control Valve

**MODELS: 2006-2008 Chevrolet Cobalt
2006 Pontiac Pursuit, G4
2007-2008 Pontiac G5
2006-2007 Saturn ION**

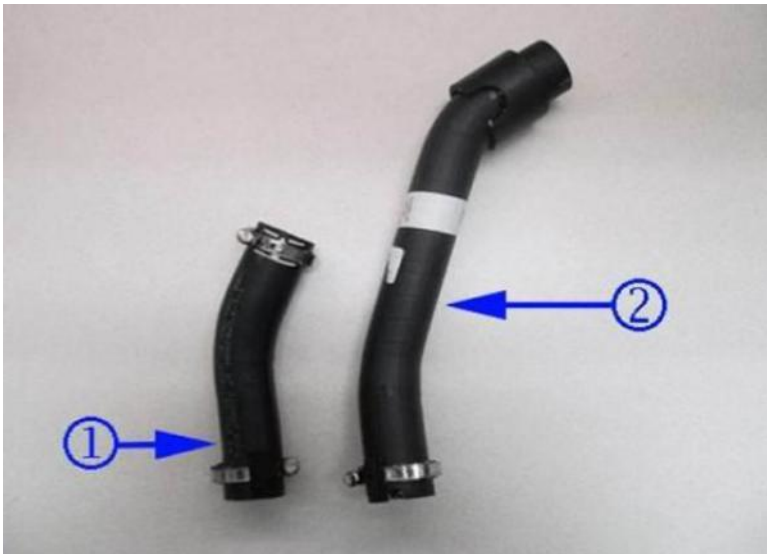
4109439

2. Match the new hose (2) to the original (1), aligning side by side.

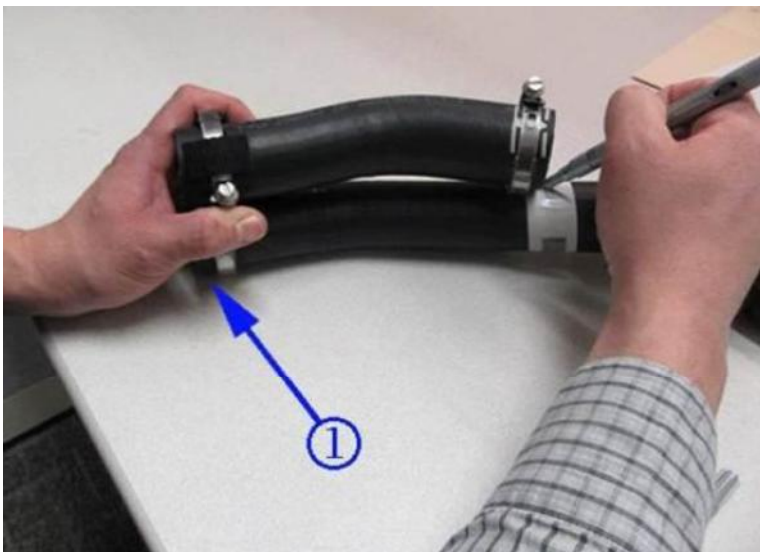
4109445

3. Using a paint pen or equivalent, mark the new hose to the original, starting with the notched fuel tank ends of the hoses so that both hoses are the same length.

Note: When cutting the hose, be sure the cut is as straight as possible. Use a hose clamp or tape as a guide. Failure to cut the hose straight could result in leaks.

4. Cut the hose **from the fill end** opposite of the side with the notch (1) to match the length.
5. Transfer the clamp on the newly cut hose.
6. Install the new trimmed hose to vehicle mounted fill pipe, and to the tank.
