**February 6, 2016**

02790 Version 3

## Product Update: 2016 HR-V Front Passenger's Door Handle Bracket

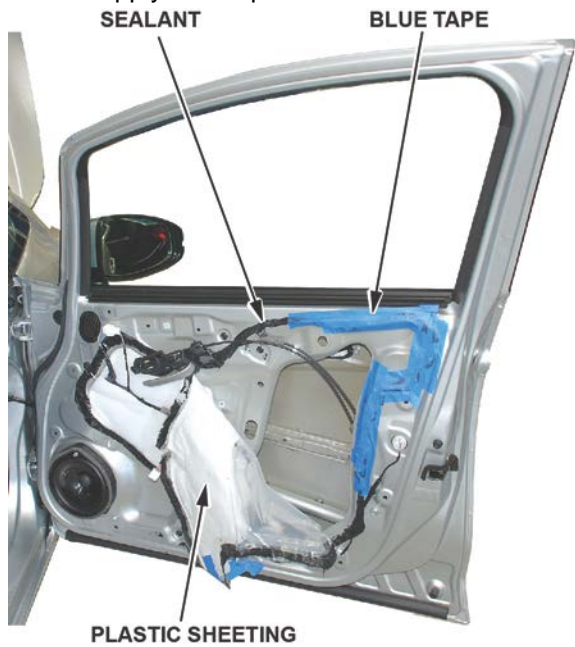
2. Remove the plastic sheet as needed to access the door handle area.

NOTE: Apply blue tape over the sealant to avoid making a mess.

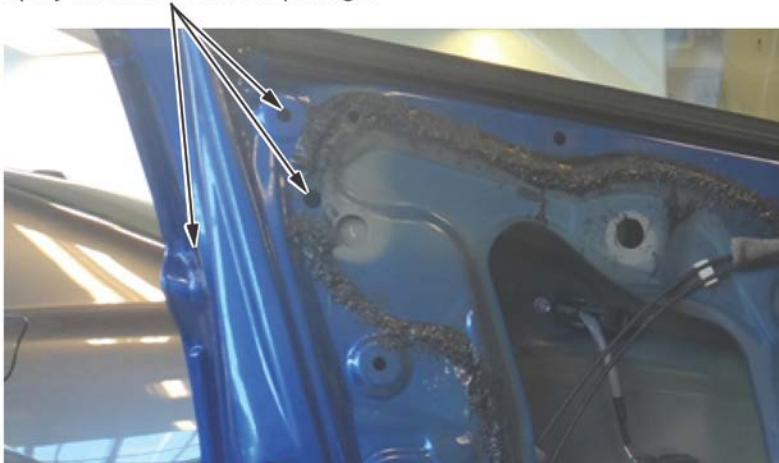
Spray Nox-Rust in these openings.

Apply Nox-Rust behind door handle mechanism.

6. Spray the front passenger's inner door area around the door handle with Nox-Rust. Also have an assistant pull on the door handle to make sure the Nox-Rust covers the area behind the mechanism.

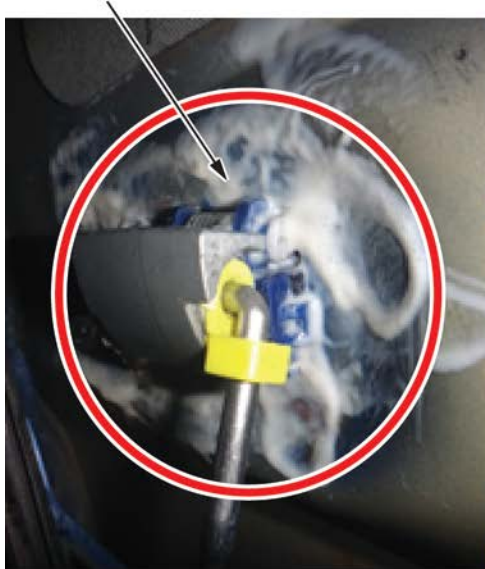
Make sure to hold the door handle against the door.

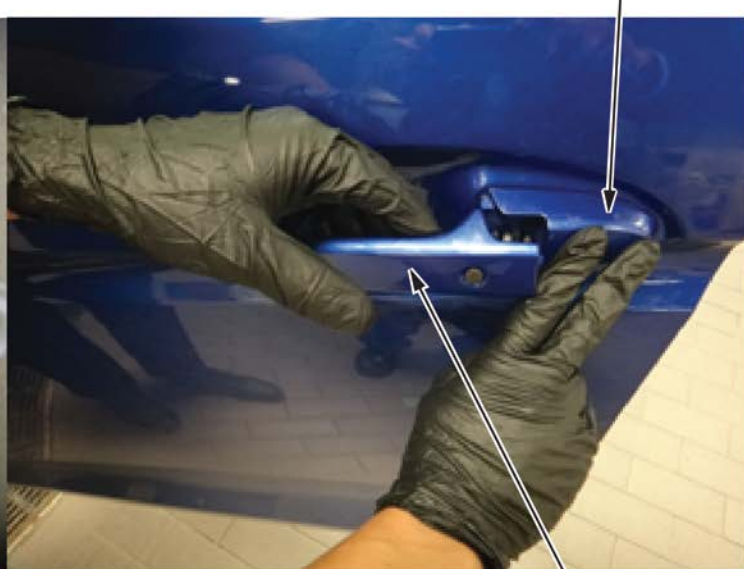
Have an assistant open the door handle.

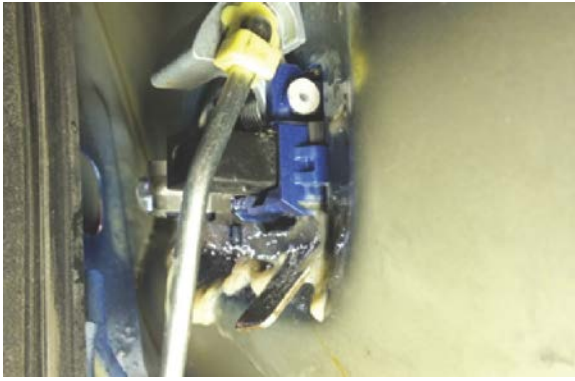
8. Reinstall the bolt and body plug. Torque the bolt to **9.4 N·m (6.9 lb-ft)**.
9. Apply a second coating or Nox-Rust to the assembled components.

**NOTE:** Avoid spraying Nox-Rust onto the door handle mechanism. **Also avoid spraying heavy amounts of Nox-Rust.**

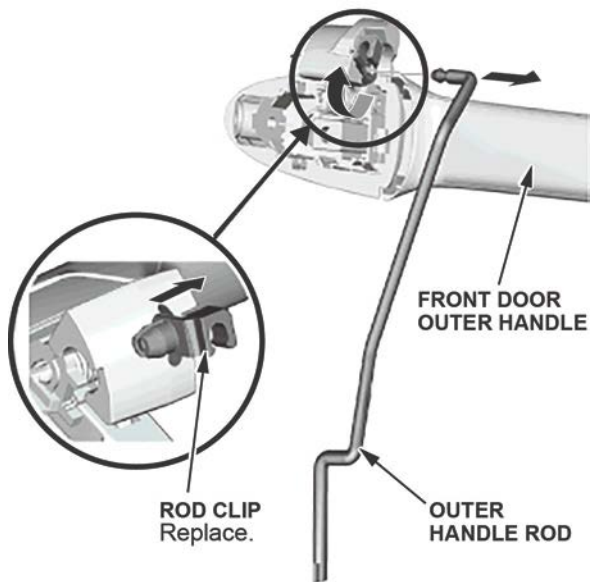
3. Replace the rod clip with a new one.

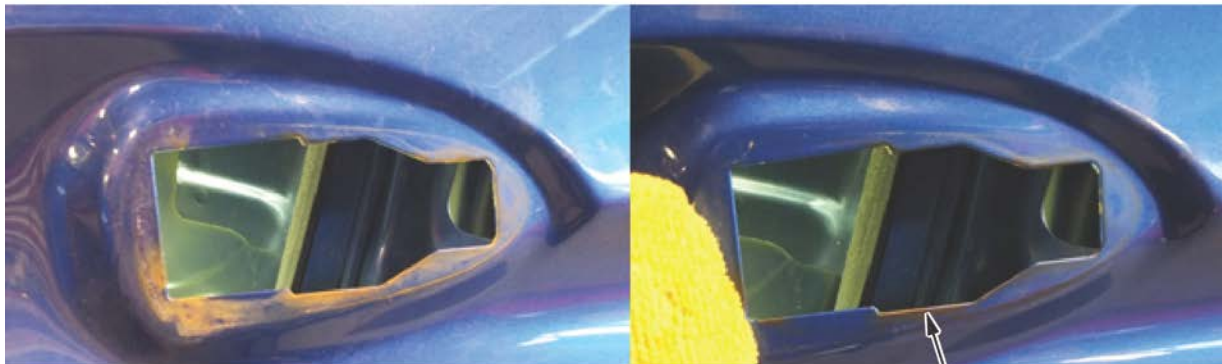
4. If there is any corrosion on the outer door skin, remove it with a soft damp cloth.

**BEFORE**

**AFTER**

A small amount of corrosion is OK.

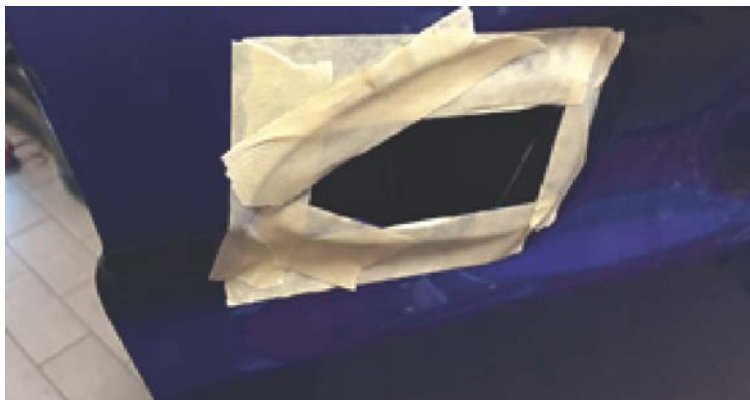
5. Use masking tape to tape the outside door around the handle area as shown to prevent scratching the clear coat.

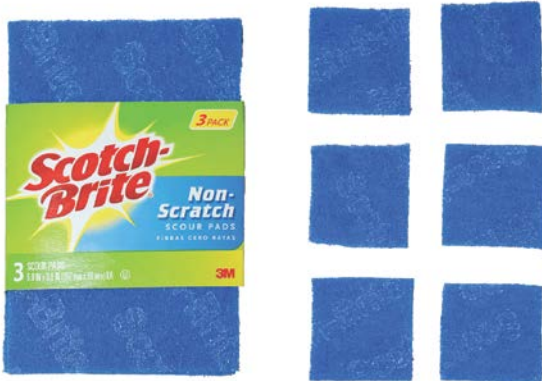
## **“CLEANING THE CORROSION” VIDEO**

6. Remove the corrosion from the inner door using a 1-inch square piece of Scotch-Brite pad.

- Only use the recommended Scotch-Brite pad. Using any other pad or cleaner could remove the protective layer on the inside of the door.
- The door can be cleaned from either the inside or outside.

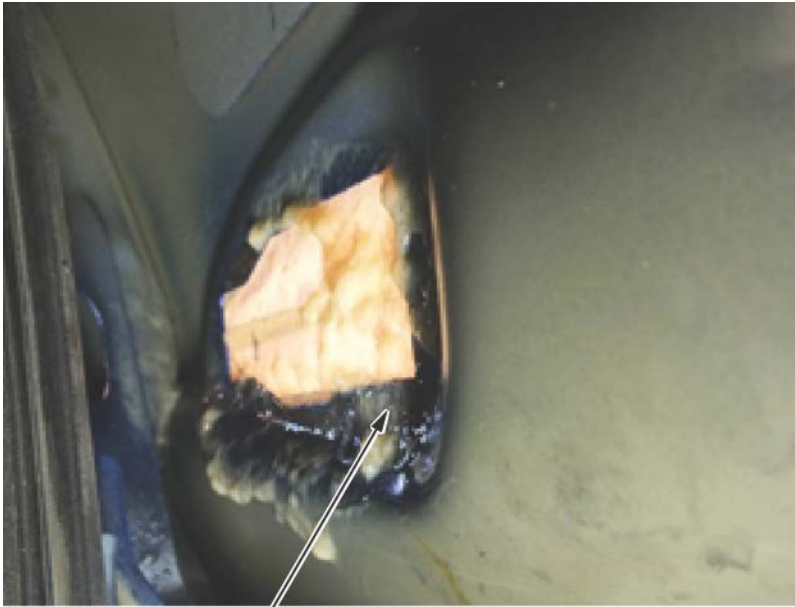
8. Spray the inner door area around the door handle and the new door handle bracket with Nox-Rust.

Apply Nox-Rust before reinstalling the door handle.
