APPLICABILITY: 2015MY WRX and STI Models **NUMBER:** 09-57-14
SUBJECT: Fuel (Gasoline) Filler Door (Flap) Does Not Open **DATE:** 06/11/14

This bulletin provides new part number information along with a service procedure to address a customer concern of the fuel filler door not opening when lifting the interior release lever.

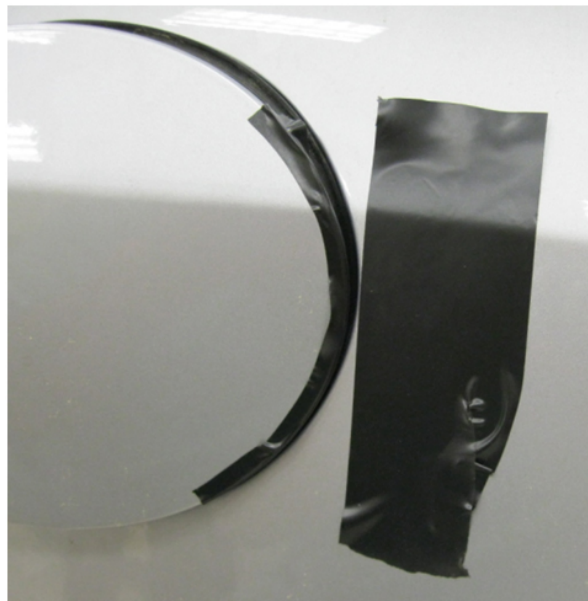
- Apply protective tape to the edge of the fuel filler door and the vehicle body to protect the finish as shown in the photo below.

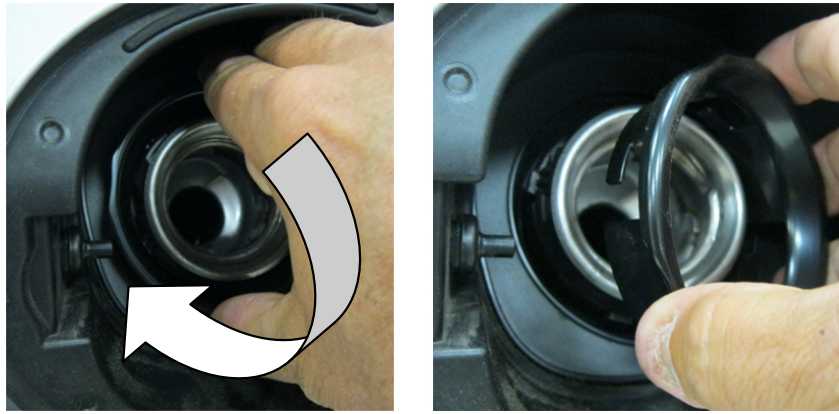
- Remove the fuel filler pipe protector (lock ring) by turning it **CLOCKWISE**.

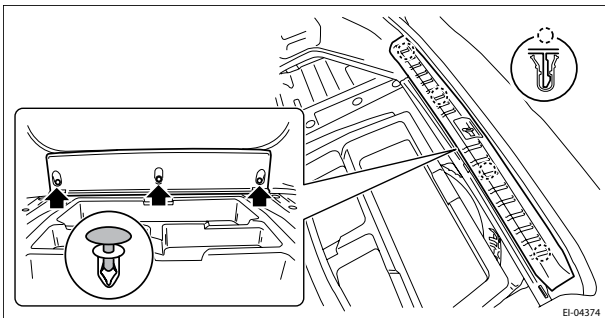
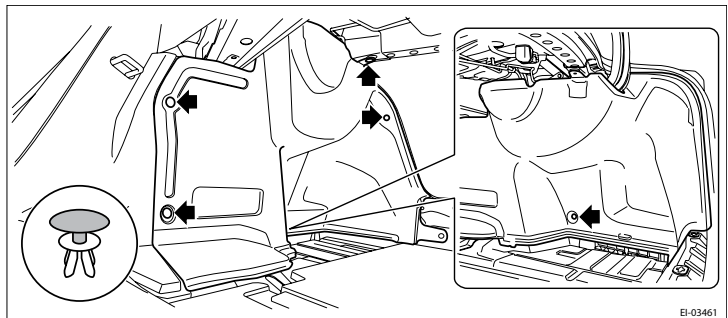
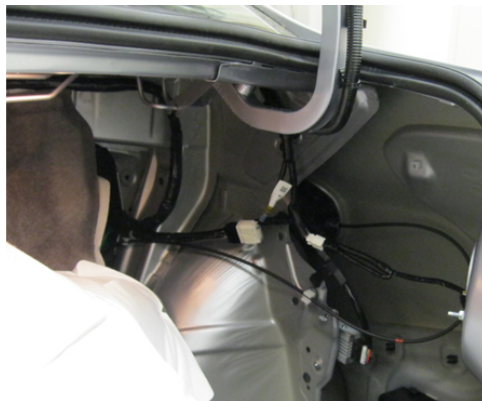
- CAREFULLY** remove the retaining clips as necessary from the trunk threshold trim and the inner liner as shown in the illustrations below to provide access to the back side of the fuel filler area.

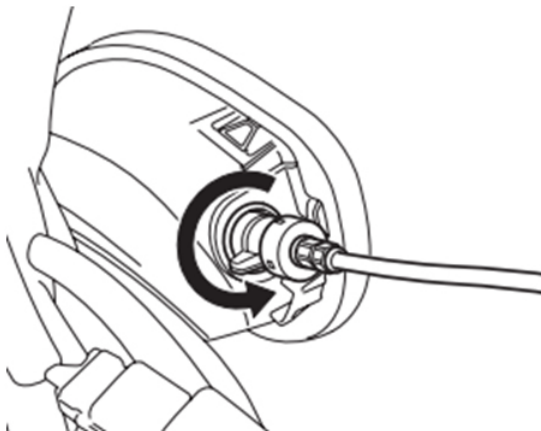
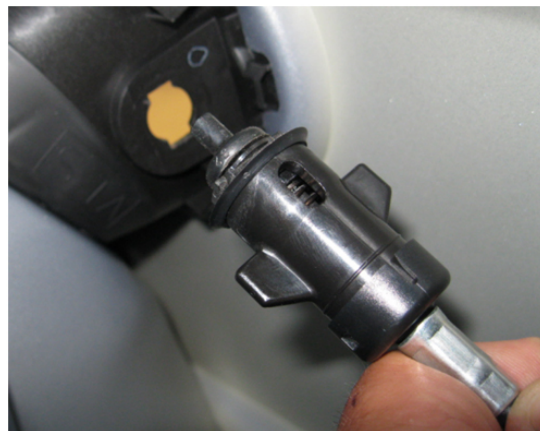
- As shown in the illustration below, rotate the housing of the fuel door release latch **COUNTER-CLOCKWISE** and remove it from the assembly.

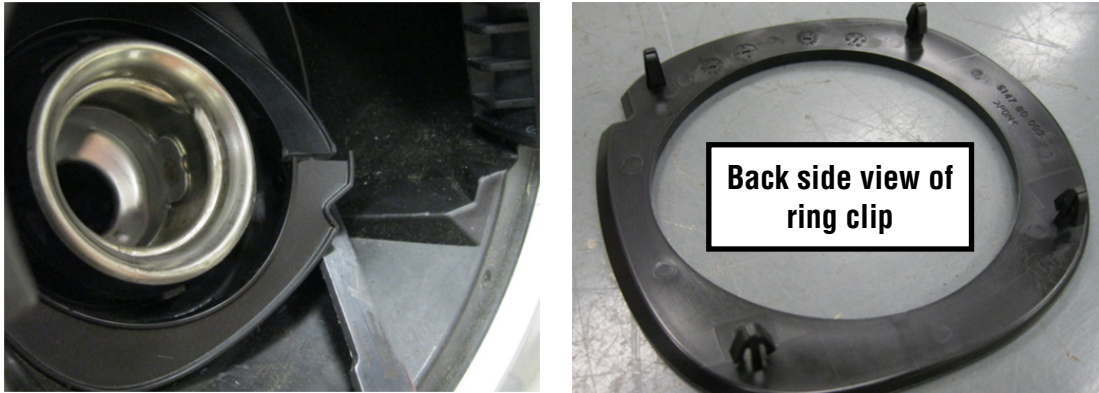
- Using a trim clip removal tool (or equivalent), pry up and remove the ring clip surrounding the fuel filler neck. There are 4 clips securing the ring clip. This part is a one-time use item as it will be broken during removal as shown in the photo below. **REMINDER:** Always take proper precautions to protect the vehicle's finish.

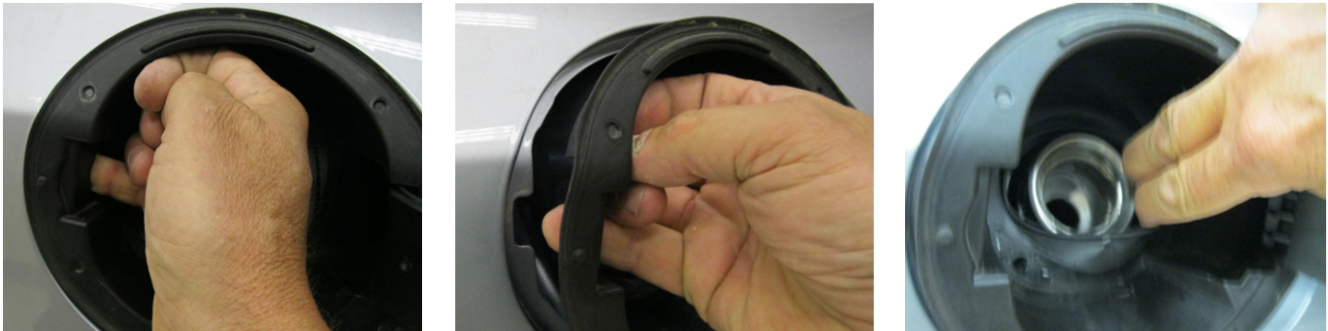
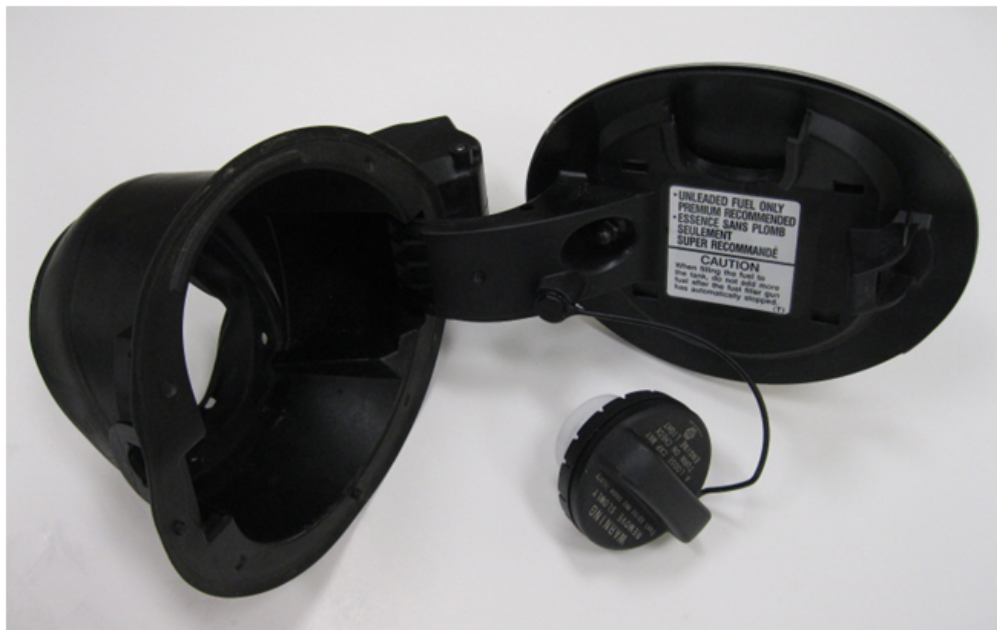
- Once the ring clip is removed, the fuel filler door assembly is ready to remove. Using a finger in the latch hole, pull the rear part of the assembly toward you to dislodge it from the body. Once loose from the body, use another finger or a plastic trim tool to “unhook” the rubber insert portion from the front of the filler neck then remove completely as shown below.

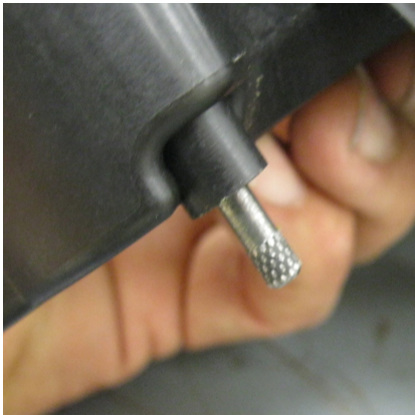
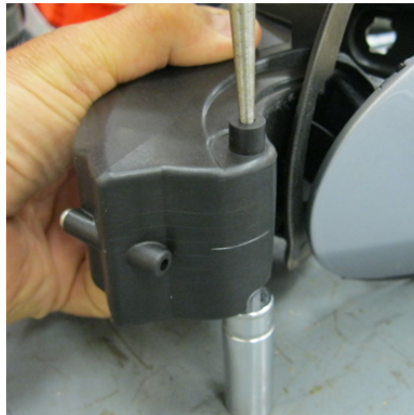
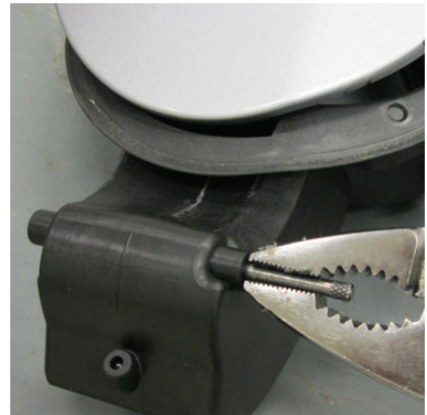
- Using a small punch and a hammer, tap the hinge pin out from the bottom. The top of the hinge pin is knurled to keep it in position. A socket is used for support while removing the pin. (The assembly is upside-down in the photo below.) Once the pin is partially removed, use a pair of pliers to remove it completely as shown in the sequence below.

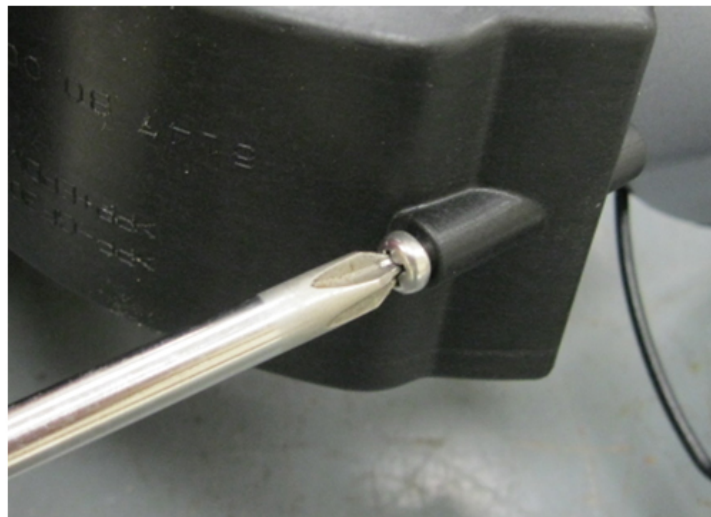
- Remove the Phillips-head tapping screw. With the hinge pin and the screw removed, the fuel filler door can be removed from the housing portion of the assembly.

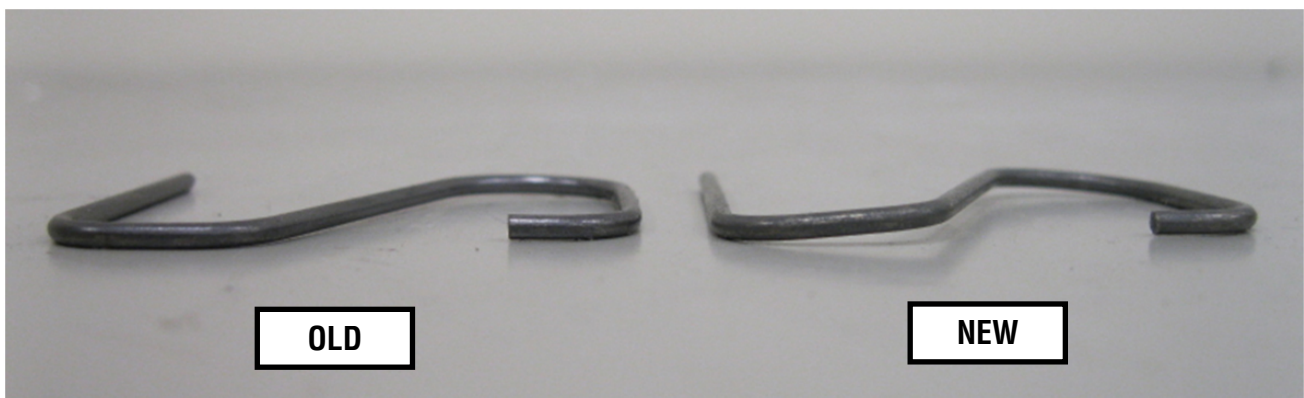
- The photo below shows the difference between the old and the new spring. The new spring has a slight curvature to it while the old spring is flat.

NOTE: The repair set includes a revised spring and a new ring clip. The ring clip is a **one-time use part**.

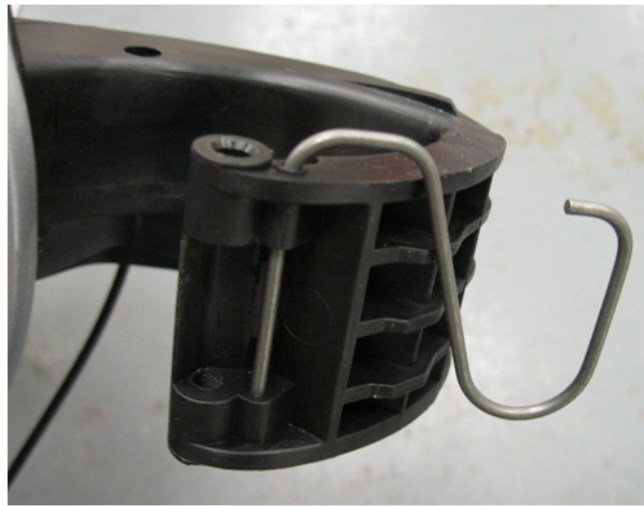
- Start reassembly by installing the new spring onto the fuel filler door as shown below.

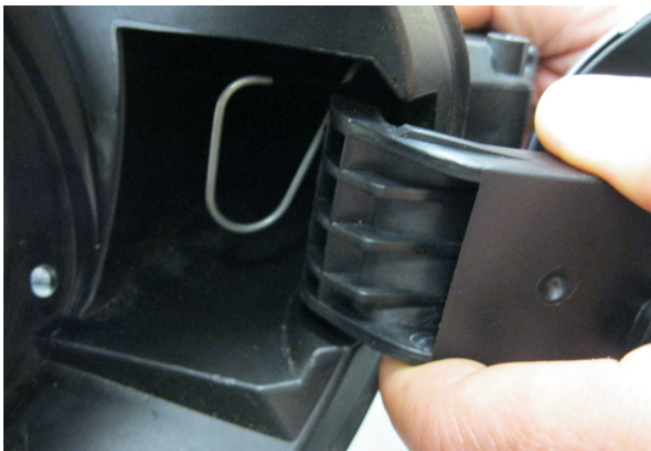
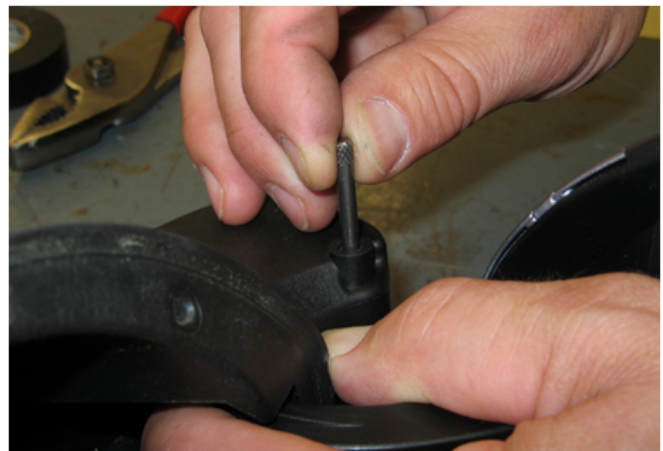
- Install the filler door back into the housing assembly then reinstall the hinge pin. The knurled portion goes in last to hold it in position.

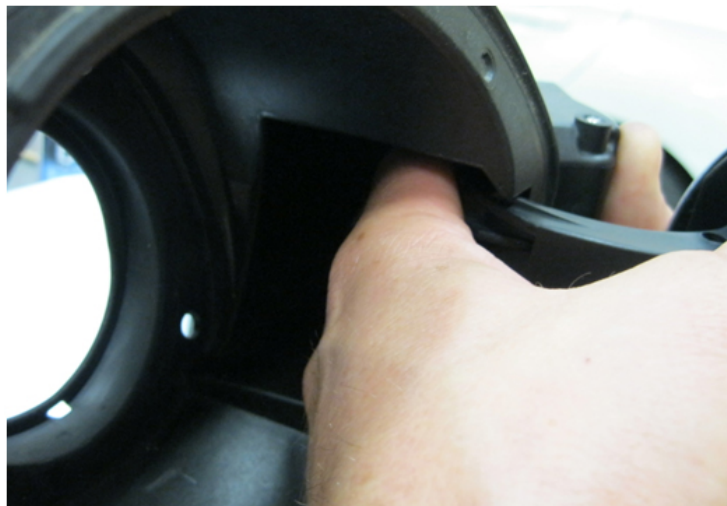
- After the pin is fully seated, use 2 fingers to push the spring all the way back into the housing. You will hear an audible “click” sound when it snaps into proper position.

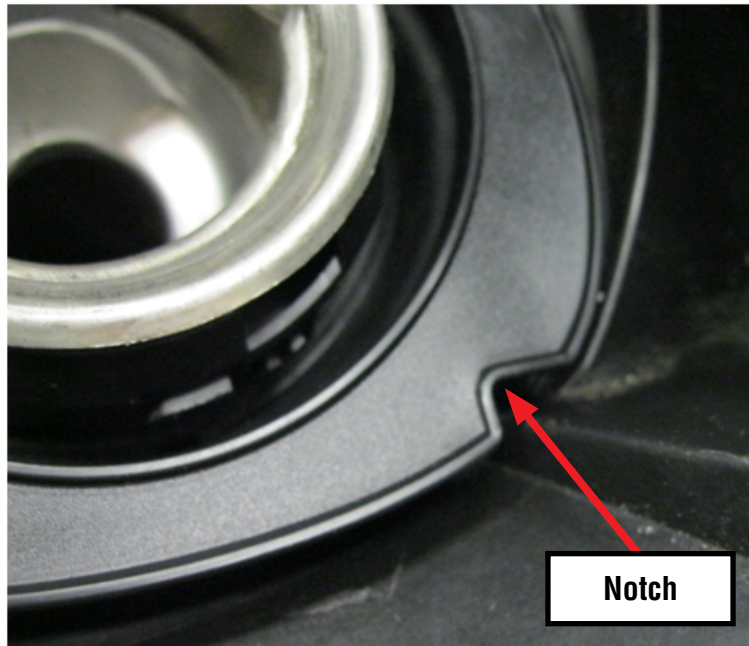
- Once the spring clicks into position, replace the Phillips-head tapping screw. Operate the filler door a few times to confirm it is working properly before reinstalling the assembly back into the vehicle.
- Once the assembly is back in position, secure it in place using the new ring clip. The ring clip can only be installed one way. Make sure the notch is positioned as shown below then make sure all 4 retaining clips lock into position properly.

- The remainder of the reassembly is in the opposite order of disassembly.
- Confirm proper operation of the fuel filler door release to complete the procedure.
