Front Brake Vibration

YEAR(S)	MODEL(S)	ADDITIONAL INFORMATION
2011 – 2016	Sienna

Some 2011 – 2016 model year Sienna vehicles may exhibit a vibration/pulsation from the front brakes that can be felt in the brake pedal while lightly applying the brake pedal. New front brake pads and a new field fix repair procedure have been developed to improve this condition.

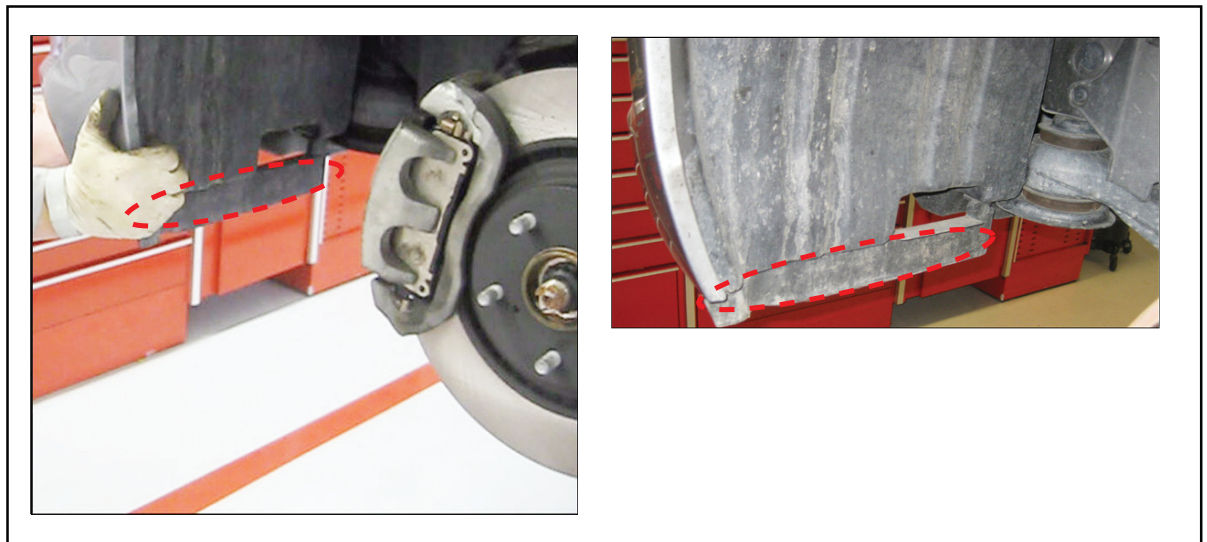
Figure 1.

- A. Locate Front Wheel Opening Extension Pad.

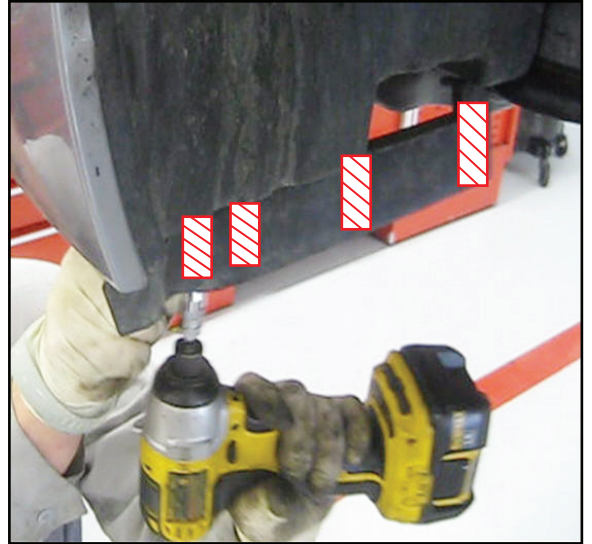
- B. Remove 4 bolts and remove the extension pad. **Figure 2.**

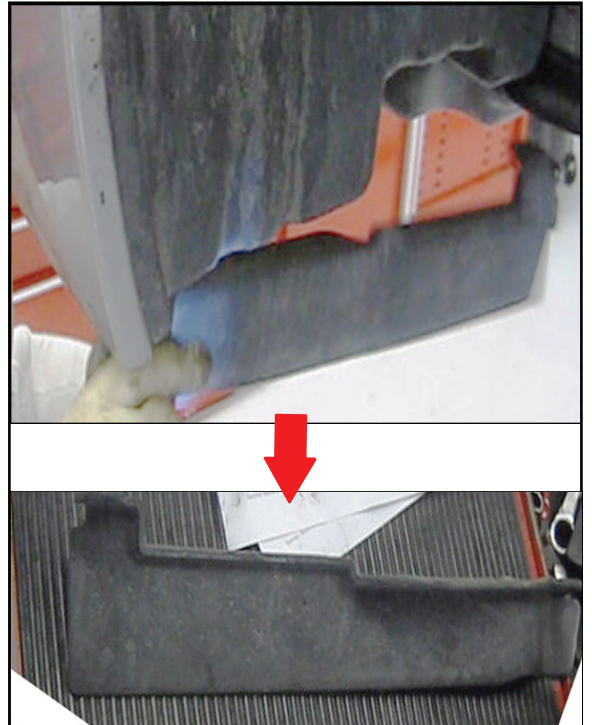
Figure 3.

- C. Place the extension pad on a flat surface for modification.

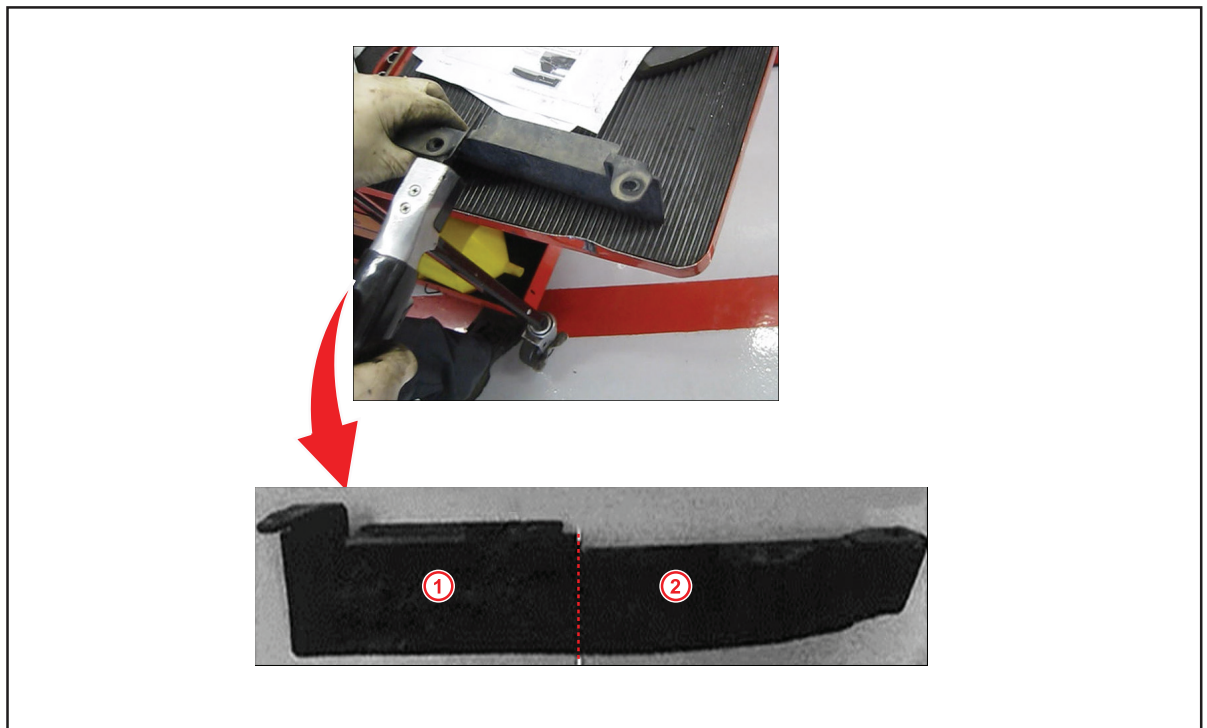
Figure 4.

D. Using a power saw, cut at location specified.

- It is recommended to draw a straight line where the cut will be made.
- Callout 1 in Figure 4 should be discarded.

1	Discard
----------	---------

2	Reinstall On The Vehicle
----------	--------------------------

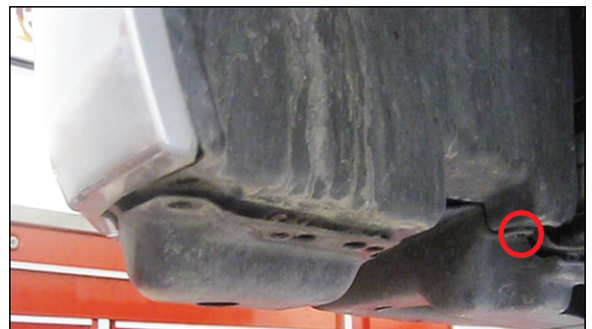
E. Install the modified extension pad back on the vehicle and reinstall the 4th remaining bolt to the original location as referenced in Figure 5.

Make sure modification is completed on both sides.

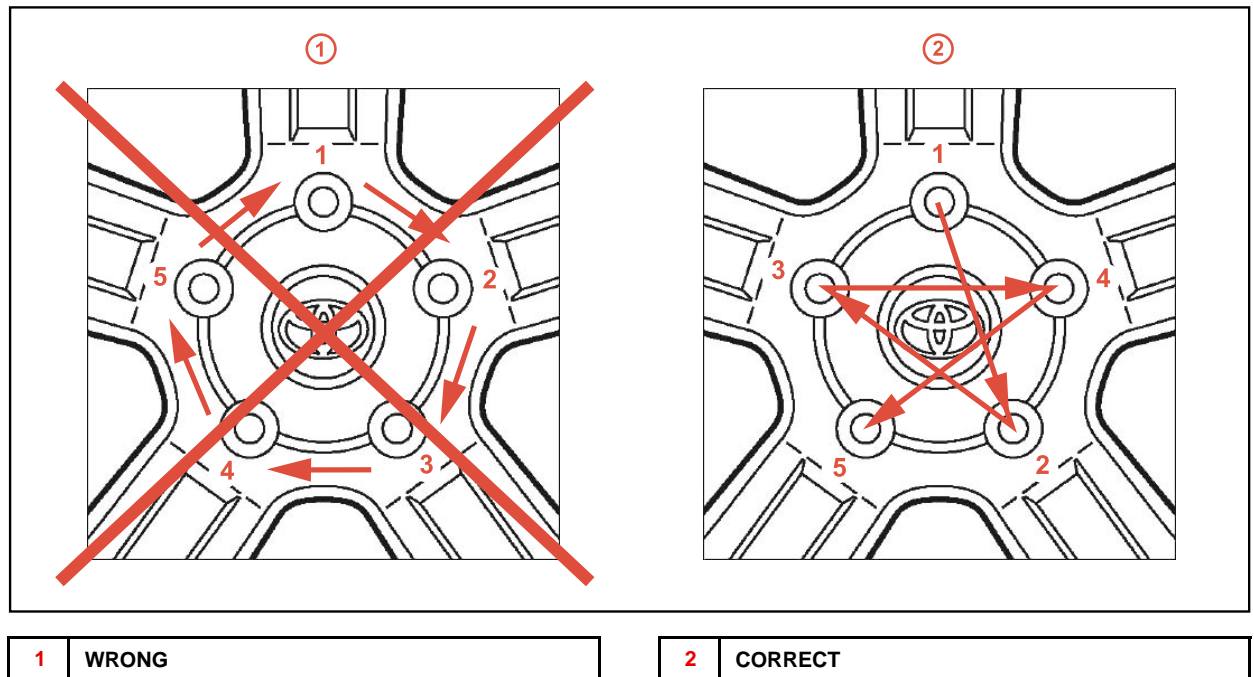
Figure 6.

3. New rotor **MUST** be phase matched to the hub assembly.
 - A. Mount rotor onto hub assembly and note the starting lug position.
 - B. Measure the runout of the hub and rotor assembly at the outermost point of rotor surface and record the runout measurement.
 - C. Rotate rotor clockwise on hub to the next lug position.
 - D. Repeat step B at each lug position.
 - E. Rotor position will be determined based on the lowest runout measurement obtained.
Max Runout Allowed: 0.05 mm (0.00197 in.)
4. Replace the original brake pads with newly developed brake pads and Shim Kit.
5. Install the front wheel and torque to specification using the correct tightening sequence.
Torque: 103 N*m (1050 kgf*cm, 76 ft*lbf)

NOTICE
 Do **NOT** use an impact gun to tighten the lug nuts, use a torque wrench and follow the correct sequence to tighten the wheels.
