| TSB140019 |

Technical Service Bulletin

Fuel Pump - Ceramic Plunger and Tappet Roller Inspection and Repair

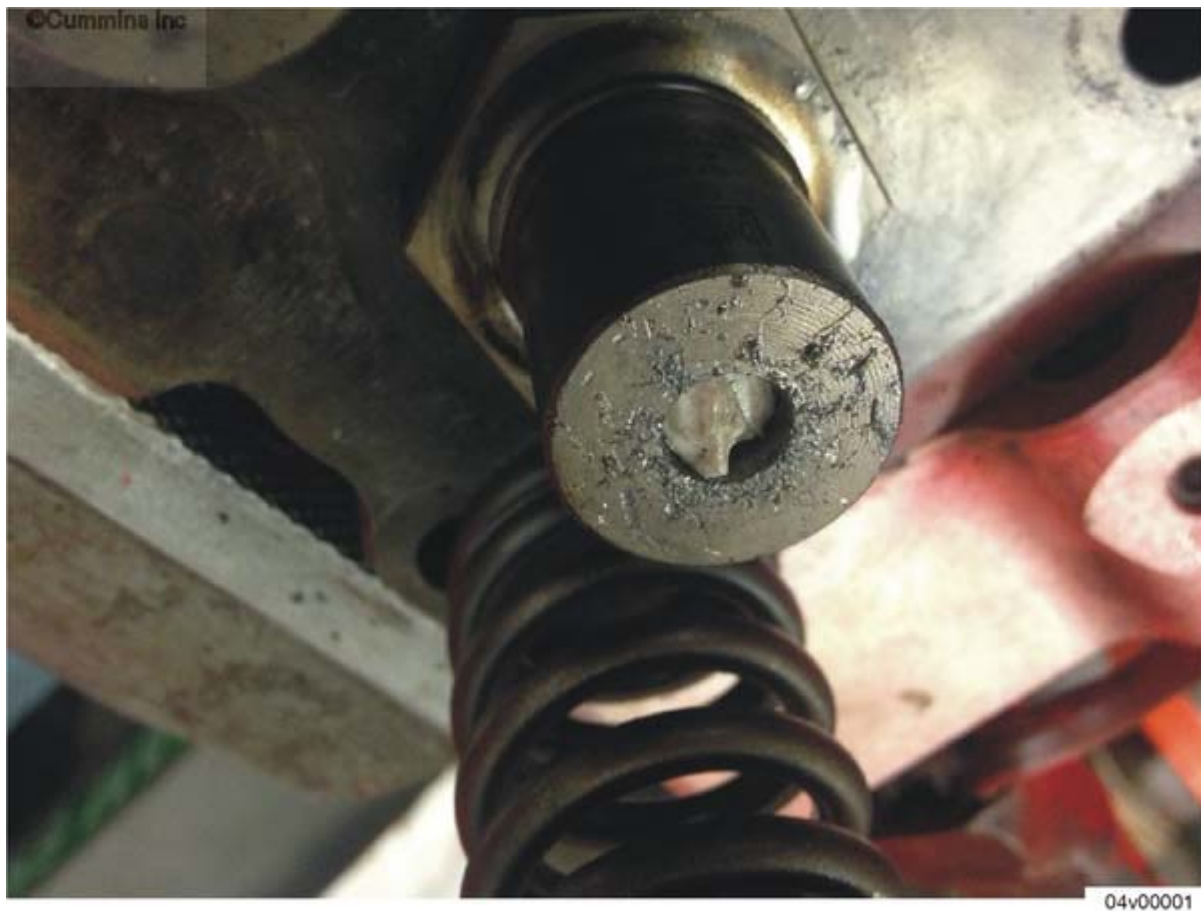
Figure 1, Fractured Fuel Pump Ceramic Pumping Plunger.

This document, in conjunction with the information provided within the manuals listed in Table 1 provides inspection and repair guidelines following the malfunction of a fuel pump pumping plunger and/or roller tappet assembly.

Previous versions of this document provided specific repair directions according to the vintage of the fuel pump and type of pumping plungers. Repair directions have now been made common and apply to all fuel pumps regardless of vintage, pumping plunger type, or tappet roller assembly type.
