CCV Housing Inlet Tube, Replacement
 D11J
 VAH, VHD, VN

FSB 257-004, CCV Housing Inlet Tube, Replacement

(September 2016)

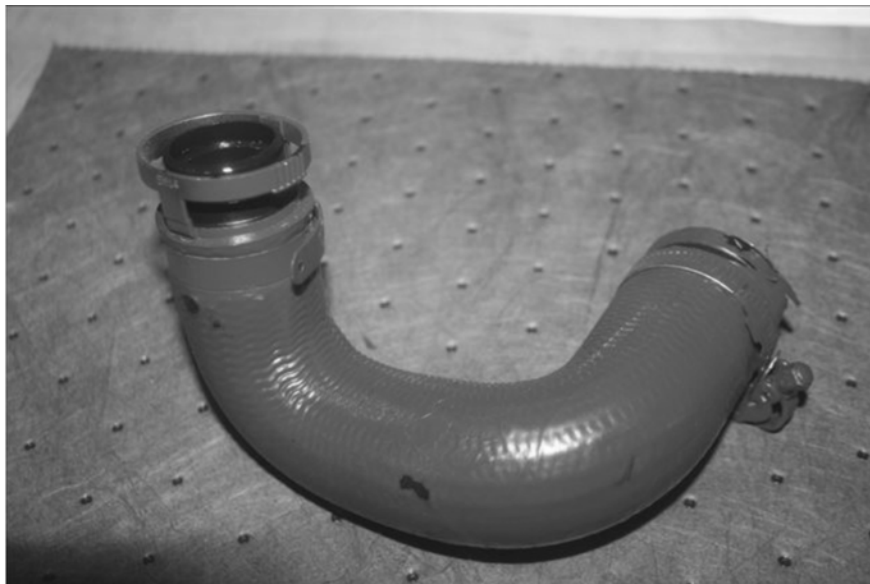
W2111722

VOLVO Trucks has received reports from the aftermarket regarding oil leaks at the CCV housing inlet tube and at the split line between the upper and lower housings on chassis builds between January 1, 2014 and January 26, 2016 with D11 engines. It has been determined that the O-ring installed on the inlet tube is the source of the leak and oil may leak down the back of the housing giving the impression that the housing split line is also leaking.

Should there be a report of this nature on a chassis built within the affected date range, do not disassemble the CCV. Replace the inlet tube with part number 22858729. Clean the surrounding area to complete the repair. If it is determined that there is a leak at the housing other than the inlet O-ring, the complete CCV assembly will need to be replaced as this is a non-serviceable part. Do not attempt to tighten the split line screws on the housing or disassemble the assembly as seals and repair parts are no longer available for this component as they were on the older version of this component. If the collar on the CCV inlet is worn or broken at the locking lip, replace the complete CCV assembly. Additionally, Replace the CCV to cylinder block gasket any time the CCV assembly is removed.

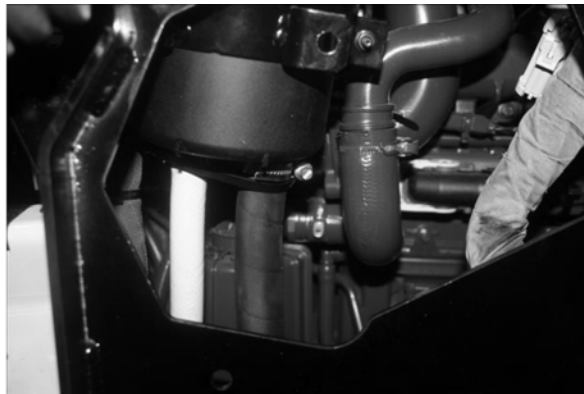
W2111721

- 3 Remove the formed rubber hose from the metal ventilation pipe coming from the valve cover.
