Cummins ISX Fuel Pump Campaign Discussion

March 26th 2015

Lube Oil Filter Head (LOFH) Bypass Valve Specifics

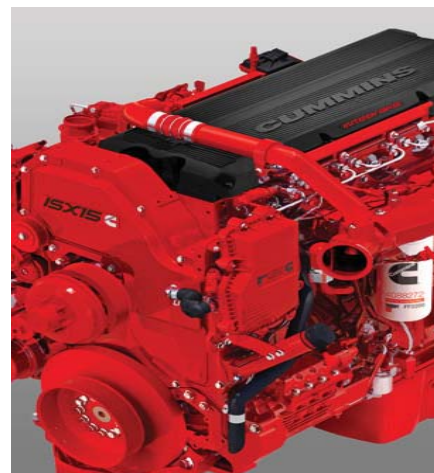
- Located on hot side of engine, within the oil filter housing.
- New design reduces leakage when closed.
- Precision molded and machined seat/plunger interface.

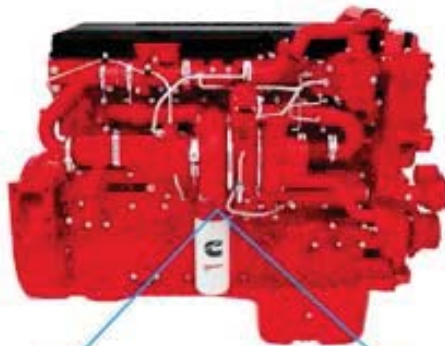
Old BPV Design

Plug, Spring & Valve

Injection molded polyetherimide
