TSB140019

ISX15 CM2250, QSX15 CM2250 ECF, ISX12 CM2250, and QSX11.9 CM2250 ECF Fuel Pump - Ceramic Plunger and Tappet Roller Inspection and Repair

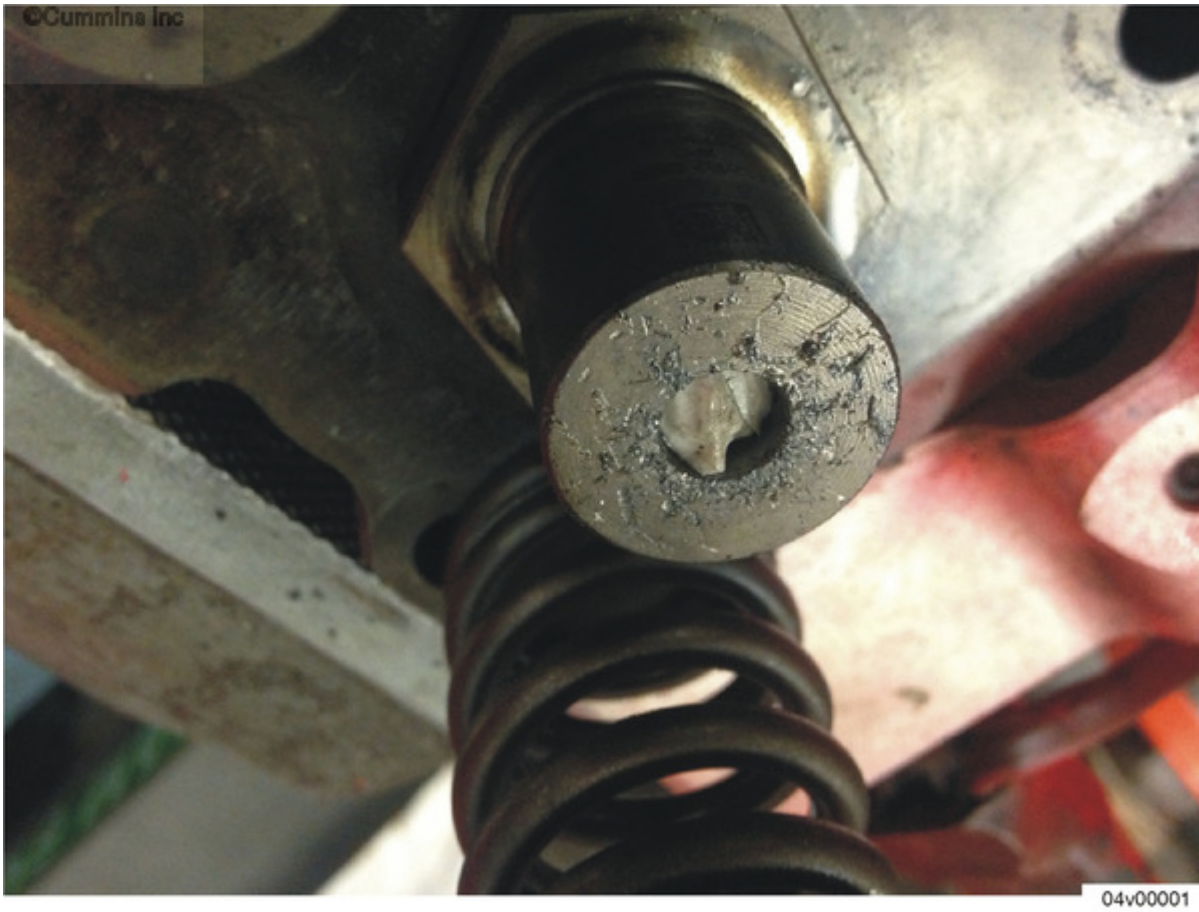
Figure 1: Fractured Fuel Pump Ceramic Pumping Plunger

This document, in conjunction with the information provided within the manuals listed in the table above, provides the inspection and repair practice when ceramic plungers are found to be fractured (see Figure 1) and/or tappet roller damage is found on fuel pumps with ceramic plungers (see Figure 2). Ceramic plungers can be identified by their white color. See Procedure 005-227 in the Associated Procedures Table for removal of the fuel pump head.

If the ceramic plungers are fractured (see Figure 1), but no damage is found on the fuel pump tappet rollers (see Figure 2), no further inspection is needed. Perform the following steps for the appropriate engine (ISX15 CM2250, QSX15 CM2250 ECF, ISX12/ISX11.9 CM2250, or QSX11.9 CM2250 ECF):

1. Replace the fuel pump. See Procedure 005-016 in the Associated Procedures Table.
 - a. For ISX15 CM2250 or QSX15 CM2250 ECF: Refer to TSB110064 (New Two-Cylinder High-Pressure Fuel Pump Assembly) if replacing a three-cylinder two-piston pump with a two-cylinder pump.
 - b. For ISX15 CM2250 or QSX15 CM2250 ECF: New fuel lines are required if replacing a fuel pump gear pump with bottom mount fuel lines. See Technical Service Bulletin, New Fuel Pump Gear Pump with Revised Fuel Line Locations, TSB130044.
2. Change the engine lubricating oil and lubricating oil filter. See Procedure 007-013 in the Associated Procedures Table.
