GROUP Body	MODEL 2014~2016MY Soul (PS), Soul EV (PS EV)
NUMBER 124	DATE December 2015

TECHNICAL SERVICE BULLETIN

SUBJECT: SERVICE ACTION: 2014~2016MY SOUL (PS) AND SOUL (PS EV)
REAR CENTER SEAT BELT WEBBING GUIDE REPLACEMENT (SA 206)

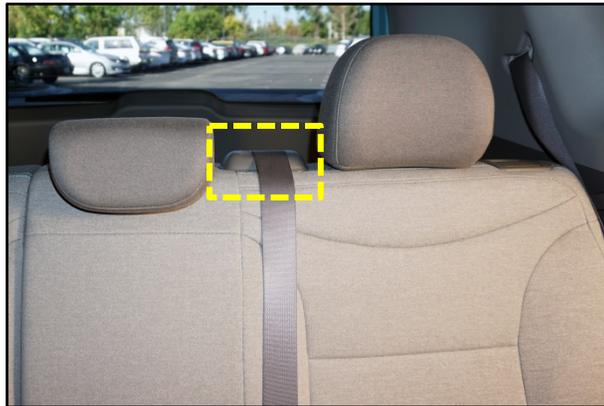
This bulletin provides the procedure for the replacement of the seat belt webbing guide for the rear center seat in 2014~2016MY Soul (PS) vehicles, produced from July 21, 2013 through September 15, 2015, and some 2014~2016MY Soul EV (PS EV) vehicles, produced from November 26, 2013 through September 03, 2015. Some customers have identified that the webbing in the subject Soul vehicles may twist in the webbing guide slot and interfere with the free movement of the belt. To address this concern, Kia is launching a Service Action to replace the rear center seat belt webbing guide with one that has a narrower slot.

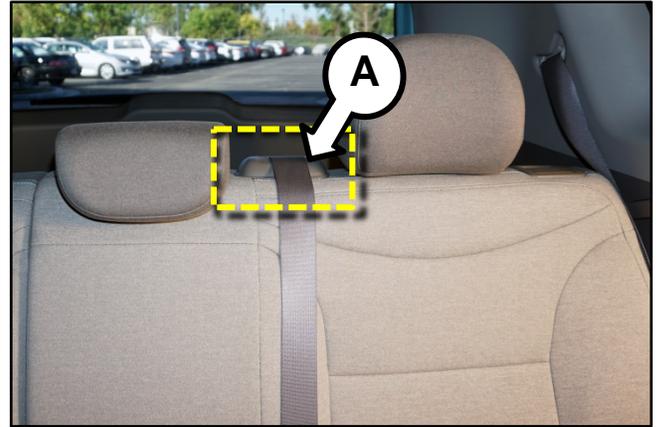
1. Locate the rear seat center seat belt guide cover (A), as shown.

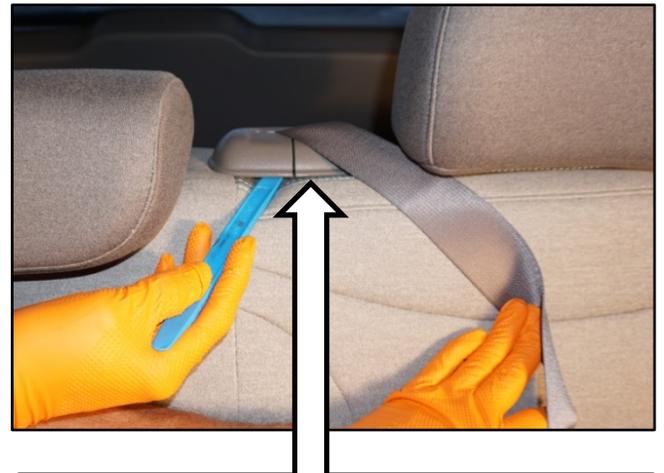
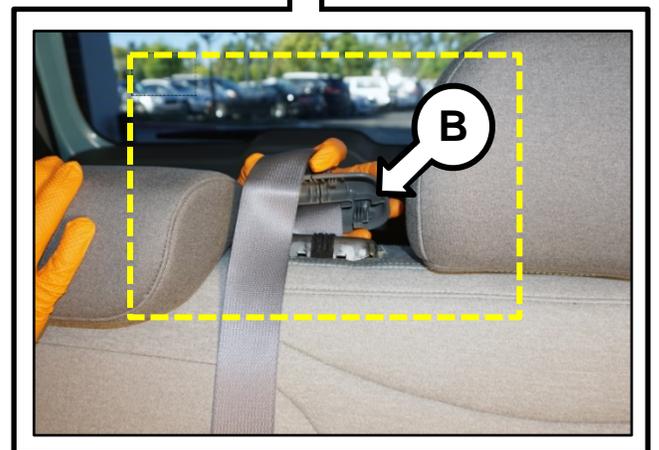
2. Remove the center seat belt guide cover (B) using a trim removal tool, as shown.

- Be sure to wear disposable gloves throughout this procedure to avoid soiling any interior trim components.
- Use a non-marring trim removal tool (such as Snap-on® P/N PBN5 or equivalent) to avoid damaging trim pieces.

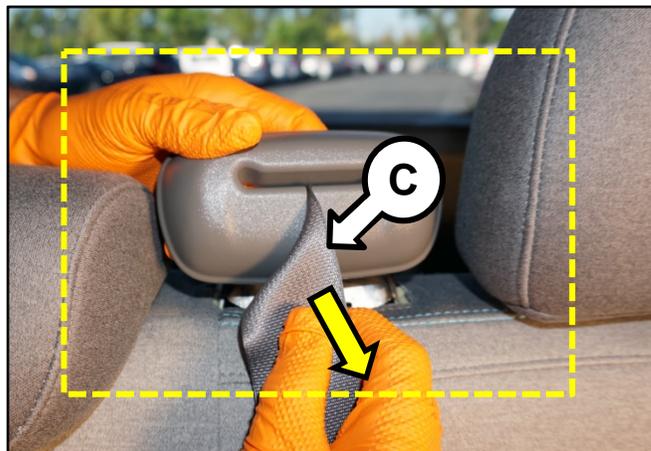
- Carefully pull the seat belt (C) through the slit in the center seat belt guide cover, as shown.

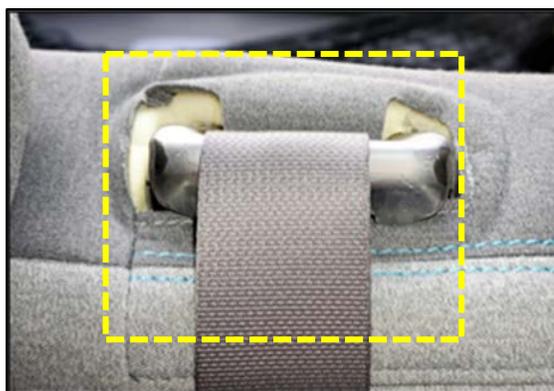
Prior to installing the replacement seat belt guide cover, make sure to correct any twists in the seat belt.

- Install the replacement seat belt guide cover by reversing the removal steps.
- Verify proper seat belt extension and retraction.
