### Multi-Model - Non-Reusable Part Service Caution

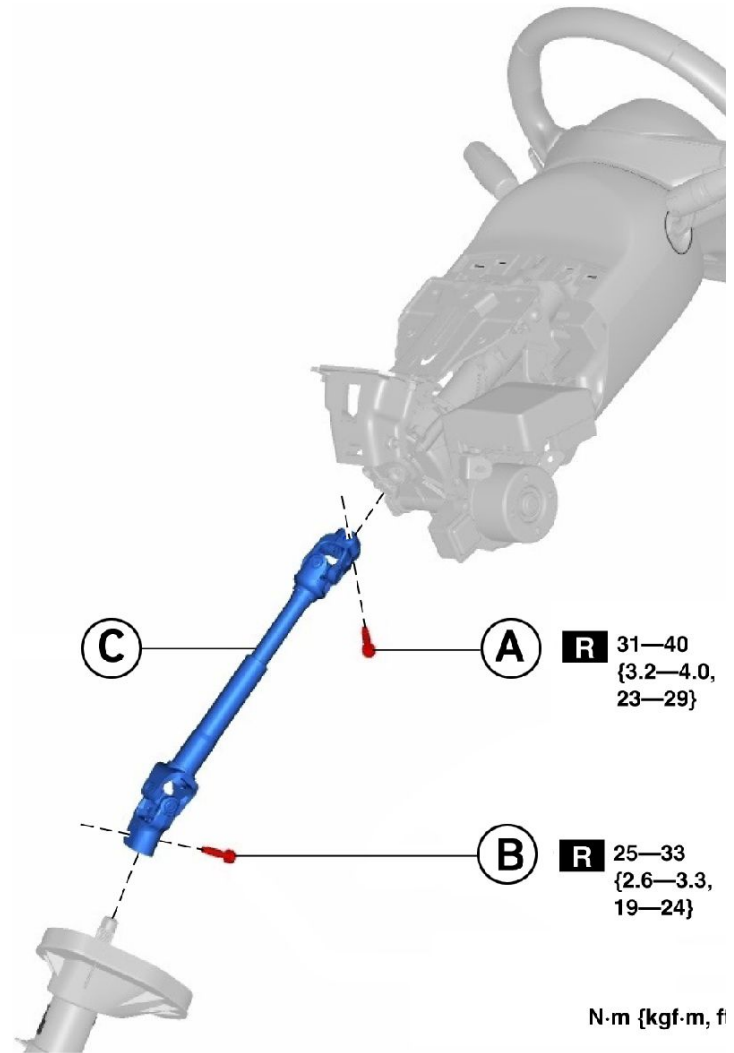
Below is an example of a 2016-2017 Mazda2 intermediate shaft removal/installation:

Intermediate shaft bolts are NON-REUSABLE. If intermediate shaft (C) removal is necessary, discard bolt A and B. Replace them with a new ones. The bolts may come loose while driving if reused.
